FACILITY CONDITION ASSESSMENT

Shelby County Board of Education
160 South Hollywood Street
Memphis, Tennessee 38112-4892
Michelle Stuart

A. B. Hill Elementary School
345 East Olive Avenue
Memphis, Tennessee 38106

March 30, 2024

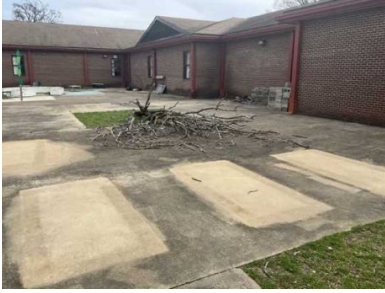
Landscaping in Poor condition.

Mature Trees, Removal/Trimming
A. B. Hill Elementary School Site

Dead/Fallen, hazard to children - AssetCALC ID: 7427997

Uniformat Code: G2080
Recommendation: **Repair in 2024**

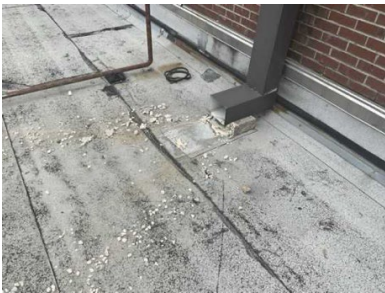
Roofing in Failed condition.

any type, Repairs per Man-Day
A. B. Hill Elementary School Roof

Uniformat Code: B3010
Recommendation: **Repair in 2024**

Replace damaged splash blocks at downspouts - AssetCALC ID: 7427980

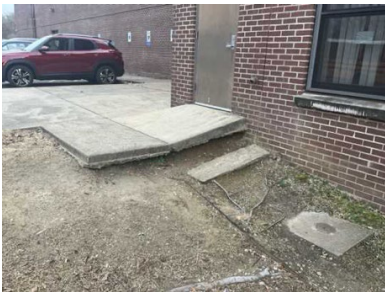
Storm Drainage Components in Poor condition.

Catch Basin, 6' Deep
A. B. Hill Elementary School Site

Stormwater eroding away soil, undermining concrete walkway - AssetCALC ID: 7427965

Uniformat Code: G3030
Recommendation: **Replace/Install in 2024**

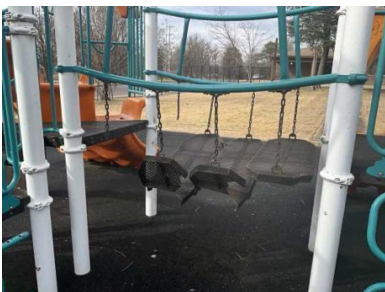
Play Structure in Poor condition.

Multipurpose, Large
A. B. Hill Elementary School Site

Broken pieces - AssetCALC ID: 7428002

Uniformat Code: G2050
Recommendation: **Replace in 2024**

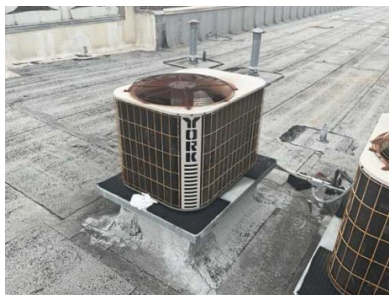
The HVAC equipment present on the rooftop was observed to all be original to building construction (2001), with one unit observed to be malfunctioning. The failed split system heat pump was visually not functioning, hot to the touch, and exhibiting a loud buzzing sound. The site escort was made aware of this unit and in turn informed BV that the HVAC system has been planned for replacement in the next few years. Due to the aged HVAC system, it was reported to BV that areas of the school are poorly heated and cooled. The fire suppression system in the building was also observed to be original to construction.

Split System in Failed condition.

Condensing Unit/Heat Pump, 4 TON
A. B. Hill Elementary School Roof

Uniformat Code: D3030
Recommendation: **Replace in 2024**
