FACILITY CONDITION ASSESSMENT

American Way Middle School
3805 American Way
Memphis, Tennessee 38118

163745.23R000-062.354

August 20, 2024

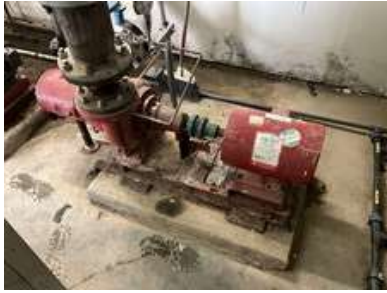
Motor in Poor condition.

AHU or Pump
American Way Middle School AHU room

Exposed rotating parts - AssetCALC ID: 7926966

Uniformat Code: D5030
Recommendation: **Replace in 2025**

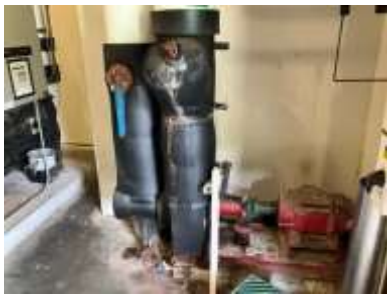
Pump in Poor condition.

Distribution, HVAC Chilled or Condenser Water
American Way Middle School Mechanical room

Exposed rotating component - AssetCALC ID: 7927099

Uniformat Code: D3050
Recommendation: **Replace in 2025**

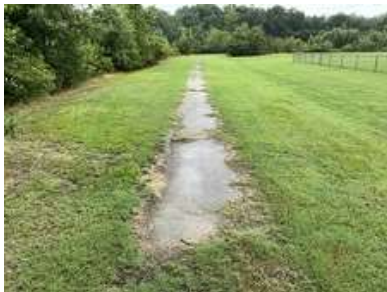
Sidewalk in Failed condition.

Asphalt
American Way Middle School Site

Pathway disintegrating, reclaimed by earth - AssetCALC ID: 7927039

Uniformat Code: G2030
Recommendation: **Replace in 2025**

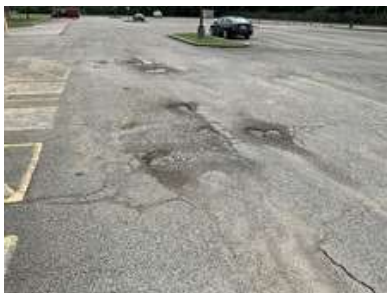
Parking Lots in Poor condition.

Pavement, Asphalt
American Way Middle School Site

Developing potholes in pavement - AssetCALC ID: 7927071

Uniformat Code: G2020
Recommendation: **Cut and Patch in 2024**

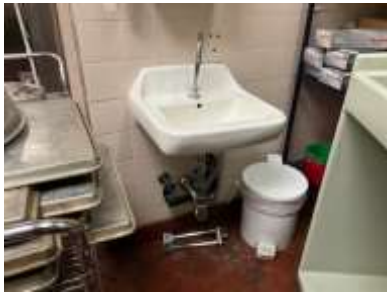
Sink/Lavatory in Failed condition.

Wall-Hung, Vitreous China
American Way Middle School Kitchen

Petal actuators detached - AssetCALC ID: 7926972

Uniformat Code: D2010
Recommendation: **Replace in 2024**

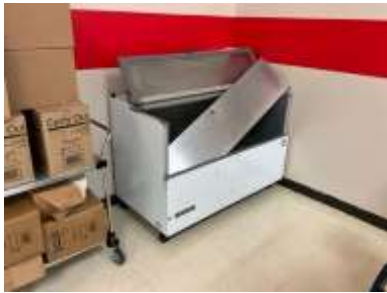
Foodservice Equipment in Failed condition.

Dairy Cooler/Wells
American Way Middle School Cafeteria

Broken enclosure - AssetCALC ID: 7927082

Uniformat Code: E1030
Recommendation: **Replace in 2024**

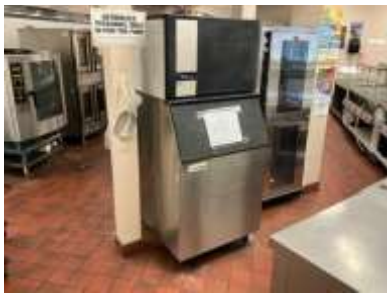
Foodservice Equipment in Poor condition.

Icemaker, Freestanding
American Way Middle School Kitchen

Not functioning at time of assessment replace/repair - AssetCALC ID: 7926957

Uniformat Code: E1030
Recommendation: **Replace in 2024**

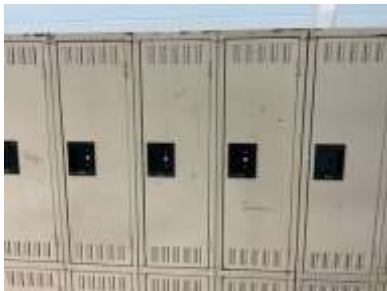
Lockers in Poor condition.

Steel-Baked Enamel, 12" W x 15" D x 72" H
American Way Middle School Throughout building

Remove/demolish worn unused lockers - AssetCALC ID: 7927079

Uniformat Code: C1090
Recommendation: **Replace in 2024**

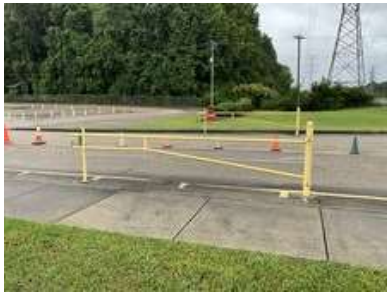
Fences and Gates in Poor condition.

Vehicle Gate, Chain Link Manual
American Way Middle School Parking lot

1 of 2 pairs failed - AssetCALC ID: 7932474

Uniformat Code: G2060
Recommendation: **Replace in 2025**

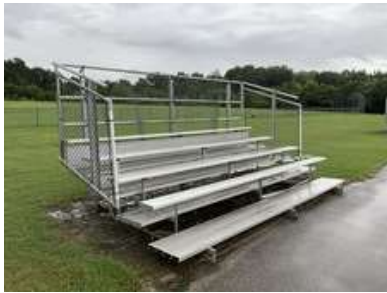
Bleachers in Poor condition.

Fixed Steel Frame, Aluminum Benches (per Seat)
American Way Middle School Site

9xYseats - AssetCALC ID: 7927051

Uniformat Code: E2010
Recommendation: **Replace in 2026**

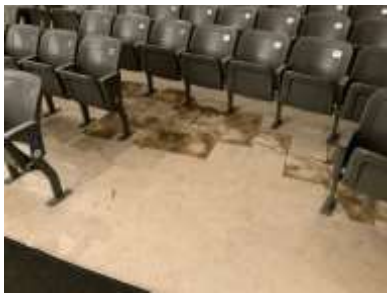
Flooring in Poor condition.

Vinyl Tile (VCT)
American Way Middle School Auditorium

Auditorium VCT worn and detached in some areas - AssetCALC ID: 7927127

Uniformat Code: C2030
Recommendation: **Replace in 2026**

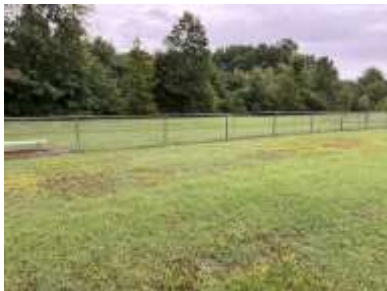
Fences and Gates in Poor condition.

Fence, Chain Link 6'
American Way Middle School Site

Aged, mow back vegetation, replace - AssetCALC ID: 7927100

Uniformat Code: G2060
Recommendation: **Replace in 2026**

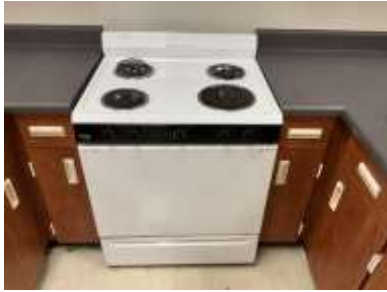
Residential Appliances in Poor condition.

Cooktop, Countertop
 American Way Middle School Home Economics

Broken/Collapsed heating elements - AssetCALC ID: 7927065

Uniformat Code: E1060
 Recommendation: **Replace in 2026**

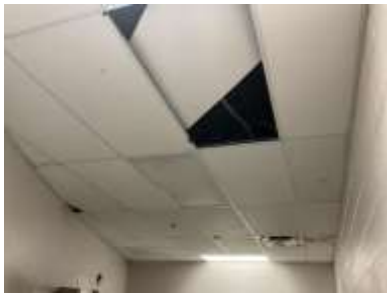
Suspended Ceilings in Poor condition.

Acoustical Tile (ACT)
 American Way Middle School Throughout building

Replace back stage Act 15x60 Leak at stage - AssetCALC ID: 7926983

Uniformat Code: C1070
 Recommendation: **Replace in 2026**
