FACILITY CONDITION ASSESSMENT

Shelby County Board of Education
160 South Hollywood Street
Memphis, Tennessee 38112-4892
Michelle Stuart

Balmoral Elementary
5905 Grosvenor Avenue
Memphis, Tennessee 38119

September 30, 2024

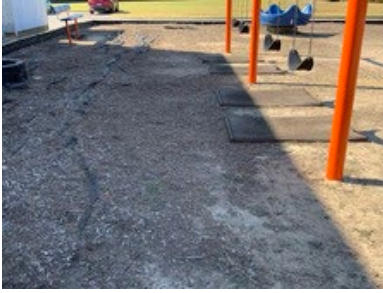
Playfield Surfaces in Poor condition.

Chips Engineered Wood, 3" Depth
Balmoral Elementary Site

Engineered Wood chips are significantly deteriorated. 90 percent of the play surface is now bare soil. - AssetCALC ID: 8086701

Recommendation: **Replace in 2025**

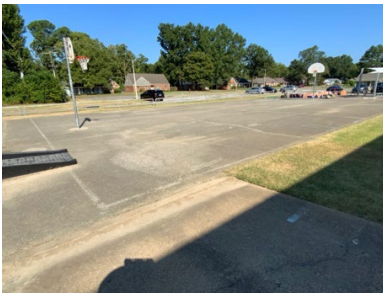
Athletic Surfaces and Courts in Poor condition.

Basketball/General, Asphalt Pavement
Balmoral Elementary Site

Asphalt basketball court has significant deterioration. Uneven surfaces and separation of asphalt is a safety issue. - AssetCALC ID: 8086689

Recommendation: **Seal and Stripe in 2025**

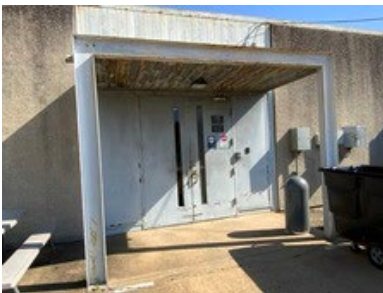
Structural Elements in Poor condition.

any type, Repairs per Man-Day
Balmoral Elementary East side of building

Doors and entryway have major paint deterioration and moderate surface corrosion. - AssetCALC ID: 8086667

Recommendation: **Repair in 2024**

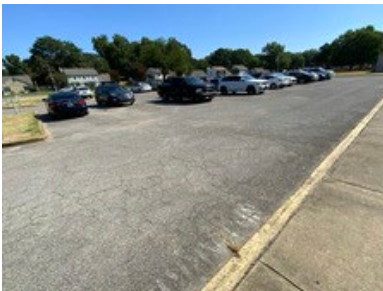
Parking Lots in Poor condition.

Pavement, Asphalt
Balmoral Elementary Site

Driveways and parking areas have degraded to the point that they are predominantly potholes and gravel. - AssetCALC ID: 8086705

Recommendation: **Overlay in 2026**

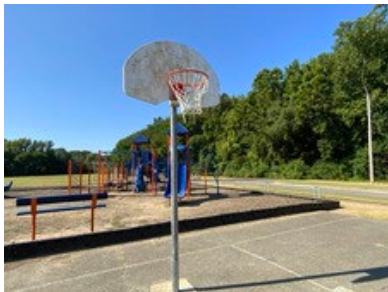
Sports Apparatus in Poor condition.

Basketball, Backboard/Rim/Pole
Balmoral Elementary Site

Unit has moderate corrosion on 80 percent of its surface and support structure. - AssetCALC ID: 8086740

Unifomat Code: G2050
Recommendation: **Replace in 2026**
