FACILITY CONDITION ASSESSMENT

Shelby County Board of Education

Barret's Chapel (K-8)
10280 Godwin Road
Arlington, Tennessee 38002

September 30, 2024

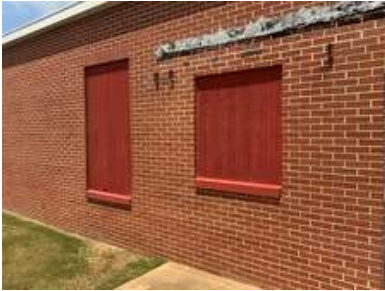
**Window in Poor condition.**

Steel, up to 15 SF
Music Building Barret's Chapel (K-8) Building
Exterior

Windows boarded over - AssetCALC ID: 8030104

Uniformat Code: B2020
Recommendation: **Replace in 2026**

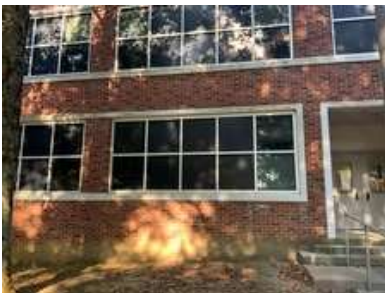
**Storefront in Poor condition.**

Glazing & Framing
Classroom Building Barret's Chapel (K-8)
Building Exterior

Broken seals, aged - AssetCALC ID: 8040910

Uniformat Code: B2020
Recommendation: **Replace in 2026**

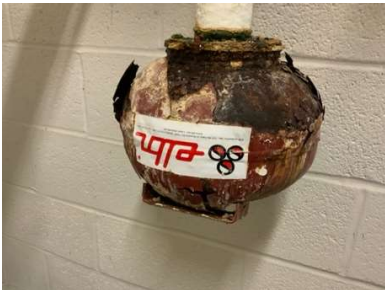
**Boiler Supplemental Components in Failed condition.**

Expansion Tank
Classroom Building Barret's Chapel (K-8) Utility
Rooms/Areas

Leaking, rusted out - AssetCALC ID: 8040971

Uniformat Code: D3020
Recommendation: **Replace in 2024**

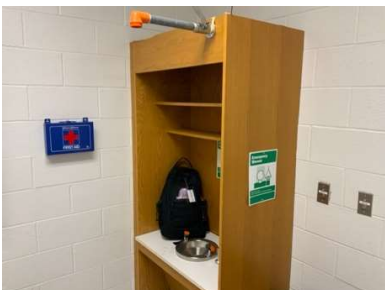
**Emergency Plumbing Fixtures in Failed condition.**

Eye Wash & Shower Station
Classroom Building Barret's Chapel (K-8)
Classrooms Science

Shower head not connected - AssetCALC ID: 8040908

Uniformat Code: D2010
Recommendation: **Replace in 2025**

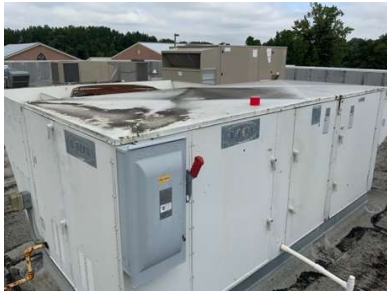
Packaged Unit in Failed condition.

Out of service per poc - AssetCALC ID: 8040888

Uniformat Code: D3050
Recommendation: **Replace in 2024**

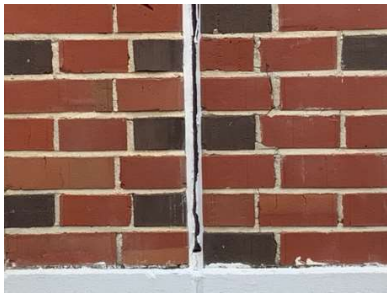
Caulking in Failed condition.

Split open - AssetCALC ID: 8040914

Uniformat Code: B2010
Recommendation: **Replace in 2024**

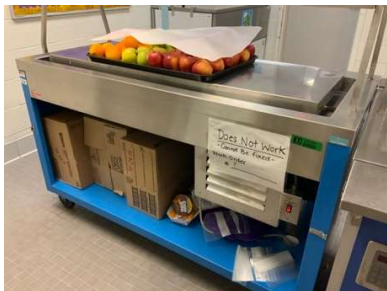
Foodservice Equipment in Failed condition.

Per note cannot be fixed - AssetCALC ID: 8040918

Uniformat Code: E1030
Recommendation: **Replace in 2024**

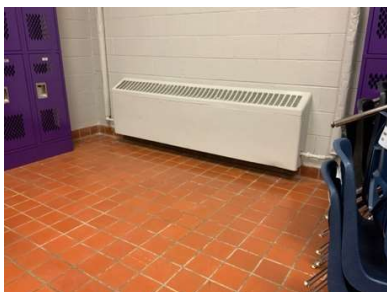
Radiator in Failed condition.

Not in use, boiler removed - AssetCALC ID: 8031336

Uniformat Code: D3020
Recommendation: **Replace in 2024**

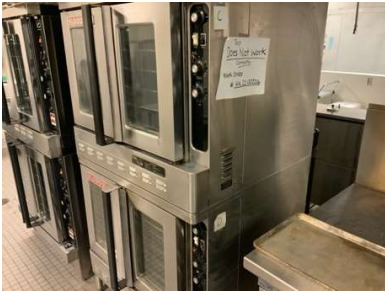
Foodservice Equipment in Poor condition.

Convection Oven, Double
Classroom Building Barret's Chapel (K-8)
Kitchen

Top not working - AssetCALC ID: 8040924

Uniformat Code: E1030
Recommendation: **Replace in 2026**

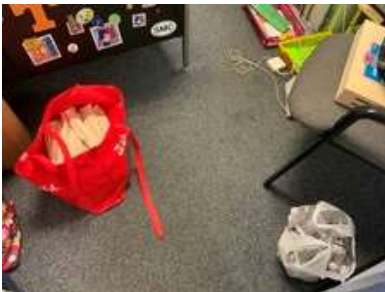
Flooring in Poor condition.

Carpet, Commercial Standard
Music Building Barret's Chapel (K-8) Office
Areas

Worn - AssetCALC ID: 8030112

Uniformat Code: C2030
Recommendation: **Replace in 2026**

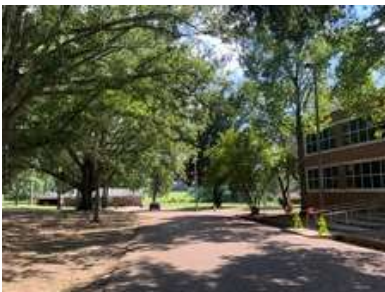
Landscaping in Poor condition.

Mature Trees, Removal/Trimming
Site Barret's Chapel (K-8) Site

Trees have fallen on car and another on the house - AssetCALC ID: 8031421

Uniformat Code: G2080
Recommendation: **Repair in 2026**

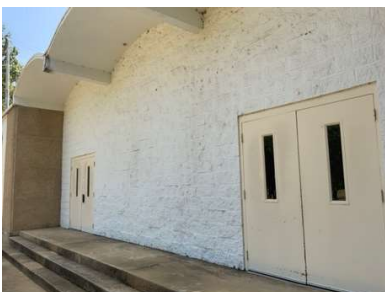
Exterior Door in Poor condition.

Steel, Standard
Gymnasium Barret's Chapel (K-8) Building
Exterior

Rust visible, daylight on inside - AssetCALC ID: 8031338

Uniformat Code: B2050
Recommendation: **Replace in 2026**

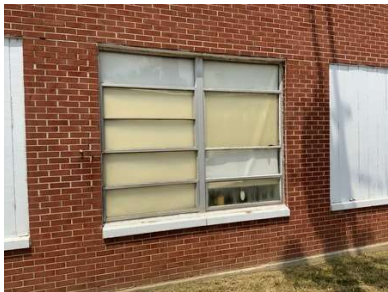
Window in Poor condition.

Aluminum Double-Glazed, up to 15 SF
Gymnasium Barret's Chapel (K-8) Building
Exterior

Single pane, some missing, covered with wood - AssetCALC ID: 8031311

Uniformat Code: B2020
Recommendation: **Replace in 2026**
