FACILITY CONDITION ASSESSMENT

Bellevue Middle School
575 South Bellevue Boulevard
Memphis, Tennessee 38104

163745.23R000-005.354

April 19, 2024

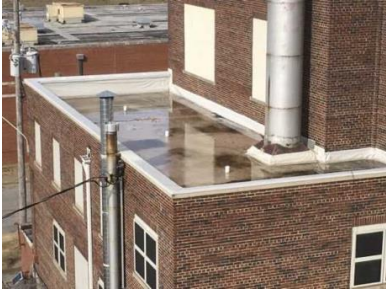
Roofing in Failed condition.

any type, Non-Destructive Moisture Inspection
Bellevue Middle School Roof

Excessive ponding, roof leaks - AssetCALC ID: 7359245

Uniformat Code: B3010
Recommendation: **Evaluate/Report in 2024**

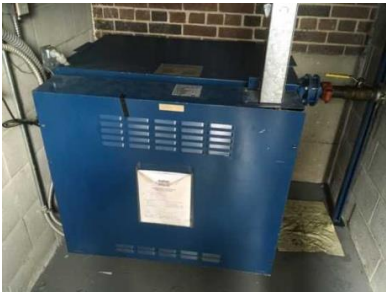
Passenger Elevator in Poor condition.

Hydraulic, 3 Floors
Bellevue Middle School Mechanical room

Regular service calls due to unreliable operation - AssetCALC ID: 7359310

Uniformat Code: D1010
Recommendation: **Renovate in 2025**

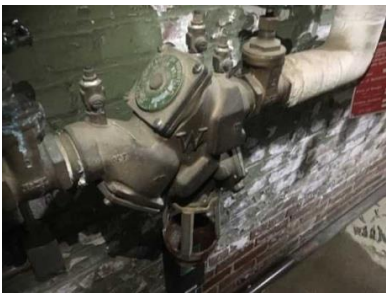
Backflow Preventer in Failed condition.

Domestic Water
Bellevue Middle School Mechanical room

Leaking - AssetCALC ID: 7359354

Uniformat Code: D2010
Recommendation: **Replace in 2024**

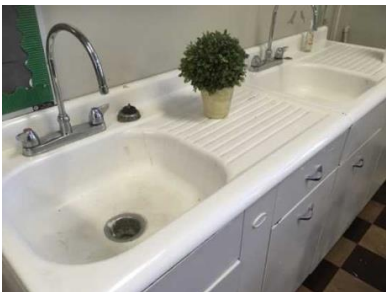
Plumbing System in Poor condition.

Supply and Sanitary, High Density (excludes fixtures)
Bellevue Middle School Throughout

On-going water pressure issues, backups and clogs - AssetCALC ID: 7365594

Uniformat Code: D2010
Recommendation: **Replace in 2024**

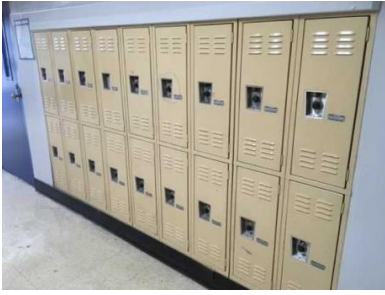
Lockers in Poor condition.

Steel-Baked Enamel, 12" W x 15" D x 72" H
Bellevue Middle School Throughout building

Many failed locks, unusable - AssetCALC ID: 7359269

Uniformat Code: C1090
Recommendation: **Replace in 2024**

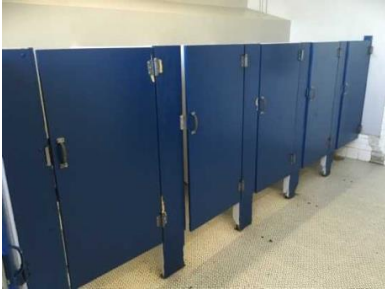
Toilet Partitions in Poor condition.

Plastic/Laminate
Bellevue Middle School Restrooms

Rusted or rotted, rickety, inadequate height, hardware worn - AssetCALC ID: 7359350

Uniformat Code: C1090
Recommendation: **Replace in 2024**

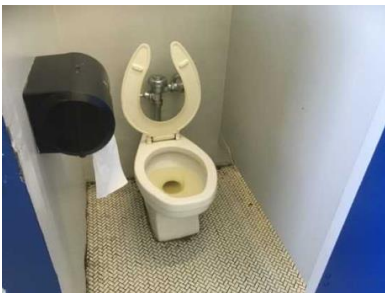
Toilet in Poor condition.

Commercial Water Closet
Bellevue Middle School Restrooms

Obvious wear, issues with maintenance, persistent problems - AssetCALC ID: 7359278

Uniformat Code: D2010
Recommendation: **Replace in 2024**

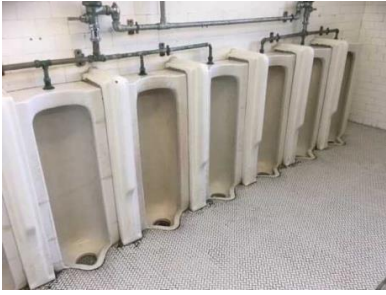
Urinal in Poor condition.

Standard
Bellevue Middle School Restrooms

Obvious wear, marginal reliability, unnecessary quantity - AssetCALC ID: 7359375

Uniformat Code: D2010
Recommendation: **Replace in 2024**

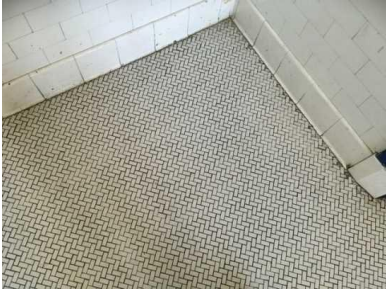
Flooring in Poor condition.

Ceramic Tile
Bellevue Middle School Restrooms

Obvious wear, loose or missing areas - AssetCALC ID: 7359277

Uniformat Code: C2030
Recommendation: **Replace in 2024**

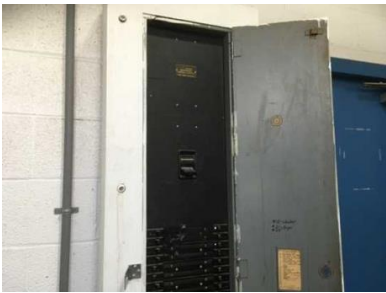
Distribution Panel in Poor condition.

120/208 V
Bellevue Middle School Gymnasium

Obsolete - AssetCALC ID: 7359275

Uniformat Code: D5020
Recommendation: **Replace in 2024**

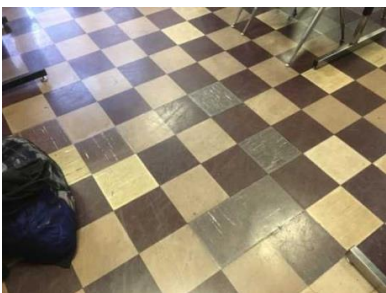
Flooring in Poor condition.

Vinyl Tile (VCT), with Asbestos Abatement
Bellevue Middle School Classrooms

Obvious wear, 9x9 probably ACM - AssetCALC ID: 7359263

Uniformat Code: C2030
Recommendation: **Replace in 2025**

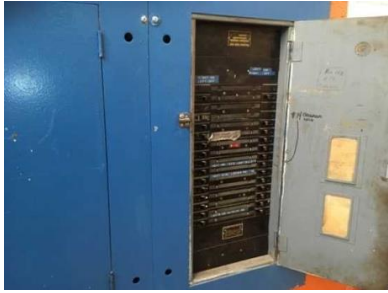
Electrical System in Poor condition.

Full System Renovation/Upgrade, Medium Density/Complexity
Bellevue Middle School Gymnasium

Obsolete - AssetCALC ID: 7359249

Uniformat Code: D5020
Recommendation: **Replace in 2025**

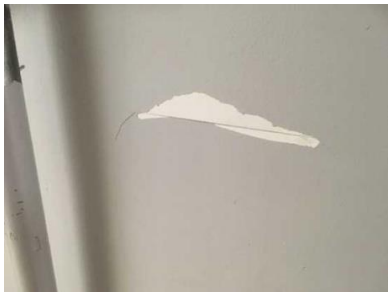
Wall Finishes in Poor condition.

any surface
Bellevue Middle School Throughout building

Many areas of peeling or missing - AssetCALC ID: 7359353

Uniformat Code: C2010
Recommendation: **Prep and Paint in 2025**
