FACILITY CONDITION ASSESSMENT

Berclair Elementary School
810 Perkins Road
Memphis, Tennessee 38122

163745.23R000-006.354

May 3, 2024

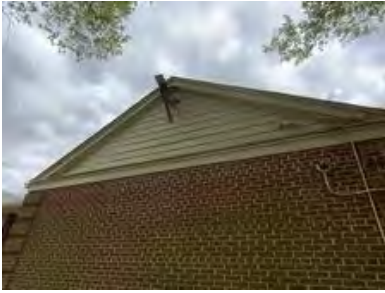
Exterior Walls in Poor condition.

Wood Shakes/Shingles
Main Building Berclair Elementary School
Building Exterior

Exterior siding wall paint is peeling - AssetCALC ID: 7523936

Uniformat Code: B2010
Recommendation: **Replace in 2026**

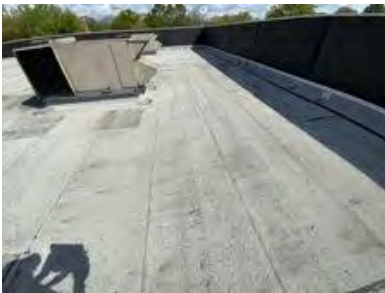
Roofing in Poor condition.

Modified Bitumen
New Annex Building Berclair Elementary
School New Annex Building Roof

Several areas in the roof have started bulging with air pockets throughout the roof. - AssetCALC ID: 7523960

Uniformat Code: B3010
Recommendation: **Replace in 2025**

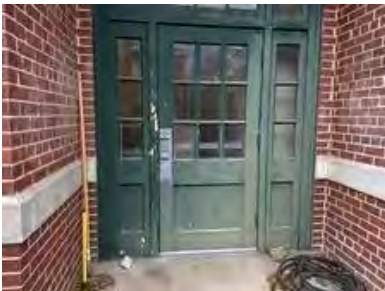
Exterior Door in Poor condition.

Wood, Solid-Core
Main Building Berclair Elementary School
Building Exterior

Exterior wood doors are peeling and faded - AssetCALC ID: 7524018

Uniformat Code: B2050
Recommendation: **Replace in 2026**

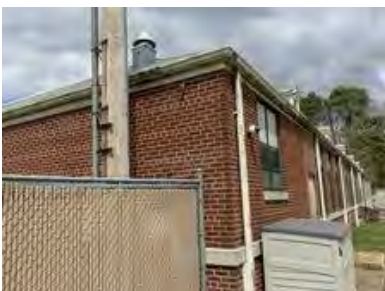
Roof Appurtenances in Poor condition.

Gutters and Downspouts, Aluminum with
Fittings
Old Annex Building Berclair Elementary School
Old Annex Building Roof

Gutters are peeling and damaged in some areas. - AssetCALC ID: 7524020

Uniformat Code: B3020
Recommendation: **Replace in 2026**
