FACILITY CONDITION ASSESSMENT

Bethel Grove Elementary School
2459 Arlington Avenue
Memphis, Tennessee 38114

January 11, 2024

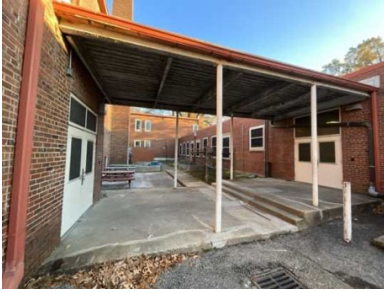
Structural Elements in Poor condition.

The structure was observed to be in poor condition. Deficiencies were: significant paint peeling; rusting and deterioration. - AssetCALC ID: 7156060

any type, Repairs per Man-Day
Bethel Grove Elementary School Building exterior
Uniformat Code: B1010
Recommendation: **Repair in 2023**

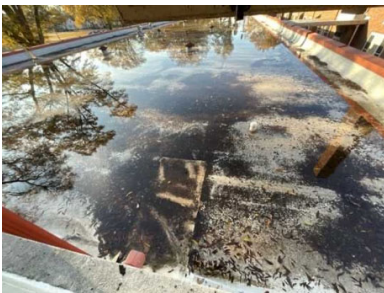
Roofing in Poor condition.

The roofing system was observed to be in poor conditions. Deficiencies included: significant ponding; previous patch repairs, and separation. - AssetCALC ID: 7156074

Single-Ply Membrane, TPO/PVC
Bethel Grove Elementary School Roof
Uniformat Code: B3010
Recommendation: **Replace in 2024**

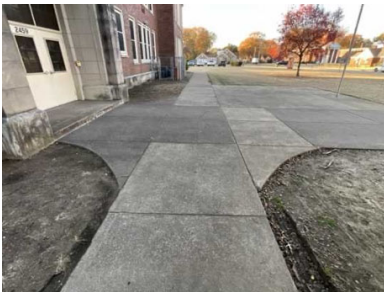
Sidewalk in Poor condition.

The walkways in some areas were observed to have linear cracking and separation to 10% of the area. - AssetCALC ID: 7156048

Concrete, Small Areas/Sections
Bethel Grove Elementary School Building exterior
Uniformat Code: G2030
Recommendation: **Replace in 2024**

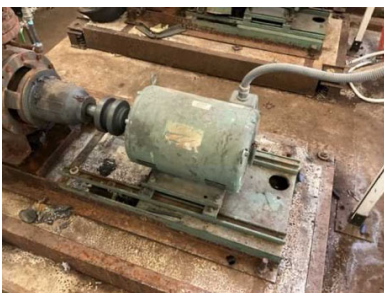
Pump in Poor condition.

Pump was observed to be more than 20 years old. Significant corrosion, and rusting was observed. No data plate was present. - AssetCALC ID: 7156052

Distribution, HVAC Heating Water, 8 to 10 HP
Bethel Grove Elementary School Boiler room
Uniformat Code: D3050
Recommendation: **Replace in 2025**

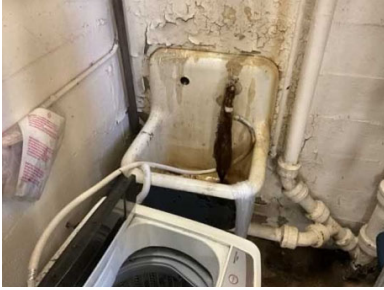
Sink/Lavatory in Failed condition.
 Service Sink, Wall-Hung
 Bethel Grove Elementary School Boiler room
 Uniformat Code: D2010
 Recommendation: **Replace in 2023**

The service in the boiler was observed to be in poor condition. Deficiencies included: broken handles, leaking pipes and rust finishes. - AssetCALC ID: 7156056

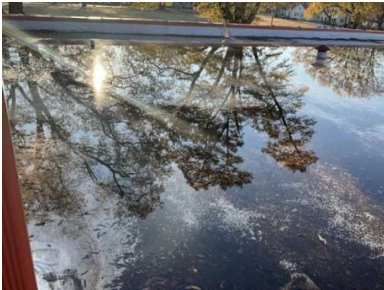
Excessive ponding was observed on the second level roof. Additional drainage is required. A roof evaluation by a qualified consultant is recommended. - AssetCALC ID: 7161513

**Recommended Follow-up Study:
 Building Envelope, Roof**
 Building Envelope, Roof
 Bethel Grove Elementary School Roof
 Uniformat Code: P2030
 Recommendation: **Evaluate/Report in 2023**

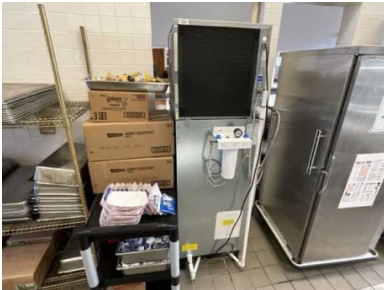
Foodservice Equipment in Failed condition.
 Icemaker, Freestanding
 Bethel Grove Elementary School Kitchen
 Uniformat Code: E1030
 Recommendation: **Replace in 2023**

Machine is not working. - AssetCALC ID: 7156073

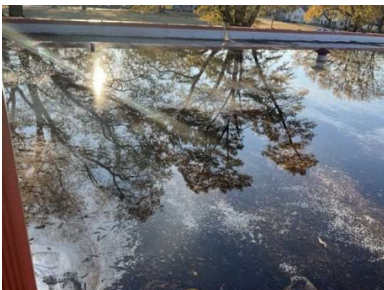
Excessive ponding was observed on the second level roof. Additional drainage is required. - AssetCALC ID: 7161512

Roof drains and interior leaders
 Bethel Grove Elementary School Roof
 Uniformat Code: B3020
 Recommendation: **Install in 2023**
