FACILITY CONDITION ASSESSMENT

Shelby County Board of Education
160 South Hollywood Street
Memphis, Tennessee 38112-4892
Michelle Stuart

Bolton Stadium
7323 Brunswick Road
Arlington, Tennessee 38002

October 21, 2024

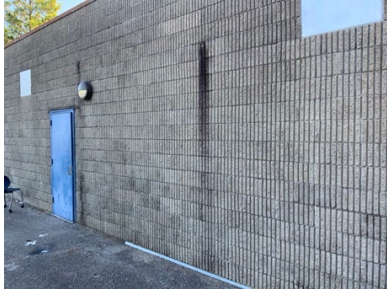
**Exterior Walls in Poor Condition.**

Concrete, Clean & Seal
Bolton Stadium
Building Exterior

Clean & Seal - AssetCALC ID: 8355352

Uniformat Code: B2010
Recommendation: **Maintain in 2026**

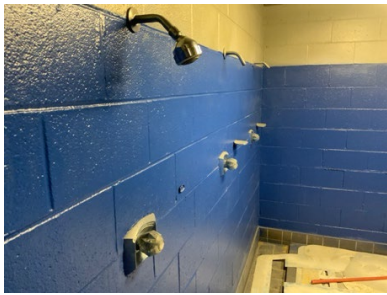
**Shower in Failed Condition.**

Valve & Showerhead
Bolton Stadium
Locker Rooms

Appear out of service - AssetCALC ID: 8355368

Uniformat Code: D2010
Recommendation: **Replace in 2024**

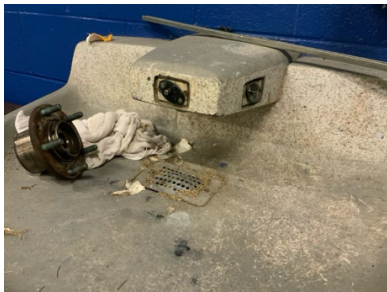
**Sink/Lavatory in Failed Condition.**

Trough Style, Solid Surface
Bolton Stadium
Locker Rooms

Appears out of service - AssetCALC ID: 8355366

Uniformat Code: D2010
Recommendation: **Replace in 2024**

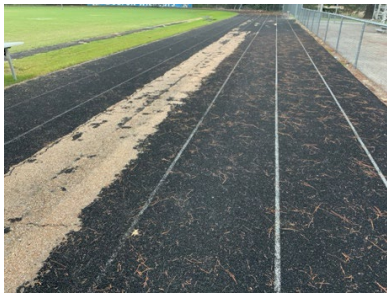
**Athletic Surfaces and Courts in Failed Condition.**

Track Surface, Rubber
Bolton Stadium
Site

Peeling up - AssetCALC ID: 8355409

Uniformat Code: G2050
Recommendation: **Replace in 2026**

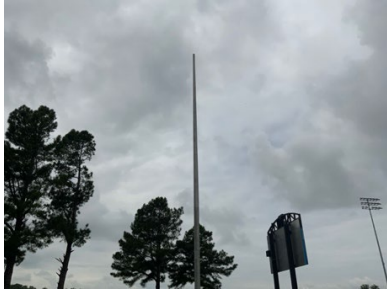
Flagpole in Failed Condition.

Metal
Bolton Stadium
Site

Top with pulley missing - AssetCALC ID: 8355351

Uniformat Code: G2060
Recommendation: **Replace in 2025**

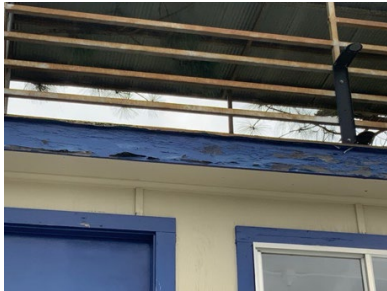
Soffit/Fascia in Poor Condition.

Wood
Bolton Stadium
Roof

Some dry rot, peeling paint - AssetCALC ID: 8355347

Uniformat Code: B3080
Recommendation: **Replace in 2025**

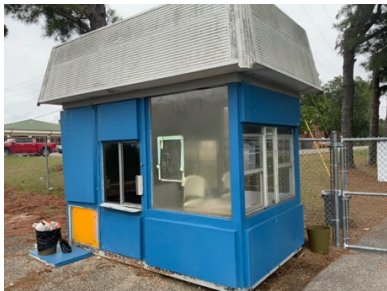
Shed Structure in Failed Condition.

Wood or Metal-Framed, Standard
Bolton Stadium
Site

Broken windows water damage - AssetCALC ID: 8355326

Uniformat Code: F1020
Recommendation: **Replace in 2026**

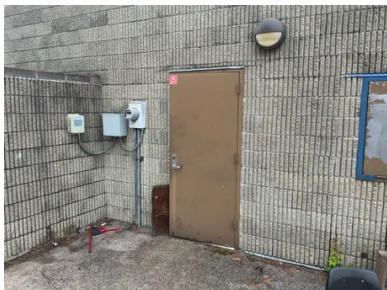
Exterior Door in Poor Condition.

Steel, Standard
Bolton Stadium
Building Exterior

Starting to rust out - AssetCALC ID: 8355372

Uniformat Code: B2050
Recommendation: **Replace in 2026**

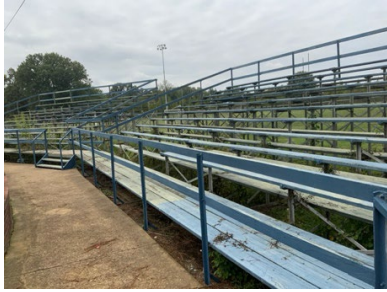
Bleachers in Poor Condition.

Fixed Steel Frame, Aluminum Benches (per Seat)
Bolton Stadium
Baseball

Some seat boards open so you could miss floor board and fall into benches - AssetCALC ID: 8355338

Uniformat Code: E2010
Recommendation: **Replace in 2026**

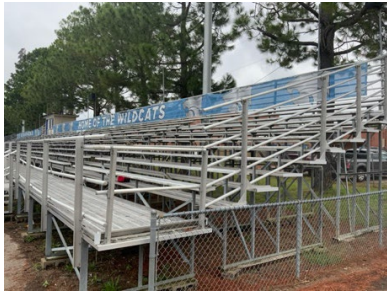
Bleachers in Poor Condition.

Fixed Steel Frame, Aluminum Benches (per Seat)
Bolton Stadium
Site

No ADA seating or ramps, open underneath - AssetCALC ID: 8355378

Uniformat Code: E2010
Recommendation: **Replace in 2026**

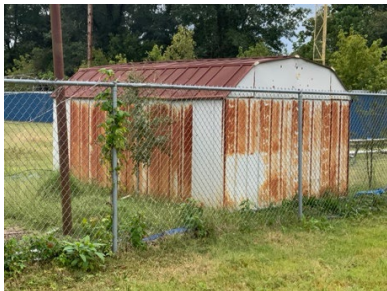
Shed Structure in Poor Condition.

Wood or Metal-Framed, Basic/Minimal
Bolton Stadium
Site

Rusting out - AssetCALC ID: 8355369

Uniformat Code: F1020
Recommendation: **Replace in 2026**

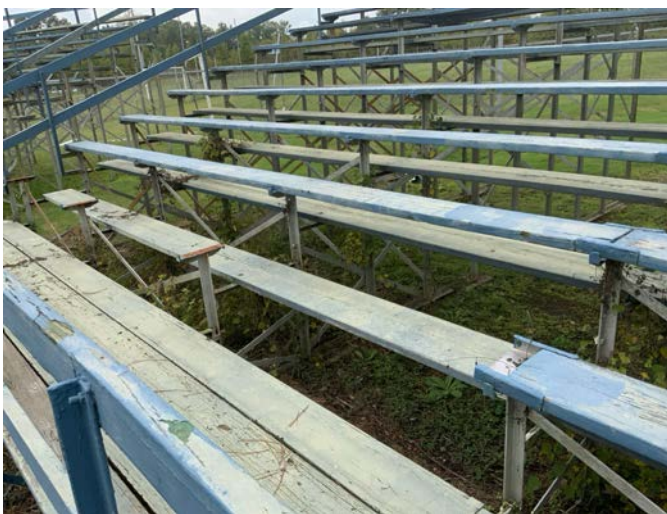
29 - BLEACHERS WITH MISSING BOARDS
