FACILITY CONDITION ASSESSMENT

Shelby County Board of Education
160 South Hollywood Street
Memphis, Tennessee 38112-4892
Michelle Stuart

B.T. Washington High School
715 South Lauderdale Street
Memphis, Tennessee 38126

February 26, 2024

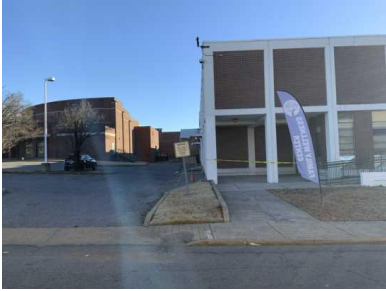
Structural, General Design
B.T. Washington High School Classroom

The northeast corner of the classroom wing has structural cracking and failure of the exterior coating. The roof has been partially replaced with a TPO roof. The remaining area of Modified Bitumen has been coated. That coating is end of life and there are numerous active roof leaks in the building. The exterior windows in the gymnasium are single pane steel framed windows. The interior paint in some areas is peeling off. The hardwood floors have water damage and need to be refinished. The theater curtains are torn with holes. The toilet partitions are rusting out. Generally, the finishes are end of life. There are many areas in the building that have not been maintained.

The stucco is in poor condition. The Northeast Corner of the classroom wing has wall cracking and coating failure visible. A professional engineer must be retained to analyze the existing condition, provide recommendations and, if necessary, estimate the scope and cost of any required repairs. The cost of this study is included in the cost tables. Due to the ambiguity of the required repair scope at the time of this assessment, the cost for any possible subsequent repairs is not included.

Recommended Follow-up Study: Structural, General Design

Exterior coating broken off, cracks visible in exterior wall - AssetCALC ID: 7377106

Uniformat Code: P2030
Recommendation: **Evaluate/Report in 2024**

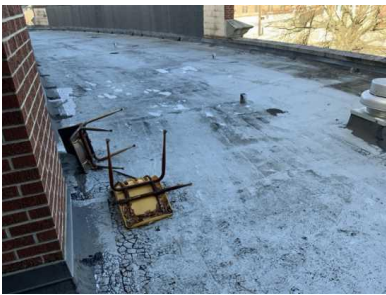
Modified Bitumen
B.T. Washington High School Roof

Roofing in Poor condition.

Roof leaks - AssetCALC ID: 7375859

Uniformat Code: B3010
Recommendation: **Replace in 2026**

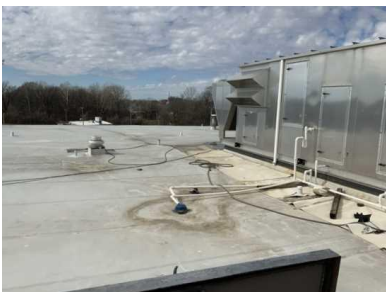
Single-Ply Membrane, TPO/PVC
B.T. Washington High School Roof

Roofing in Poor condition.

Multiple roof leaks - AssetCALC ID: 7376004

Uniformat Code: B3010
Recommendation: **Replace in 2026**

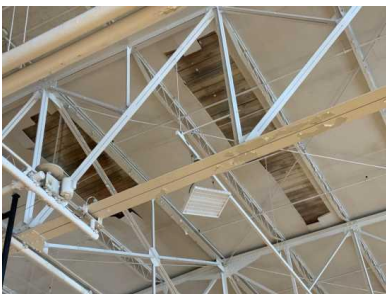
Dampening Panels for Soundproofing
B.T. Washington High School Gymnasium

Ceiling in Poor condition.

Sound panels are falling down - AssetCALC ID: 7375894

Uniformat Code: C2010
Recommendation: **Replace in 2026**

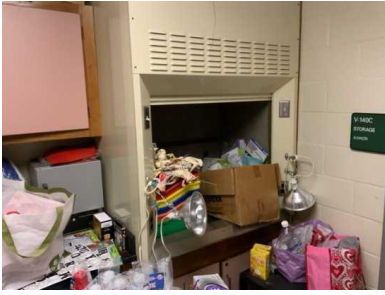
Exhaust Hood, Constant Volume 4 LF
B.T. Washington High School Classrooms

Laboratory Equipment in Failed condition.

Out of service - AssetCALC ID: 7375888

Uniformat Code: E1040
Recommendation: **Replace in 2024**

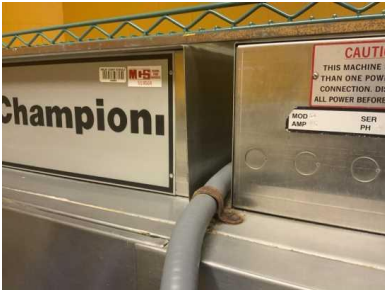
Dishwasher Commercial
B.T. Washington High School Kitchen

Foodservice Equipment in Failed condition.

Out of service - AssetCALC ID: 7376012

Uniformat Code: E1030
Recommendation: **Replace in 2024**

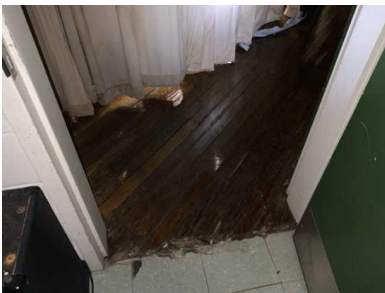
Wood, Strip
B.T. Washington High School Theater

Flooring in Poor condition.

Water Damaged - AssetCALC ID: 7375855

Uniformat Code: C2030
Recommendation: **Refinish in 2025**

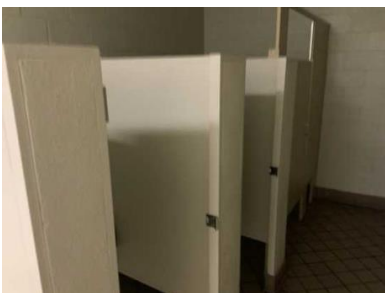
Metal
B.T. Washington High School Restrooms

Toilet Partitions in Poor condition.

Rusting out - AssetCALC ID: 7375962

Uniformat Code: C1090
Recommendation: **Replace in 2026**

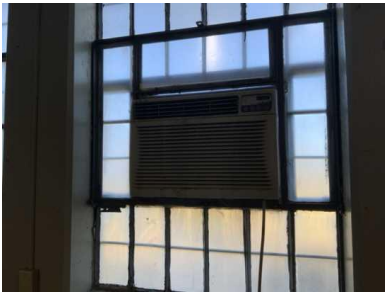
Window/Thru-Wall
B.T. Washington High School Classrooms

Air Conditioner

Uniformat Code: D3030
Recommendation: **Replace in 2025**

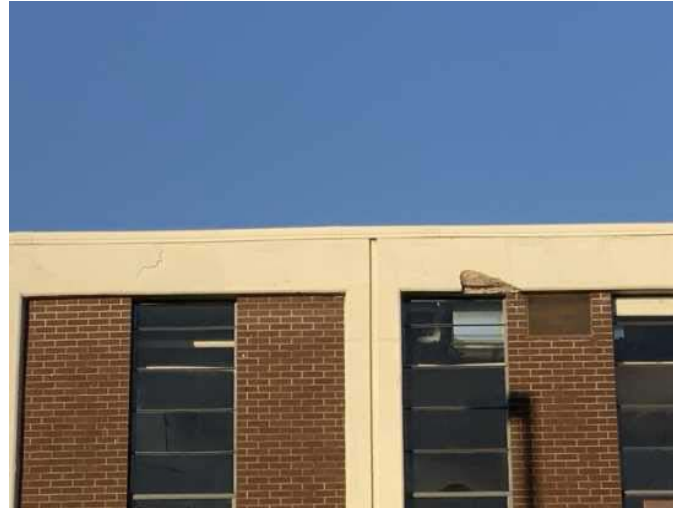
8 - STRUCTURAL ISSUE
