# FACILITY CONDITION ASSESSMENT

**Shelby County Board of Education**  
160 South Hollywood Street  
Memphis, Tennessee 38112-4892  
Michelle Stuart

Booker T. Washington High School Stadium  
715 South Lauderdale Street  
Memphis, Tennessee 38126

April 22, 2024

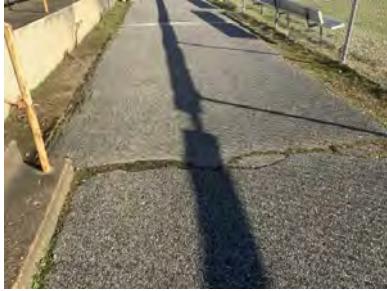
**Sidewalk in Poor condition.**

Asphalt  
Booker T. Washington High School Stadium  
Site

Large cracks, depressions and potholes - AssetCALC ID: 7381096

Uniformat Code: G2030  
Recommendation: **Replace in 2026**

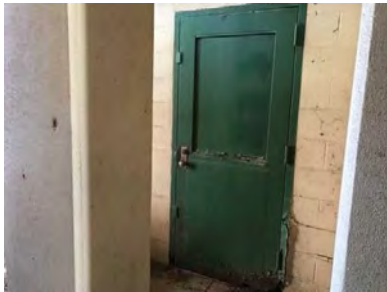
**Exterior Door in Poor condition.**

Steel, Standard  
Booker T. Washington High School Stadium  
Building Exterior

doors and frames rusting out - AssetCALC ID: 7368576

Uniformat Code: B2050  
Recommendation: **Replace in 2026**

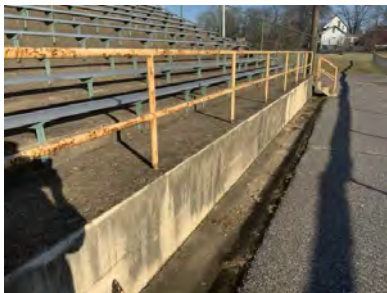
**Stair/Ramp Rails in Poor condition.**

Metal  
Booker T. Washington High School Stadium  
Site

Rusting, paint peeling - AssetCALC ID: 7381106

Uniformat Code: B1080  
Recommendation: **Refinish in 2026**

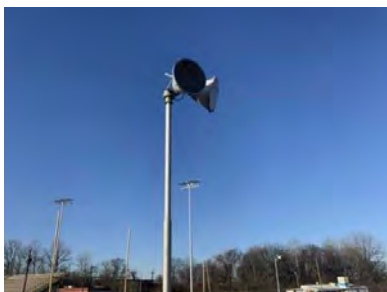
**Pole Light Fixture with Lamps in Poor condition.**

any type 20' High, with LED Replacement  
Booker T. Washington High School Stadium  
Site

Might not be functional - AssetCALC ID: 7381098

Uniformat Code: G4050  
Recommendation: **Replace/Install in 2026**

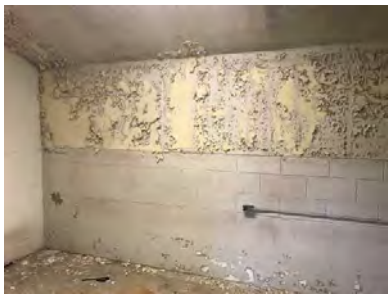
Wall Finishes in Poor condition.

any surface  
Booker T. Washington High School Stadium  
Throughout building

Failing Paint in the locker rooms. - AssetCALC ID: 7368573

Uniformat Code: C2010  
Recommendation: **Prep and Paint in 2026**

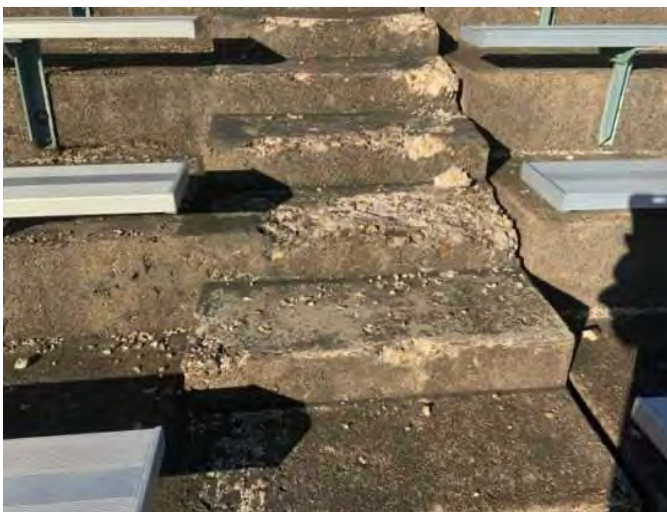
23 - BALCONY STRUCTURE - SPALLING

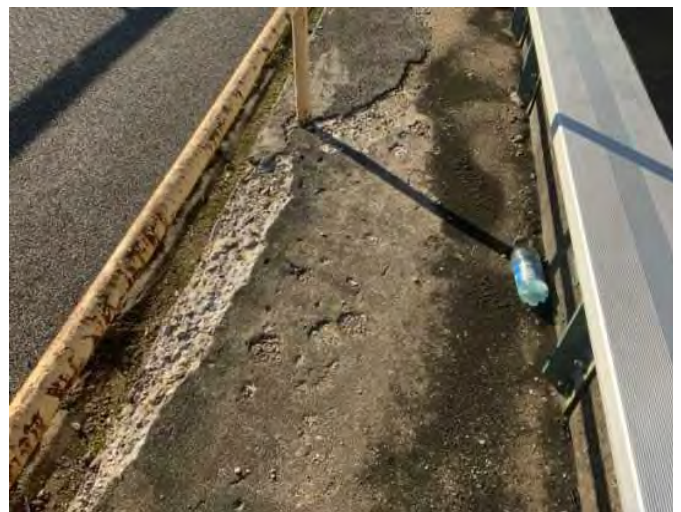
24 - BALCONY STRUCTURE - SPALLING
