FACILITY CONDITION ASSESSMENT

Brownsville Road Elementary
5292 Banbury Avenue
Memphis, Tennessee 38135

163745.23R000-072.354

November 21, 2024

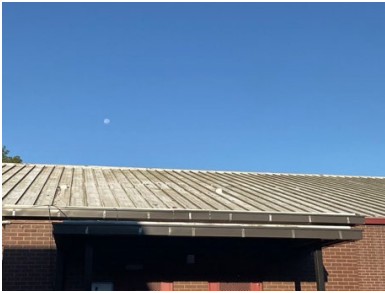
Roofing in Poor Condition.

Metal
Gymnasium Brownsville Road Elementary
Roof

Roof leaks - AssetCALC ID: 8520739

Uniformat Code: B3010
Recommendation: **Replace in 2025**

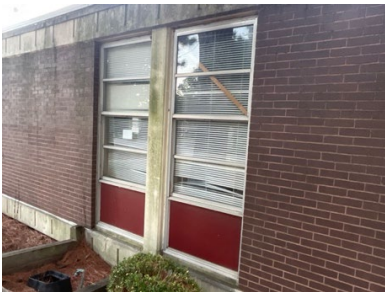
Window in Poor Condition.

Aluminum Double-Glazed, 28-40 SF
Main School Brownsville Road Elementary
Building Exterior

Damaged seals, damaged caulking - AssetCALC ID: 8520797

Uniformat Code: B2020
Recommendation: **Replace in 2025**

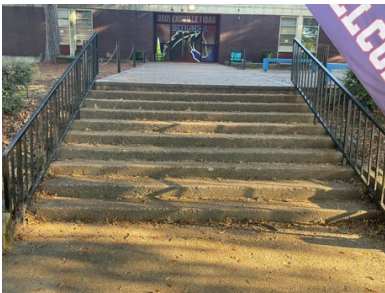
Site Stairs and Ramps in Poor Condition.

Steps, Concrete (per LF of nosing)
Site Brownsville Road Elementary
Site

Damaged/broken concrete at the bottom of the steps. Crack/damaged stairs and landing. Several chipped stairs throughout site. - AssetCALC ID: 8520741

Uniformat Code: G2030
Recommendation: **Replace in 2026**

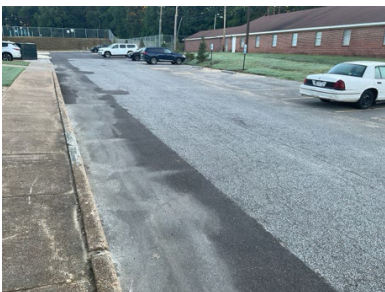
Parking Lots in Poor Condition.

Pavement, Asphalt
Site Brownsville Road Elementary
Parking lot

Potholes and cracked surface - AssetCALC ID: 8520785

Uniformat Code: G2020
Recommendation: **Mill & Overlay in 2026**

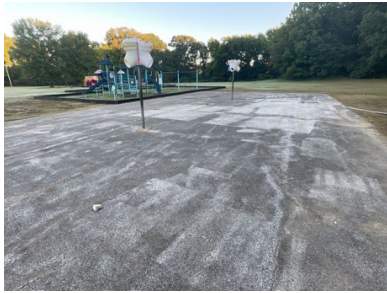
Athletic Surfaces and Courts in Poor Condition.

Basketball/General, Asphalt Pavement
Site Brownsville Road Elementary Site

Several small holes in asphalt. Cracked surface with asphalt debris attached. - AssetCALC ID: 8520839

Uniformat Code: G2050
Recommendation: **Mill & Overlay in 2026**

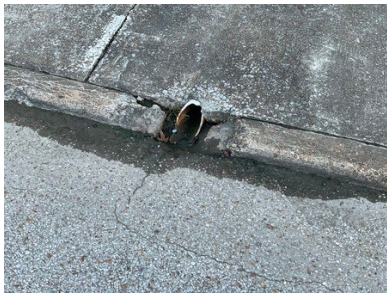
Roof Drains and Interior Leaders in Poor Condition.

Main School Brownsville Road Elementary
Roof

Broken/clogged drain. Drain near curb floods during heavy rain. - AssetCALC ID: 8520800

Uniformat Code: B3020
Recommendation: **Replace in 2025**

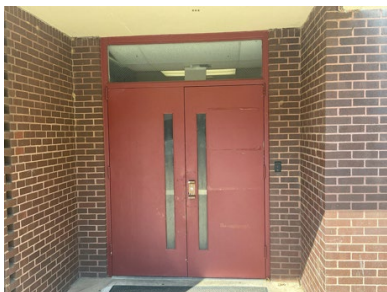
Exterior Door in Poor Condition.

Steel, Commercial
Main School Brownsville Road Elementary
Building Exterior

Door seals are not functional. During heavy rains interior hallway floods. - AssetCALC ID: 8520775

Uniformat Code: B2050
Recommendation: **Replace in 2025**

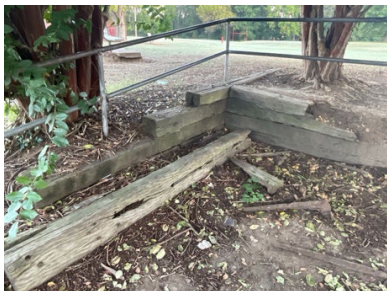
Retaining Wall in Poor Condition.

Treated Timber
Site Brownsville Road Elementary Site

Damaged/corroded wood. Wall has corroded to the point of separation from foundation. - AssetCALC ID: 8520842

Uniformat Code: G2060
Recommendation: **Replace in 2025**

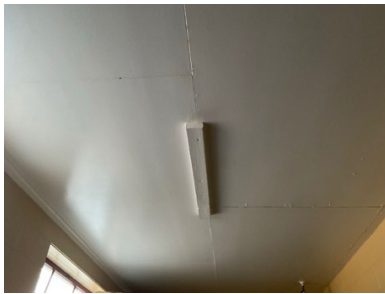
Ceiling Finishes in Poor Condition.

Wood Paneling
Gymnasium Brownsville Road Elementary
Storage room

Worn ceiling finishing - AssetCALC ID: 8520767

Uniformat Code: C2050
Recommendation: **Replace in 2026**

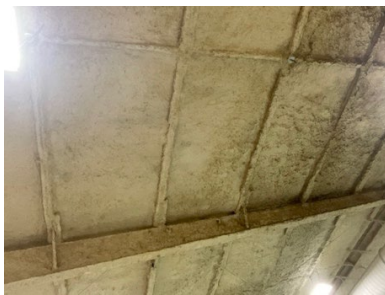
Ceiling Finishes in Poor Condition.

Textured Spray Coating
Gymnasium Brownsville Road Elementary
Gymnasium

Ceiling is stain from water damage. Water leaks from metal roof - AssetCALC ID: 8520760

Uniformat Code: C2050
Recommendation: **Replace in 2026**

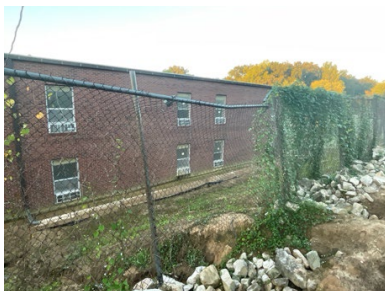
Fences & Gates in Poor Condition.

Fence, Chain Link 8'
Site Brownsville Road Elementary
Site

Fence is damaged. Several locations where fencing is missing or bent. - AssetCALC ID: 8520790

Uniformat Code: G2060
Recommendation: **Replace in 2026**
