FACILITY CONDITION ASSESSMENT

Bruce Elementary School
581 South Bellevue Boulevard
Memphis, Tennessee 38104

April 19, 2024

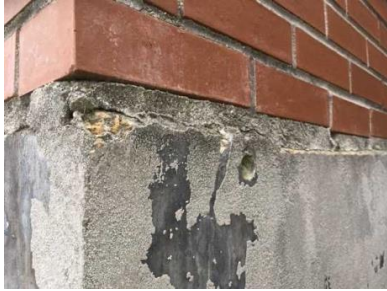
Exterior Walls in Failed condition.

Concrete
Bruce Elementary School Building exterior

Surface finish is scaling away - AssetCALC ID: 7359145

Uniformat Code: B2010
Recommendation: **Repair in 2024**

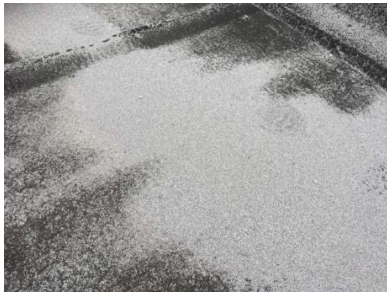
Roofing in Poor condition.

Modified Bitumen
Bruce Elementary School Roof

Leaks during heavy rain, advanced age-wear, missing grit - AssetCALC ID: 7359111

Uniformat Code: B3010
Recommendation: **Replace in 2025**

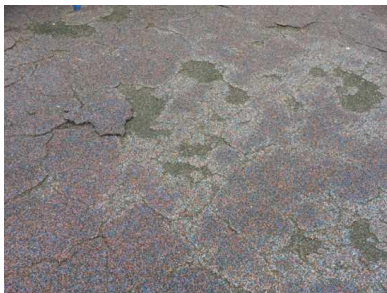
Playfield Surfaces in Failed condition.

Rubber, Small Areas
Bruce Elementary School Site

Worn through and missing portions - AssetCALC ID: 7359171

Uniformat Code: G2050
Recommendation: **Replace in 2024**

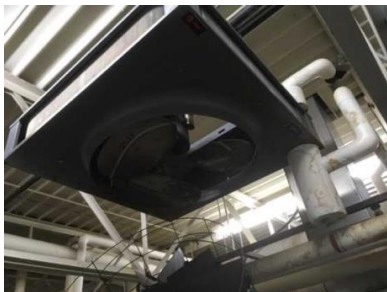
Unit Heater in Failed condition.

Hydronic
Bruce Elementary School Mechanical room

Undetermined failure - AssetCALC ID: 7359158

Uniformat Code: D3020
Recommendation: **Replace in 2024**

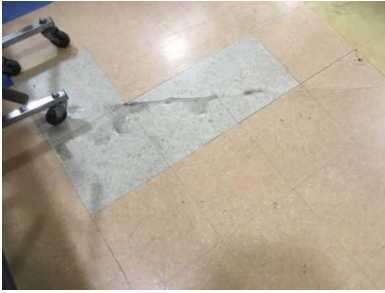
Flooring in Poor condition.

Vinyl Tile (VCT)
Bruce Elementary School Multi purpose

Cracks and voids, heaving - AssetCALC ID: 7359126

Uniformat Code: C2030
Recommendation: **Replace in 2024**

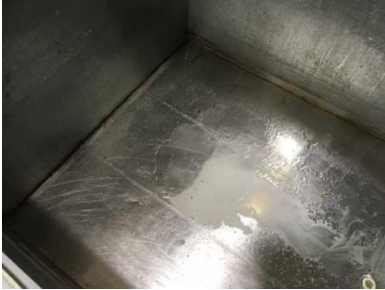
Foodservice Equipment in Poor condition.

Dairy Cooler/Wells
Bruce Elementary School Kitchen

Multiple failed seals, excessive moisture and rusting - AssetCALC ID: 7359196

Uniformat Code: E1030
Recommendation: **Replace in 2025**

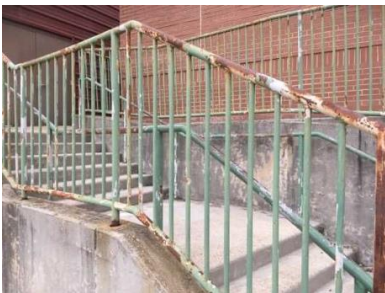
Stair/Ramp Rails in Poor condition.

Metal
Bruce Elementary School Site

Peeling and rusting throughout - AssetCALC ID: 7359222

Uniformat Code: B1080
Recommendation: **Refinish in 2024**

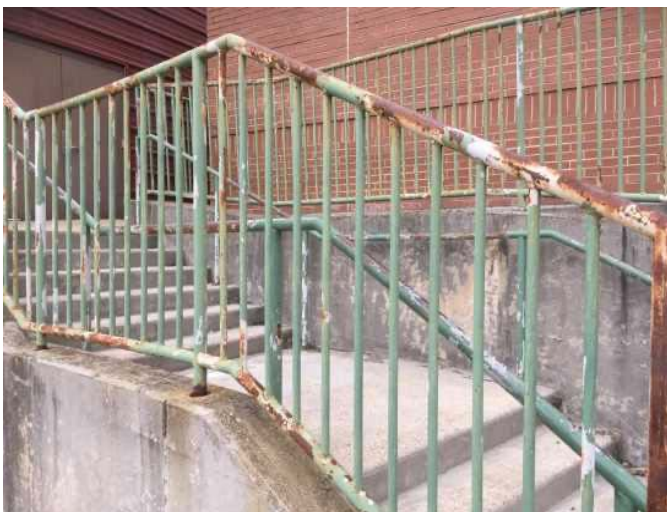
5 - RAILS, METAL, REFINISH

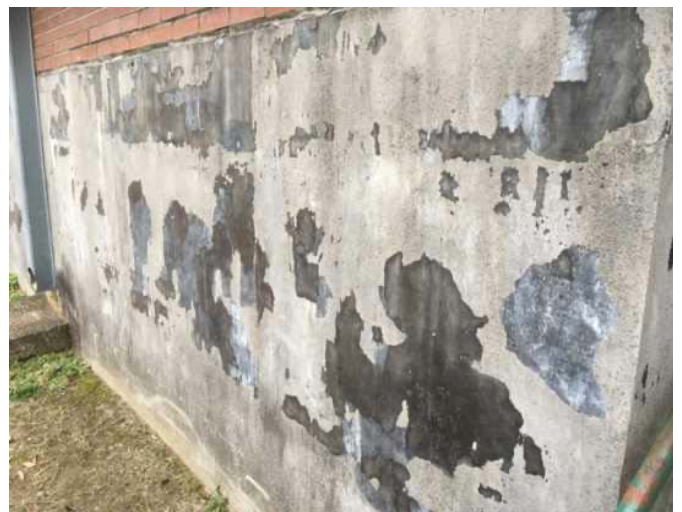
6 - EXTERIOR WALLS, CONCRETE, REPAIR

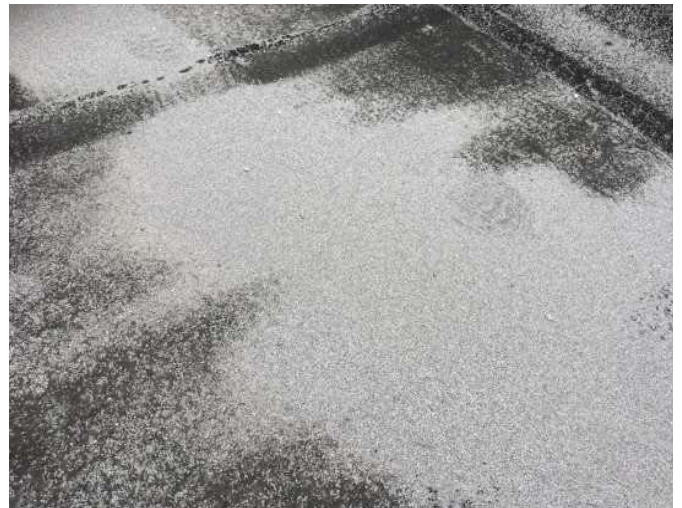
10 - ROOFING, MODIFIED BITUMEN
