FACILITY CONDITION ASSESSMENT

Central High School
306 South Bellevue Boulevard
Memphis, Tennessee 38104

163745.23R000-076.354

October 17, 2024

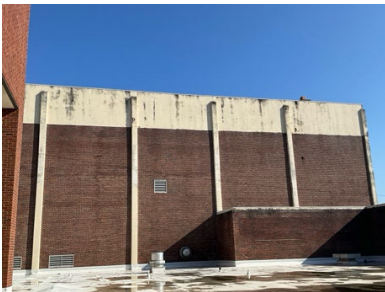
**Exterior Walls in Poor Condition.**

Any surface, Heavy Staining/Soiling
Central High School
Building Exterior

Heavy staining - AssetCALC ID: 8333847

Uniformat Code: B2010
Recommendation: **Replace in 2024**

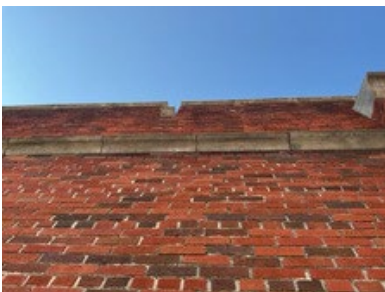
**Exterior Walls in Poor Condition.**

Stone
Central High School
Building Exterior

Many of the stone elements should be caulked. - AssetCALC ID: 8176440

Uniformat Code: B2010
Recommendation: **Repair in 2024**

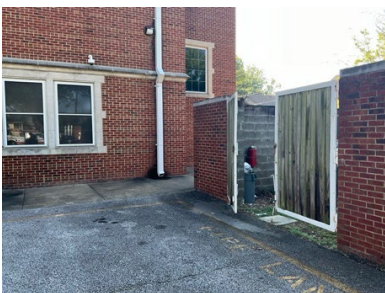
**Exterior Walls in Poor Condition.**

Brick
Central High School
Building Exterior

About 30-40% of the exterior brick needs to have tuckpointing or be replaced. - AssetCALC ID: 8333858

Uniformat Code: B2010
Recommendation: **Repair in 2024**

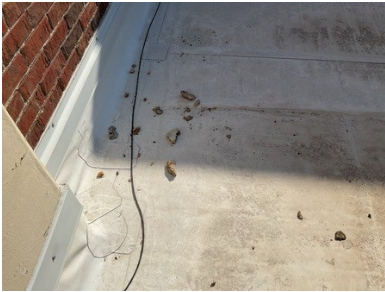
Sections of deteriorated concrete were observed. In particular, sections of crumbled concrete were observed on the roof surfaces. It appeared that sections of the concrete coping of the auditorium roof parapets had disintegrated and fallen onto the roof below. Also, it appeared that the (north-west) concrete spandrel column of the auditorium structure was spalling. A section of exterior wall at the east side of the building, near the kitchen exhibited significant damage as well.

Roofing in Poor Condition.

Any type, Repairs per Man-Day
Central High School
Building Exterior

Some of the concrete coping elements have disintegrated. Some sections of external concrete have deteriorated as well. - AssetCALC ID: 8176420

Uniformat Code: B3010
Recommendation: **Repair in 2024**

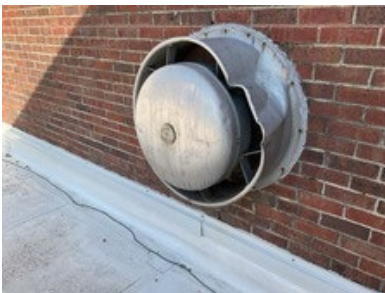
Exhaust Fan in Poor Condition.

Centrifugal, 12" Damper
Central High School
Roof

Appeared to be non-functional. - AssetCALC ID: 8176461

Uniformat Code: D3060
Recommendation: **Replace in 2024**

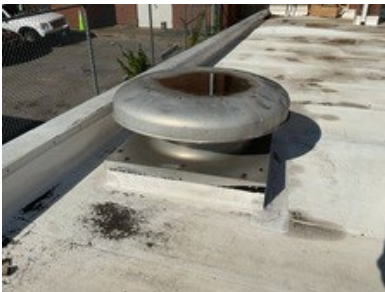
Exhaust Fan in Poor Condition.

Centrifugal, 12" Damper
Central High School
Roof

The fan has exceeded its Expected Useful Life by a wide margin. - AssetCALC ID: 8176459

Uniformat Code: D3060
Recommendation: **Replace in 2024**

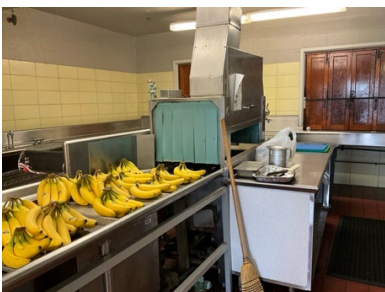
Foodservice Equipment in Failed Condition.

Dishwasher Commercial
Central High School
Kitchen

Not in use. - AssetCALC ID: 8333902

Uniformat Code: E1030
Recommendation: **Replace in 2024**

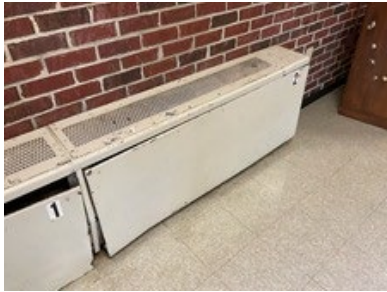
**Unit Ventilator in Poor Condition.**

Approx./nominal 2 Ton
Central High School
Lobby

The units are no longer in service. - AssetCALC ID: 8170080

Unifomat Code: D3030
Recommendation: **Replace in 2024**

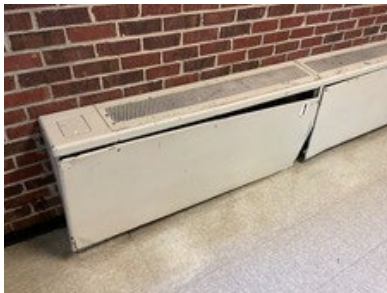
**Unit Ventilator in Poor Condition.**

Approx./nominal 2 Ton
Central High School
Lobby

The units are no longer in service. - AssetCALC ID: 8170133

Unifomat Code: D3030
Recommendation: **Replace in 2024**

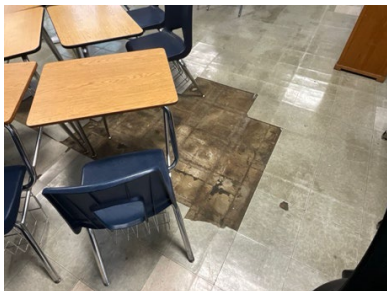
**Recommended Follow-up Study:
Environmental, Analysis of
Suspect Fungal Growth**

Environmental, Analysis of Suspect Fungal
Growth
Central High School
Classrooms General

Suspect fungal growth observed. - AssetCALC ID: 8333911

Unifomat Code: P2030
Recommendation: **Evaluate/Report in 2024**

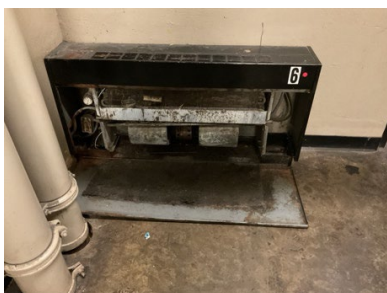
**Unit Ventilator in Poor Condition.**

Approx./nominal 2 Ton
Central High School
Stairwells

The units are no longer in use. - AssetCALC ID: 8170019

Unifomat Code: D3030
Recommendation: **Replace in 2024**

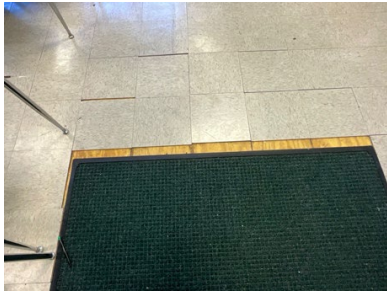
Flooring in Poor Condition.

Vinyl Tile (VCT)
Central High School
Throughout Building

Water Damage and Likely to have asbestos - AssetCALC ID: 8333852

Uniformat Code: C2030
Recommendation: **Replace in 2025**

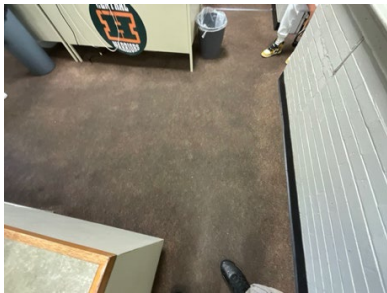
Flooring in Poor Condition.

Carpet, Commercial Standard
Central High School
Office Areas

Outdated - AssetCALC ID: 8333865

Uniformat Code: C2030
Recommendation: **Replace in 2025**

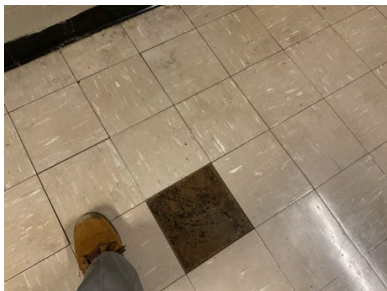
Suspect asbestos floor covering was observed in the corridors of "C"-Wing. For these reasons, a consultant must be retained to analyze the existing condition, provide recommendations and, if necessary, estimate the scope and cost of any required repairs. The cost of this study is included in the cost tables. Due to the ambiguity of the required repair scope at the time of this assessment, the cost for any possible subsequent repairs is not included.

Recommended Follow-up Study: Environmental, Asbestos (ACM) & Lead Base Paint (LBP)

Environmental, Asbestos (ACM) and Lead
Base Paint (LBP)
Central High School
Hallways and Common Areas

Uniformat Code: P2030
Recommendation: **Evaluate/Report in 2024**

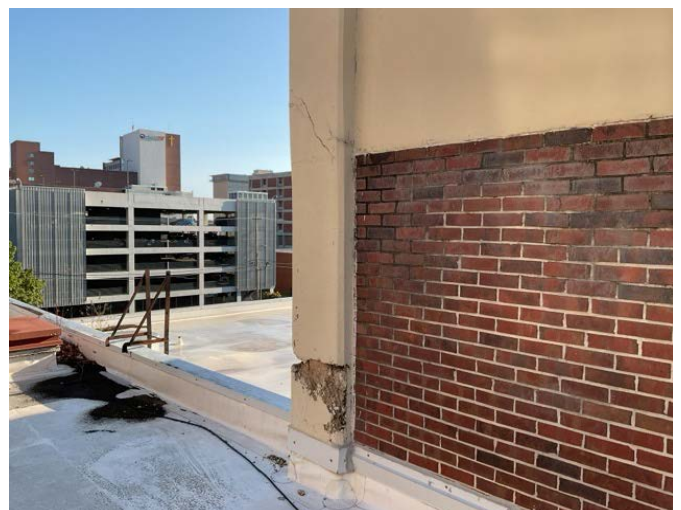
24 - CONCRETE DETERIORATION

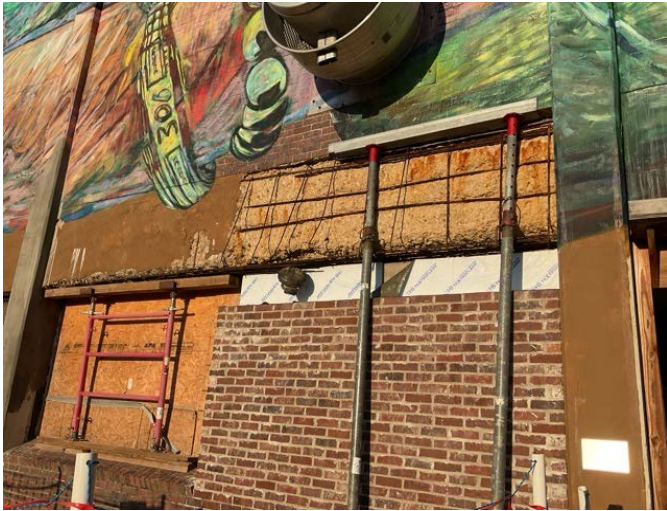
25 - EXTERIOR WALL DETERIORATION

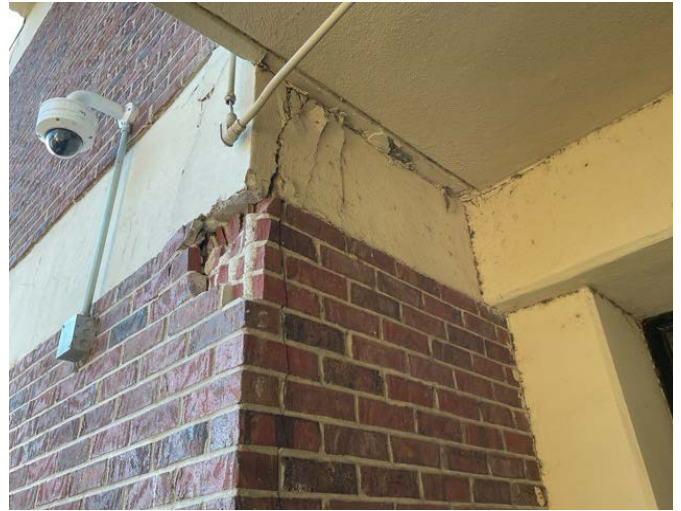
26 - EXTERIOR WALL DETERIORATION

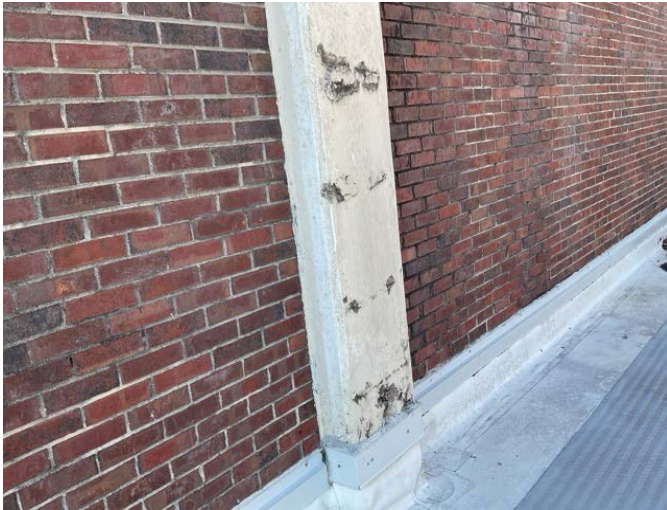
27 - SPALLED CONCRETE

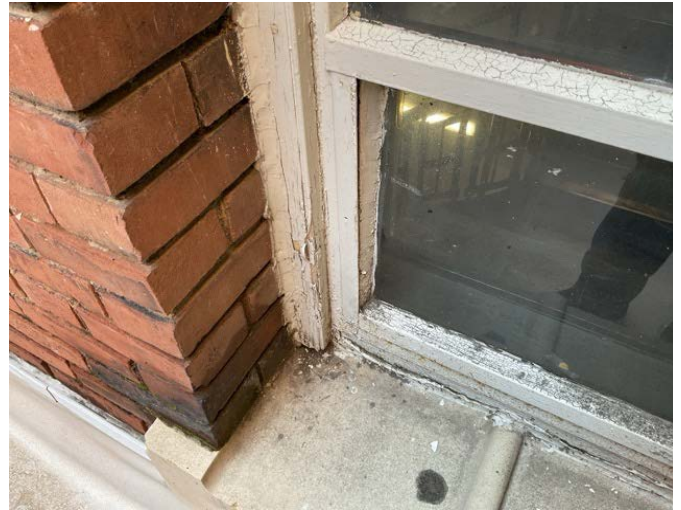
Most of the original windows of the original building (Building A) have been replaced but the courtyard windows appeared to be older, perhaps original. Some of the window frames should be scraped and re-painted. The windows of the C-Wing appeared to be the original units.

28 - OLDER WINDOWS AND FRAMES

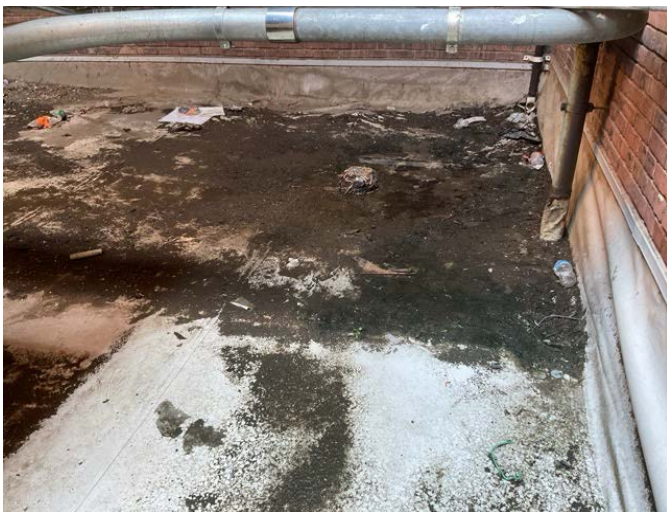
29 - ROOF DEBRIS

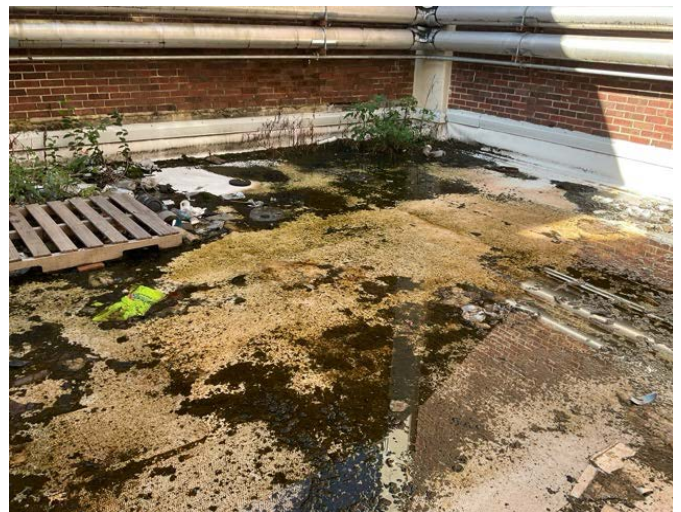
30 - ROOF DEBRIS
