FACILITY CONDITION ASSESSMENT

Cherokee Elementary School
3061 Kimball Avenue
Memphis, Tennessee 38114

163745.23R000-053.354

April 19, 2024

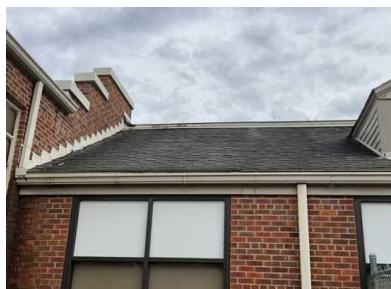
Roofing in Poor condition.

Asphalt Shingle, 20-Year Standard
Cherokee Elementary School Roof

Roof was observed to be in poor condition. - AssetCALC ID: 7181142

Uniformat Code: B3010
Recommendation: **Replace in 2025**

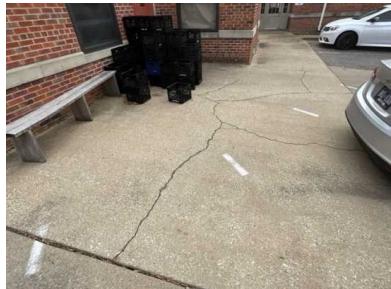
Sidewalk in Poor condition.

Concrete, Large Areas
Cherokee Elementary School Building exterior

Significant cracking was observed throughout the walk areas. - AssetCALC ID: 7181114

Uniformat Code: G2030
Recommendation: **Replace in 2024**

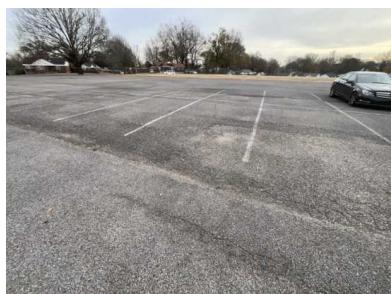
Parking Lots in Poor condition.

Pavement, Asphalt
Cherokee Elementary School Parking lot

Significant alligator cracking observed. - AssetCALC ID: 7181185

Uniformat Code: G2020
Recommendation: **Seal and Stripe in 2024**

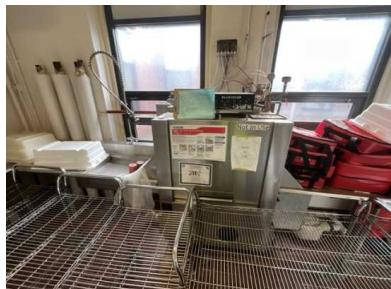
Foodservice Equipment in Poor condition.

Dishwasher Commercial
Cherokee Elementary School Kitchen

Uniformat Code: E1030
Recommendation: **Replace in 2024**
