FACILITY CONDITION ASSESSMENT

Chickasaw Middle School
4060 Westmont Road
Memphis, Tennessee 38109

163745.23R000-036.354

January 11, 2024

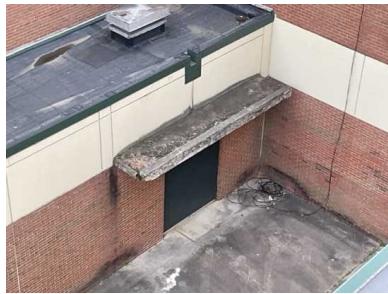
Balcony Structure in Poor condition.

Concrete
Chickasaw Middle School Music Room
Exterior Overhang

Crumbling concrete is observed on the overhang. Pieces are breaking away and falling. A life safety issue. - AssetCALC ID: 7050529

Recommendation: **Replace in 2023**

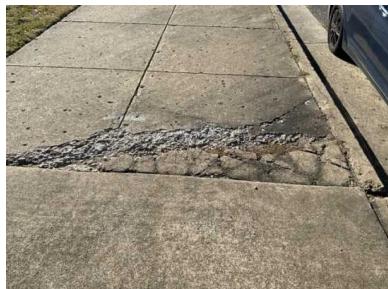
Sidewalk in Poor condition.

any pavement type, Sectional Repairs (per
Man-Day)
Chickasaw Middle School Site

Broken sidewalks at north and south ends of front entrance, and at the top of the south stairs. Trip hazards are present. The sidewalk along Westmont is cracked overall as well. - AssetCALC ID: 7127202

Recommendation: **Repair in 2023**

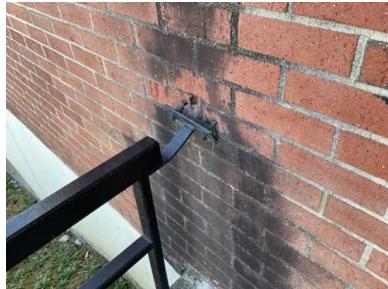
Site Stairs and Ramps in Poor condition.

Handrails, Metal
Chickasaw Middle School North Stairs

Railings are very loose and rusted/broken away at base. A life-safety issue. - AssetCALC ID: 7127203

Recommendation: **Install in 2023**

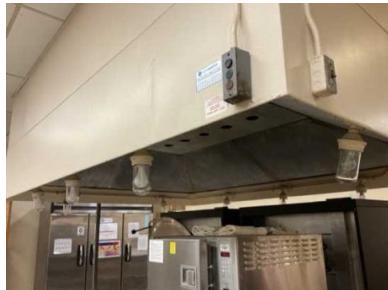
Fire Suppression System in Failed condition.

Commercial Kitchen, per LF of Hood
Chickasaw Middle School Kitchen

Missing ANSUL suppression system observed on the exhaust hood. - AssetCALC ID: 7085080

Recommendation: **Replace in 2023**

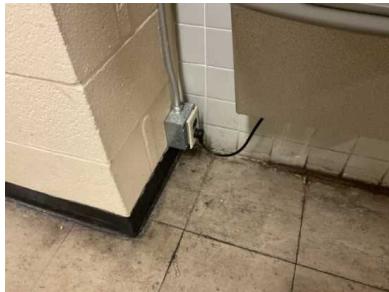
Electrical System in Failed condition.

any type, Repairs per Man-Day
Chickasaw Middle School Gymnasium Corridor

Receptacles for drinking fountains appear to be non-GFI protected. - AssetCALC ID: 7050460

Recommendation: **Repair in 2023**

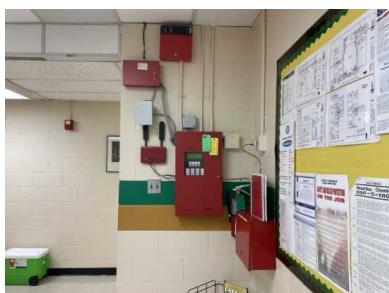
Fire Alarm Panel in Failed condition.

Fully Addressable
Chickasaw Middle School Reception

Panel is currently in trouble status and with 2020 inspection tag. - AssetCALC ID: 7050422

Recommendation: **Replace in 2023**

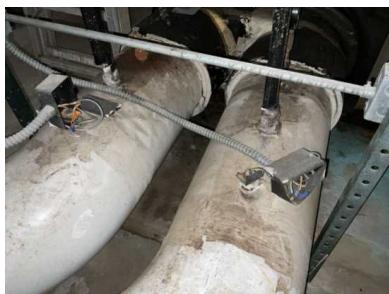
Electrical System in Poor condition.

any type, Repairs per Man-Day
Chickasaw Middle School Boiler room

Open electrical boxes are observed at the chiller. - AssetCALC ID: 7085028

Recommendation: **Repair in 2023**

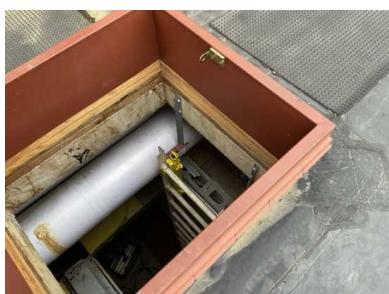
Roof Hatch in Poor condition.

Metal
Chickasaw Middle School Lower Roof 1st Floor

Unsafe roof hatch access. Ladder and pole do not extend high enough. - AssetCALC ID: 7050536

Recommendation: **Replace in 2023**

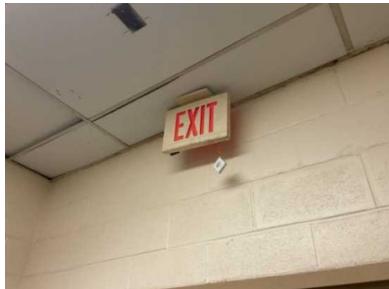
Emergency and Exit Lighting in Poor condition.

Exit Sign/Emergency Combo, LED
Chickasaw Middle School Throughout building

Exit signs are old, some are very dim or not operational. - AssetCALC ID: 7085065

Recommendation: **Replace in 2023**

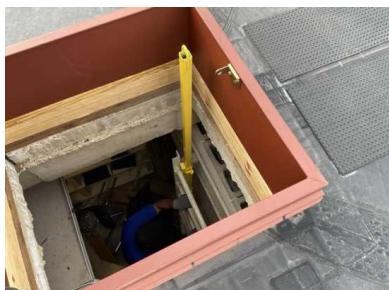
Roof Hatch in Poor condition.

Metal
Chickasaw Middle School Upper Roof 3rd Floor

Unsafe roof hatch access. Ladder and pole do not extend high enough. - AssetCALC ID: 7050535

Recommendation: **Replace in 2023**

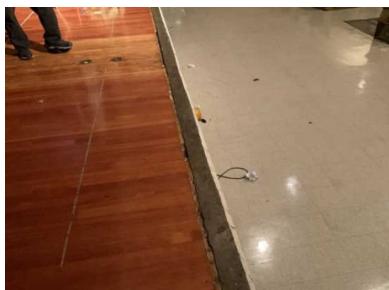
Flooring in Poor condition.

any surface, with Paint or Sealant
Chickasaw Middle School Stage

Trip hazards are present along front edge of stage. - AssetCALC ID: 7085067

Recommendation: **Prep and Paint in 2023**

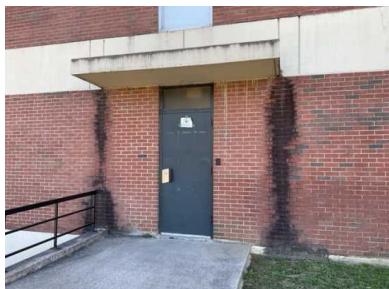
Exterior Walls in Poor condition.

any type, Repairs per Man-Day
Chickasaw Middle School Building Exterior

Substantial discoloration is observed on building exterior. - AssetCALC ID: 7127211

Recommendation: **Repair in 2023**

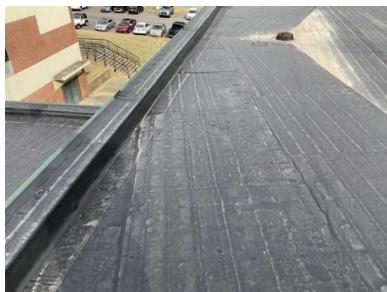
Roofing in Poor condition.

any type, Repairs per Man-Day
Chickasaw Middle School Auditorium Roof

Soft spot is observed on the auditorium roof. - AssetCALC ID: 7050500

Uniformat Code: B3010
Recommendation: **Repair in 2023**

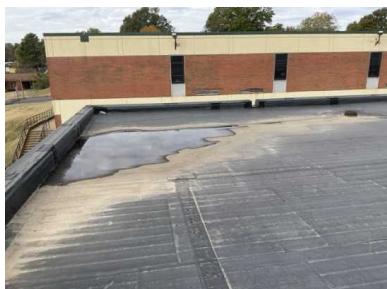
Roofing in Poor condition.

any type, Repairs per Man-Day
Chickasaw Middle School Gymnasium Roof

Water is observed to be ponding on the gymnasium roof. Negative slope to drain. - AssetCALC ID: 7050439

Uniformat Code: B3010
Recommendation: **Repair in 2023**

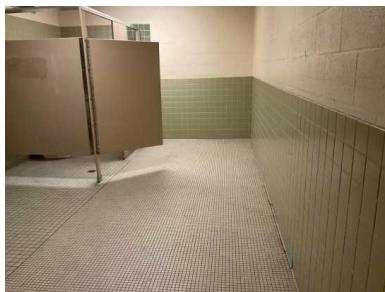
Wall Finishes in Poor condition.

Ceramic Tile
Chickasaw Middle School Restrooms

Damaged ceramic tile is observed in places. Cost is included for repairs as needed. - AssetCALC ID: 7050433

Uniformat Code: C2010
Recommendation: **Replace in 2025**

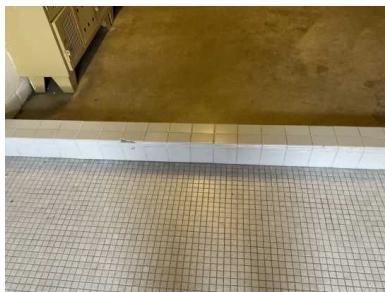
Wall Finishes in Poor condition.

Ceramic Tile
Chickasaw Middle School Boys Locker Room

Cracked grout is observed in boys locker room from wall settling. - AssetCALC ID: 7050473

Uniformat Code: C2010
Recommendation: **Replace in 2025**

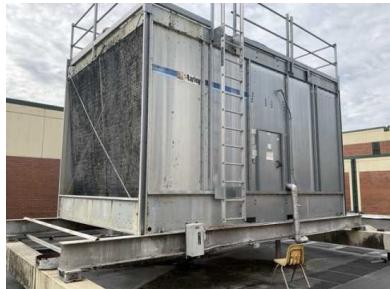
Cooling Tower in Poor condition.

(Typical) Open Circuit
Chickasaw Middle School Lower Roof 1st Floor

Fins are corroded overall, frame is rustng. - AssetCALC ID: 7050440

Uniformat Code: D3030
Recommendation: **Replace in 2024**

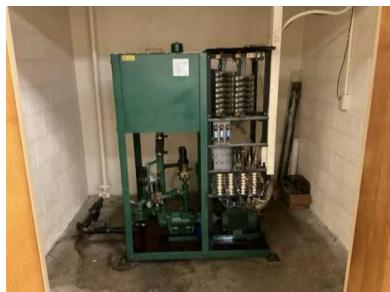
Passenger Elevator in Poor condition.

Hydraulic, 3 Floors, 1500 to 2500 LB
Chickasaw Middle School 105A Machine Room

Leaking hydraulic fluid is observed. Parts are very difficult if not impossible to find per building engineer. - AssetCALC ID: 7085072

Uniformat Code: D1010
Recommendation: **Renovate in 2023**

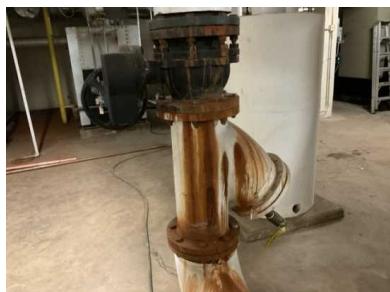
HVAC System in Poor condition.

Hydronic Piping, 2-Pipe
Chickasaw Middle School Throughout building

Significant piping issues/failures are reported within the CMU walls. Rusted piping with ongoing failures that are difficult to access. Exposed piping/flanges in boiler room is rusted as well. - AssetCALC ID: 7050452

Uniformat Code: D3050
Recommendation: **Replace in 2025**

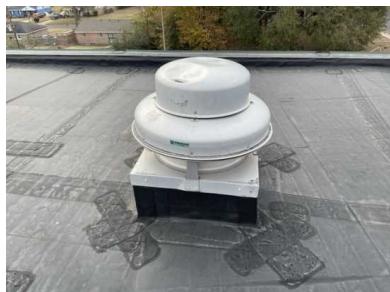
Exhaust Fan in Poor condition.

Centrifugal, 16" Damper
Chickasaw Middle School Upper Roof 3rd Floor

Fan is making noise. - AssetCALC ID: 7050443

Uniformat Code: D3060
Recommendation: **Replace in 2025**

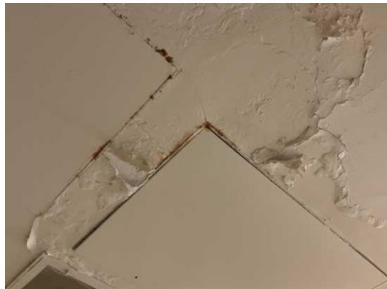
Interior Construction in Poor condition.

any type, Repairs per Man-Day
Chickasaw Middle School 3rd Boys Restroom

Ceiling is water-damaged from prior roof leak. Lights are flickering. - AssetCALC ID: 7085054

Recommendation: **Repair in 2023**

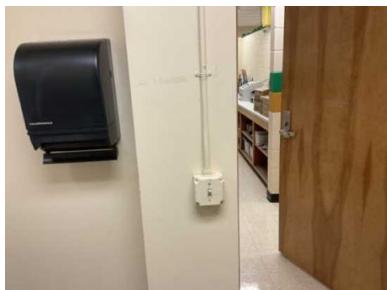
Electrical System in Poor condition.

Wiring and Switches, Average or Low Density/Complexity
Chickasaw Middle School Throughout building

Old wiring and switches are observed throughout. Many 3-way circuits are not functioning. Switch contacts are intermittent. - AssetCALC ID: 7050510

Recommendation: **Replace in 2025**

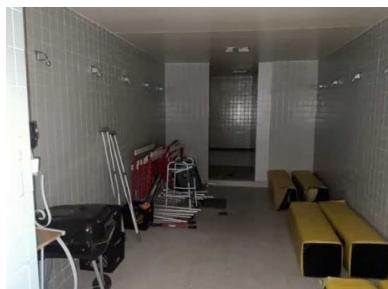
Shower in Failed condition.

Valve and Showerhead
Chickasaw Middle School Boys Locker Room

Showers are observed to be unused. - AssetCALC ID: 7050459

Recommendation: **Replace in 2023**

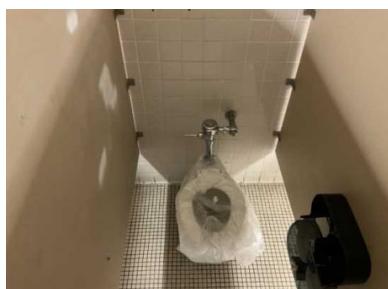
Toilet in Failed condition.

Commercial Water Closet
Chickasaw Middle School 3rd Girls Restroom

Toilet is observed to be out of service. - AssetCALC ID: 7085019

Recommendation: **Replace in 2023**

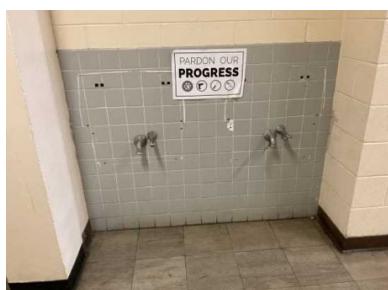
Drinking Fountain in Failed condition.

Wall-Mounted, Single-Level
Chickasaw Middle School Throughout building

Missing water bottle filling stations throughout building. - AssetCALC ID: 7050436

Recommendation: **Replace in 2023**

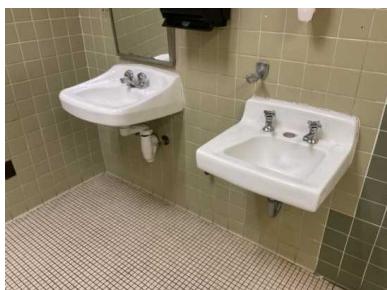
Sink/Lavatory in Poor condition.

Wall-Hung, Vitreous China
Chickasaw Middle School 1st Floor Restrooms

Most sinks are observed to be old. A number of faucets are running wide open, will not shut off. - AssetCALC ID: 7085073

Uniformat Code: D2010
Recommendation: **Replace in 2023**

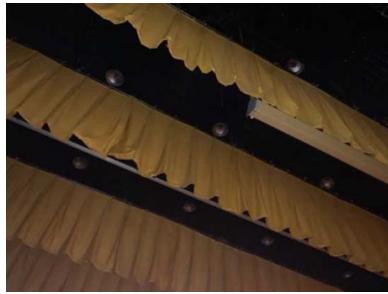
Special Fixture with Lamp in Failed condition.

any type Interior High Bay, with LED Replacement
Chickasaw Middle School Auditorium

All stage high-bay fixtures are nonfunctional. Recommend upgrading with LED fixtures. - AssetCALC ID: 7085061

Uniformat Code: D5040
Recommendation: **Replace in 2023**

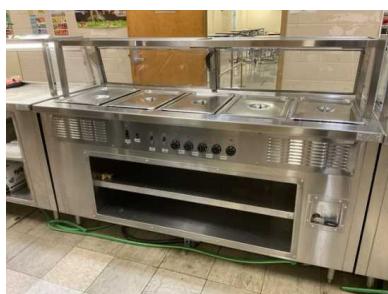
Foodservice Equipment in Failed condition.

Non-functional unit per kitchen staff. - AssetCALC ID: 7085025

Uniformat Code: E1030
Recommendation: **Replace in 2023**

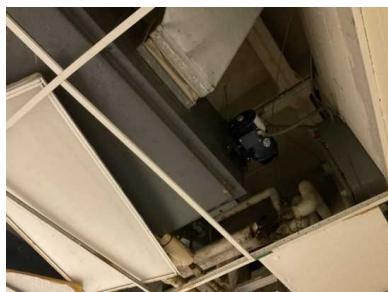
Fan Coil Unit in Failed condition.

Nonworking FCU. - AssetCALC ID: 7085030

Uniformat Code: D3050
Recommendation: **Replace in 2023**

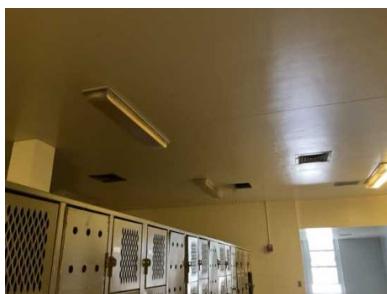
Interior Lighting System in Failed condition.

Lights are non-functional in boys locker room. - AssetCALC ID: 7050488

Uniformat Code: D5040
Recommendation: **Replace in 2023**

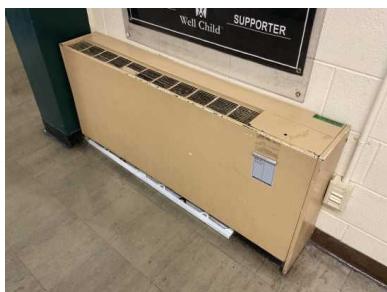
Fan Coil Unit in Failed condition.

Nonfunctional hydronic heaters. - AssetCALC ID: 7085090

Uniformat Code: D3050
Recommendation: **Replace in 2023**

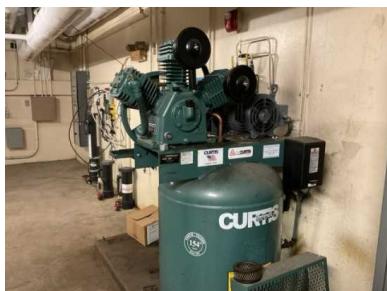
Air Compressor in Failed condition.

Air compressor is currently offline, unused, missing belts. - AssetCALC ID: 7050495

Uniformat Code: D2060
Recommendation: **Replace in 2023**

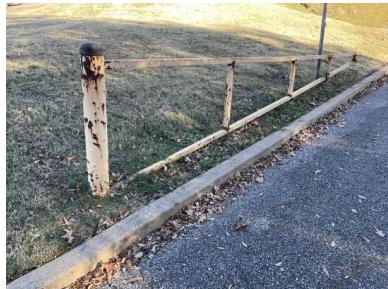
Fences and Gates in Failed condition.

Vehicle gates are observed to be non-functional, damaged and missing. - AssetCALC ID: 7127206

Recommendation: **Replace in 2023**

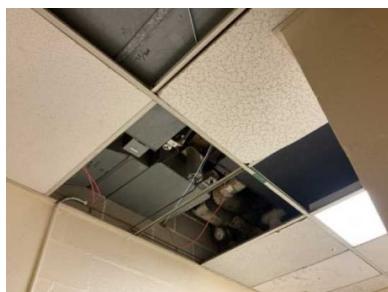
Fan Coil Unit in Failed condition.

Nonworking FCU. - AssetCALC ID: 7085032

Recommendation: **Replace in 2023**

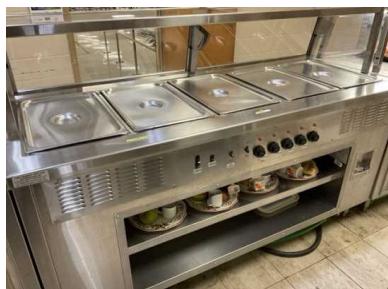
Foodservice Equipment in Failed condition.

Non-functional unit per kitchen staff. - AssetCALC ID: 7085069

Recommendation: **Replace in 2023**

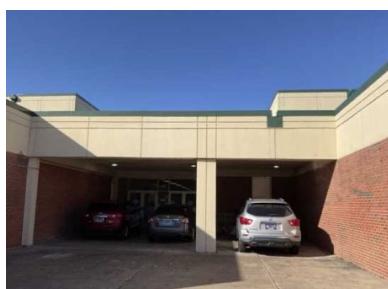
Roof Appurtenances in Poor condition.

4 missing downspouts are observed at front of building, 1 at rear entrance. - AssetCALC ID: 7050420

Recommendation: **Replace in 2024**

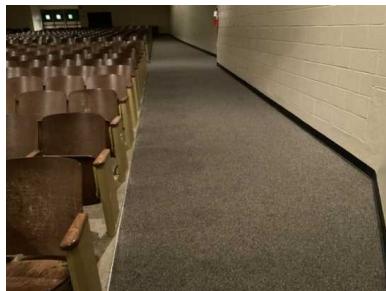
Flooring in Poor condition.

Carpet is bulging along side aisle. Recommend replacement to prevent trip hazard. - AssetCALC ID: 7085045

Uniformat Code: C2030
Recommendation: **Replace in 2024**

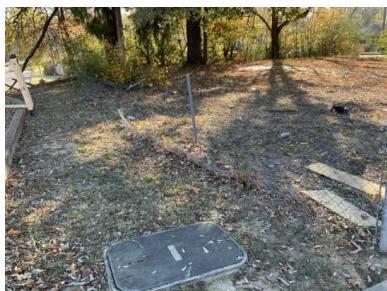
Fences and Gates in Poor condition.

Perimeter fencing is damaged overall. Sections are down with holes open to the neighborhood. The rear of the property is overgrown with vegetation. - AssetCALC ID: 7127194

Uniformat Code: G2060
Recommendation: **Replace in 2024**

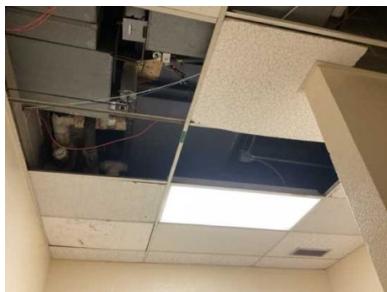
Suspended Ceilings in Poor condition.

Missing tiles are observed in restroom. - AssetCALC ID: 7085082

Uniformat Code: C1070
Recommendation: **Replace in 2023**

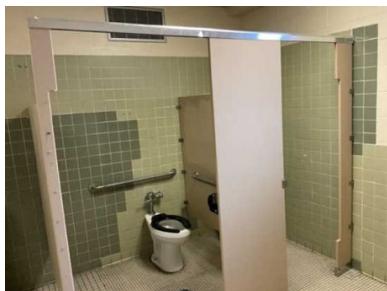
Toilet Partitions in Poor condition.

Substantial rust is observed. Doors are missing or replaced with plywood. - AssetCALC ID: 7085076

Uniformat Code: C1090
Recommendation: **Replace in 2024**

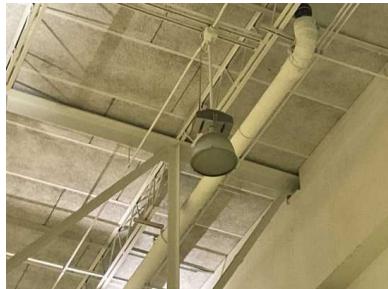
Special Fixture with Lamp in Poor condition.

any type Interior High Bay, with LED Replacement
Chickasaw Middle School Gymnasium

7 of the 56 high bay lights are non-functional. Recommend upgrading with LED fixtures. - AssetCALC ID: 7050505

Uniformat Code: D5040
Recommendation: **Replace in 2024**

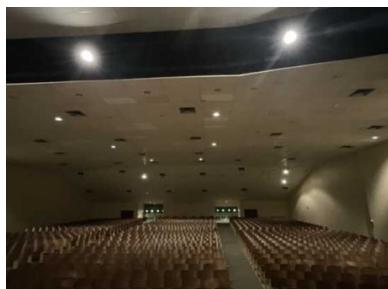
Interior Lighting System in Poor condition.

Approximately 50% of the can lights are nonfunctional, recommend upgrading with LED fixtures. - AssetCALC ID: 7085053

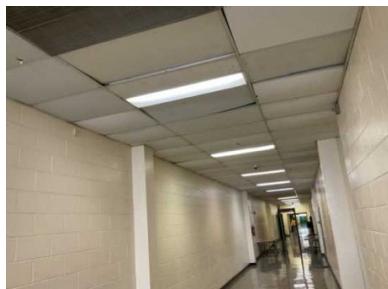
Interior Lighting System in Poor condition.

Lighting is observed to be very dim and many fixtures are non-functional in corridors. - AssetCALC ID: 7050430

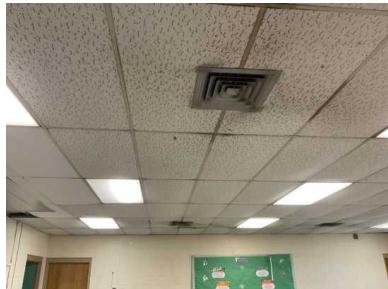
HVAC System in Poor condition.

Ductwork and registers are very old and rusted with substantial black on supplies in places. - AssetCALC ID: 7085049

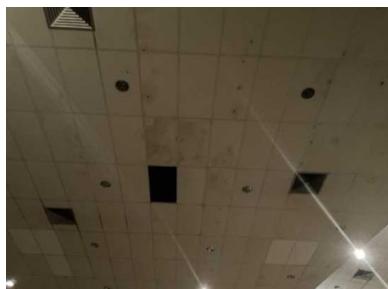
Suspended Ceilings in Poor condition.

Damaged and water stained ceiling tiles are observed from previous roof leaks. - AssetCALC ID: 7085063

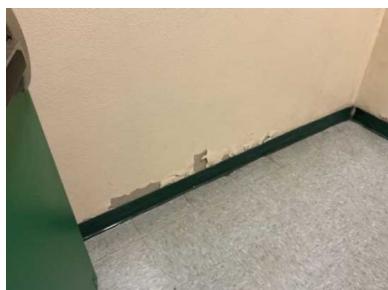
Flooring in Poor condition.

VCT is chipped along top steps in many places. Anticipate becoming more problematic. Rubber cove base is pulling away from wall. - AssetCALC ID: 7085021

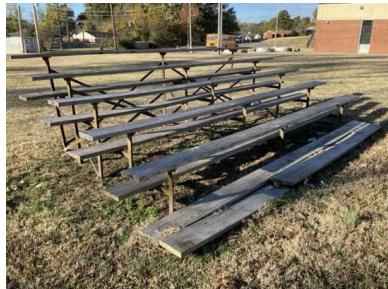
Bleachers in Poor condition.

Wooden bleacher is deteriorating. - AssetCALC ID: 7127200

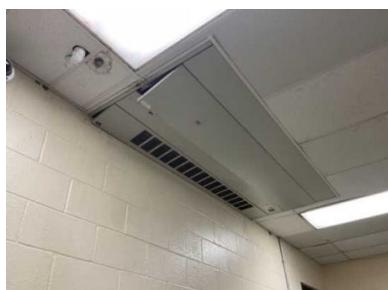
Fan Coil Unit in Poor condition.

Old rusted units are observed with damaged cover plates. - AssetCALC ID: 7085031

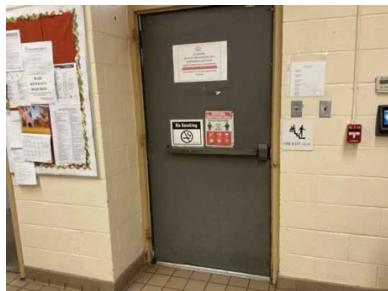
Exterior Door in Poor condition.

Significant rust is observed on exterior doors. - AssetCALC ID: 7085071

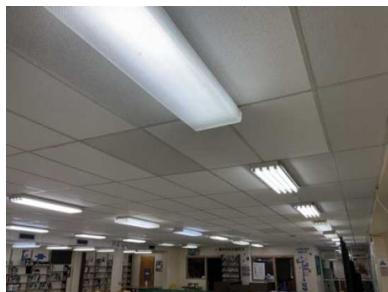
Interior Lighting System in Poor condition.

Many fixtures in the library are missing lenses, all are aged T-8 lamps. - AssetCALC ID: 7085051

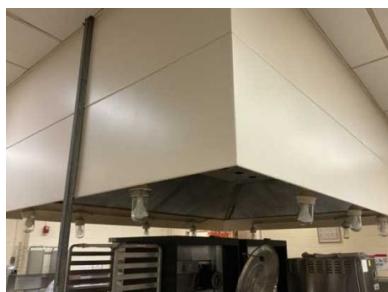
Foodservice Equipment in Poor condition.

Exhaust hood is functional but rusting and very old. - AssetCALC ID: 7085068

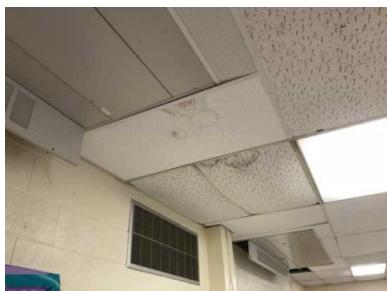
Recommended Follow-up Study: Environmental, Analysis of Suspect Fungal Growth

Fungal growth is observed on ceiling tiles at fan-coil units in classroom 214. - AssetCALC ID: 7085018
