# FACILITY CONDITION ASSESSMENT

**Shelby County Board of Education**  
160 South Hollywood Street  
Memphis, Tennessee 38112-4892  
Michelle Stuart

Chimneyrock Elementary  
8601 Chimneyrock Boulevard  
Cordova, Tennessee 38016

*November 21, 2024*

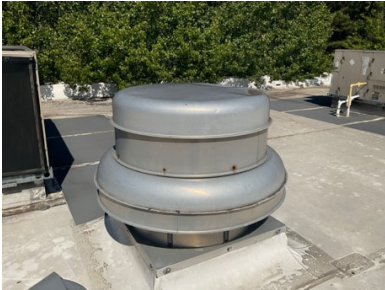
### Exhaust Fan in Failed condition.

Roof or Wall-Mounted, 24" Damper, 2001 to 5000 CFM  
Main Building Chimneyrock Elementary Roof

Exhaust fan is not functional - AssetCALC ID: 8513384

Uniformat Code: D3060  
Recommendation: **Replace in 2024**

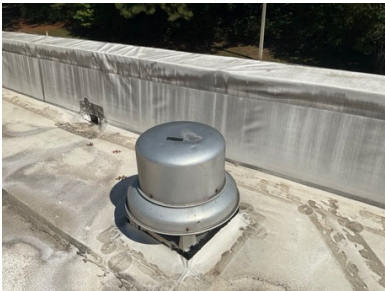
### Exhaust Fan in Poor condition.

Roof or Wall-Mounted, 12" Damper, 501 to 1000 CFM  
Main Building Chimneyrock Elementary Roof

Exhaust fan is not functional - AssetCALC ID: 8513414

Uniformat Code: D3060  
Recommendation: **Replace in 2024**

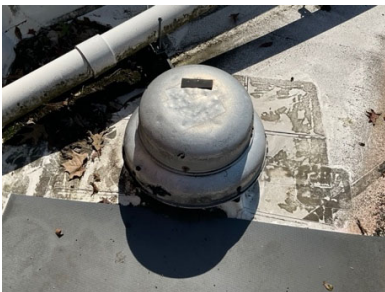
### Exhaust Fan in Poor condition.

Roof or Wall-Mounted, 10" Damper, 50 to 500 CFM  
Main Building Chimneyrock Elementary Roof

Exhaust outer cover appears to be heavily dented - AssetCALC ID: 8513440

Uniformat Code: D3060  
Recommendation: **Replace in 2026**

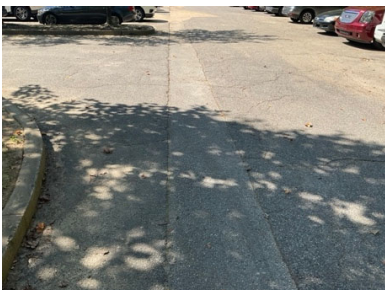
### Parking Lots in Poor condition.

Pavement, Asphalt  
Site Chimneyrock Elementary Site

Parking lot shows signs of heavy wear. Cracking and small holes found in asphalt. - AssetCALC ID: 8513492

Uniformat Code: G2020  
Recommendation: **Cut and Patch in 2024**

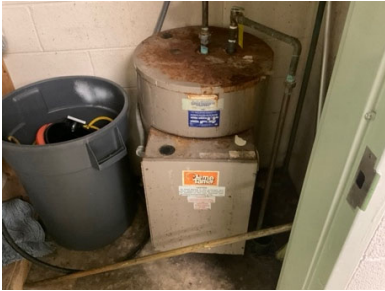
### Water Heater in Poor condition.

Electric, Commercial (12 kW)  
Main Building Chimneyrock Elementary Utility  
Rooms/Areas

Old unit. Top and Lower level of unit is rusted. - AssetCALC ID: 8513493

Uniformat Code: D2010  
Recommendation: **Replace in 2026**

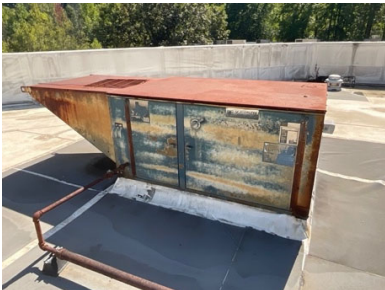
### Make-Up Air Unit in Failed condition.

MUA or MAU  
Main Building Chimneyrock Elementary Roof

Unit is not in service. - AssetCALC ID: 8513542

Uniformat Code: D3050  
Recommendation: **Replace in 2024**

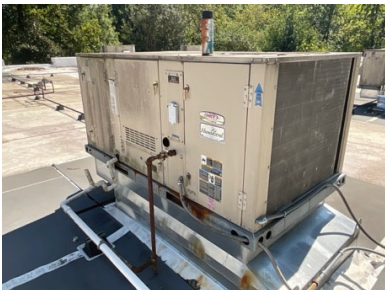
### Packaged Unit in Poor condition.

RTU, Pad or Roof-Mounted  
Main Building Chimneyrock Elementary Roof

Unit is not functional - AssetCALC ID: 8513431

Uniformat Code: D3050  
Recommendation: **Replace in 2025**

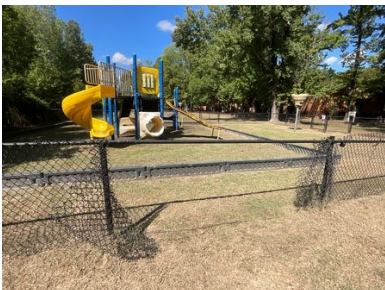
### Fences and Gates in Poor condition.

Fence, Chain Link 4'  
Site Chimneyrock Elementary Site

Damage/worn fencing throughout the property - AssetCALC ID: 8513505

Uniformat Code: G2060  
Recommendation: **Replace in 2026**

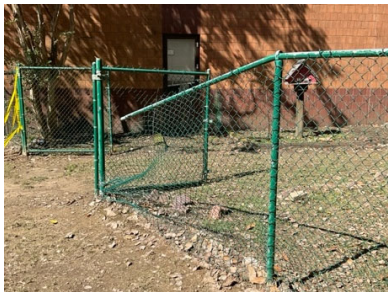
Fences and Gates in Poor condition.

Fence, Chain Link 6'  
Site Chimneyrock Elementary Site

Damaged fencing throughout property - AssetCALC ID: 8513489

Unifomat Code: G2060  
Recommendation: **Replace in 2026**
