FACILITY CONDITION ASSESSMENT

prepared for

September 30, 2024

Cordova Elementary
750 North Sanga Road
Cordova, Tennessee 38018

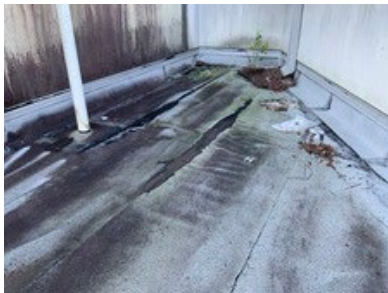
Roofing in Poor condition.

Modified Bitumen
Cordova Elementary Kitchen Roof

This area of the roof lays over the commercial kitchen. There is significant lifting and separation of the modified bitumen. - AssetCALC ID: 8185217

Uniformat Code: B3010
Recommendation: **Repair in 2024**

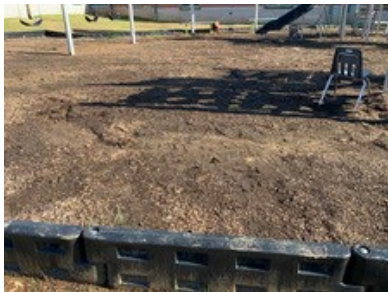
Playfield Surfaces in Poor condition.

Chips Engineered Wood, 3" Depth
Cordova Elementary Site

Wood chips are significantly deteriorated. Play surface is mostly bare soil. - AssetCALC ID: 8181077

Uniformat Code: G2050
Recommendation: **Replace in 2024**

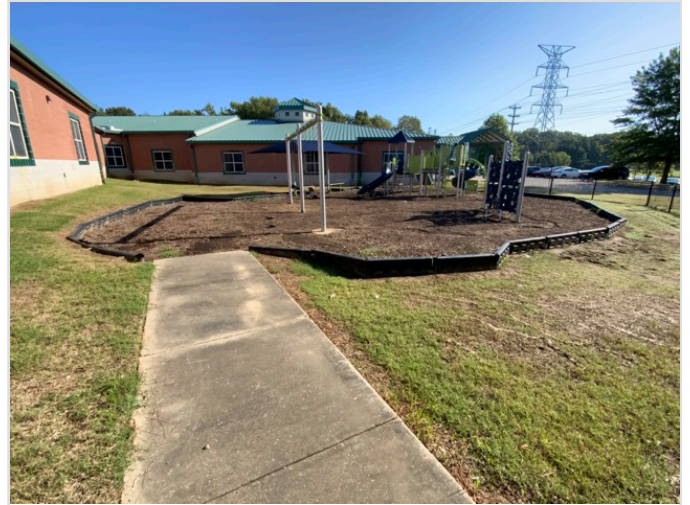
Category	Major Issues (ADA study recommended)	Moderate Issues (ADA study recommended)	Minor Issues	None*
Parking				✗
Exterior Accessible Route				✗
Building Entrances				✗
Interior Accessible Route				✗
Elevators				✗
Public Restrooms				✗
Kitchens/Kitchenettes	NA			
Playgrounds and Swimming Pools			Play surface is not suitable for ADA access.	
Other	NA

PLAYGROUND SURFACE
