FACILITY CONDITION ASSESSMENT

Shelby County Board of Education
160 South Hollywood Street
Memphis, Tennessee 38112-4892
Michelle Stuart

Cordova Middle School
900 Sanga Road
Cordova, Tennessee 38018

October 28, 2024

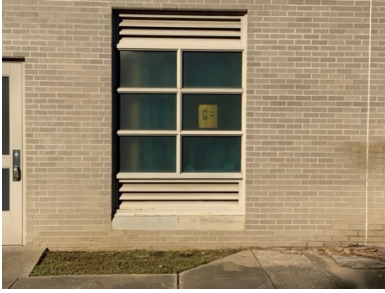
Window in Poor condition.

Steel, 16-25 SF
Cordova Middle School Building Exterior

Rust and failing caulk - AssetCALC ID: 8486826

Uniformat Code: B2020
Recommendation: **Replace in 2026**

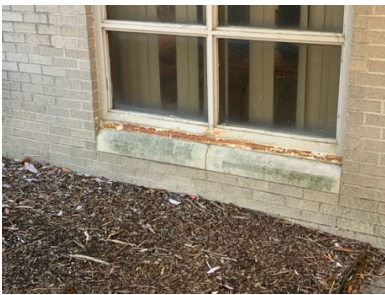
Window in Poor condition.

Steel, up to 15 SF
Cordova Middle School Building Exterior

Rust damage - AssetCALC ID: 8486808

Uniformat Code: B2020
Recommendation: **Replace in 2026**

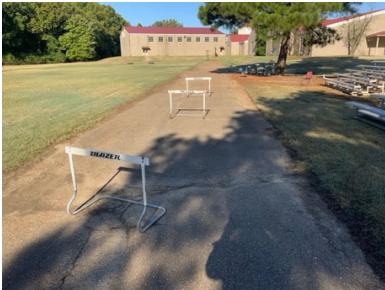
Sidewalk in Poor condition.

Asphalt
Cordova Middle School Site

Cracked, weeds growing - AssetCALC ID: 8486847

Uniformat Code: G2030
Recommendation: **Replace in 2026**

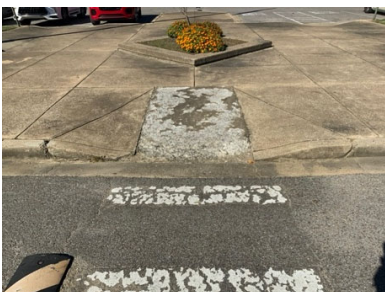
Parking Lots in Poor condition.

Pavement, Concrete
Cordova Middle School Site

Spalling concrete - AssetCALC ID: 8486852

Uniformat Code: G2020
Recommendation: **Repair in 2024**

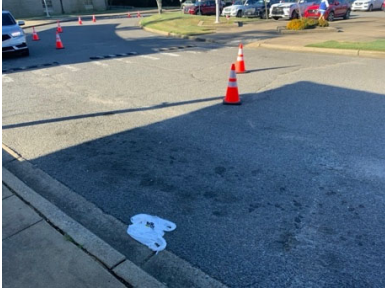
Parking Lots in Poor condition.

Pavement, Asphalt
Cordova Middle School Site

Cracked, breaking up - AssetCALC ID: 8486804

Uniformat Code: G2020
Recommendation: **Mill and Overlay in 2026**

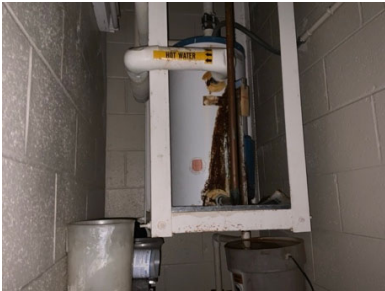
Water Heater in Failed condition.

Electric, Residential
Cordova Middle School Restrooms

Emergency relief leaking, 1/2 of case rusting out Reviewed and shown to POC - AssetCALC ID: 8486776

Uniformat Code: D2010
Recommendation: **Replace in 2024**

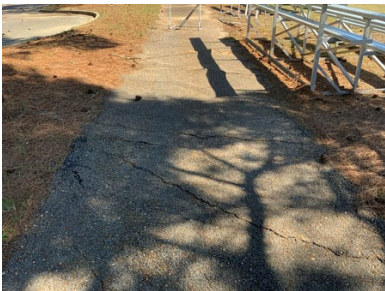
Trail in Poor condition.

Asphalt
Cordova Middle School Site

Cracked, with weeds and raised root areas - AssetCALC ID: 8486786

Uniformat Code: G2050
Recommendation: **Replace in 2026**

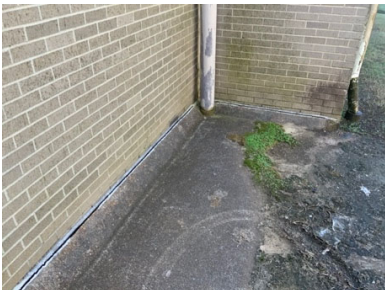
Caulking in Failed condition.

Cold Joints, 1/2" to 1"
Cordova Middle School Site

Open joint - AssetCALC ID: 8486832

Uniformat Code: B2010
Recommendation: **Replace in 2024**

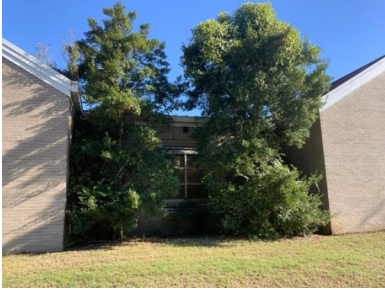
Landscaping in Poor condition.

Mature Trees, Removal/Trimming
Cordova Middle School Site

Trees hitting school, filling gutter - AssetCALC ID: 8486809

Uniformat Code: G2080
Recommendation: **Repair in 2024**

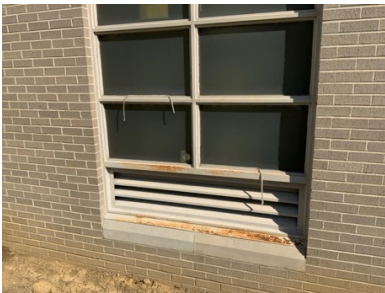
Caulking in Poor condition.

Window Edge/Trim, per LF
Cordova Middle School Building Exterior

Caulk is peeling off - AssetCALC ID: 8486824

Uniformat Code: B2010
Recommendation: **Replace in 2024**

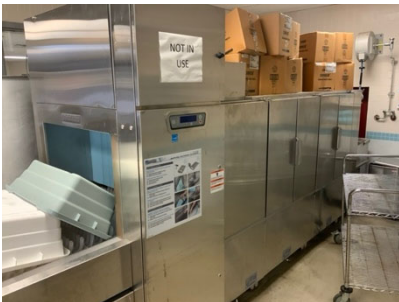
Foodservice Equipment

Dishwasher Commercial
Cordova Middle School Kitchen

Not in use - AssetCALC ID: 8486760

Uniformat Code: E1030
Recommendation: **Replace in 2026**

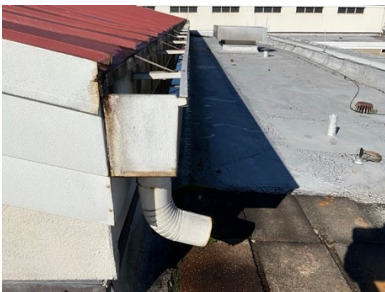
Roof Appurtenances in Poor condition.

Gutters and Downspouts, Aluminum w/
Fittings Cordova Middle School Roof

22 Downspouts damaged, require work weeds growing out of them - AssetCALC ID: 8344352

Uniformat Code: B3020
Recommendation: **Replace in 2026**
