FACILITY CONDITION ASSESSMENT

Shelby County Board of Education
160 South Hollywood Street
Memphis, Tennessee 38112-4892
Michelle Stuart

Cummings Elementary School
1037 Cummings Street
Memphis, Tennessee 38106

October 7, 2024

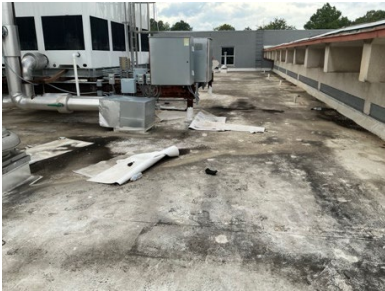
**Roofing in Poor condition.**

Built-Up
Cummings Elementary School Roof

Roof is damaged and stained - AssetCALC ID: 8310864

Uniformat Code: B3010
Recommendation: **Replace in 2026**

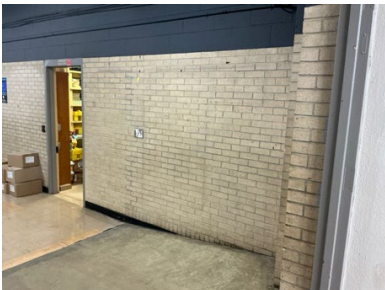
**Interior Wall in Poor condition.**

Brick
Cummings Elementary School Throughout
Building

Brick is aged but fine - AssetCALC ID: 8310830

Uniformat Code: C1010
Recommendation: **Clean in 2024**

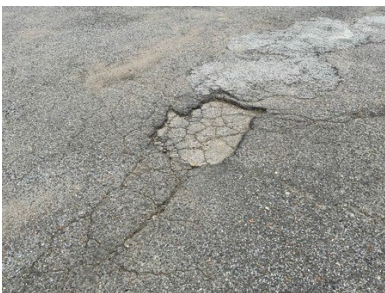
**Parking Lots in Poor condition.**

Pavement, Asphalt
Cummings Elementary School Site

Parking lot has large holes - AssetCALC ID: 8310795

Uniformat Code: G2020
Recommendation: **Cut and Patch in 2026**

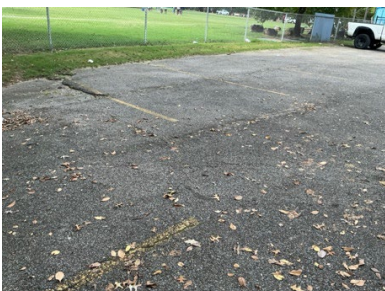
**Parking Lots in Poor condition.**

Any Pavement Type, Space or Stall Lines
Cummings Elementary School Site

Parking lot has damage - AssetCALC ID: 8310806

Uniformat Code: G2020
Recommendation: **Paint in 2026**

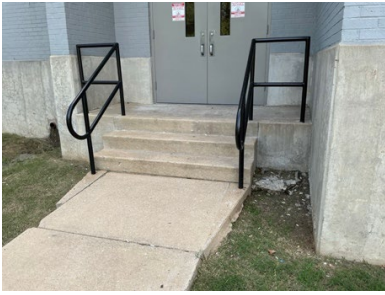
Stairs in Poor condition.

Concrete/Masonry, Exterior
Cummings Elementary School

Exterior stairs and slightly cracked - AssetCALC ID: 8310898

Uniformat Code: B1080
Recommendation: **Repair in 2024**

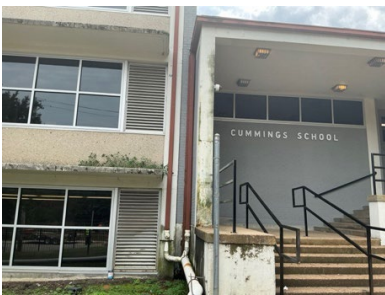
Roof Appurtenances in Poor condition.

Gutters and Downspouts, Aluminum with
Fittings
Cummings Elementary School Building Exterior

Slight corrosion - AssetCALC ID: 8310845

Uniformat Code: B3020
Recommendation: **Replace in 2026**

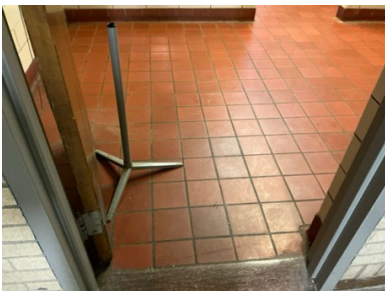
Flooring in Poor condition.

Ceramic Tile
Cummings Elementary School Restrooms

Floor in bathrooms have some slight damage. - AssetCALC ID: 8310855

Uniformat Code: C2030
Recommendation: **Repair in 2026**

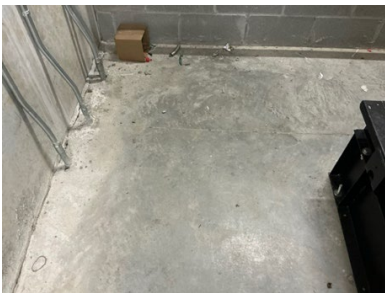
Flooring in Poor condition.

Concrete
Cummings Elementary School Throughout
Building

Concrete floor is cracked - AssetCALC ID: 8310766

Uniformat Code: C2030
Recommendation: **Repair in 2026**

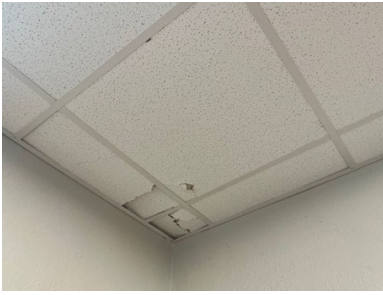
Suspended Ceilings in Poor condition.

Acoustical Tile (ACT)
Cummings Elementary School Library

Ceiling tiles are cracked and loose. - AssetCALC ID: 8310765

Uniformat Code: C1070
Recommendation: **Replace in 2026**

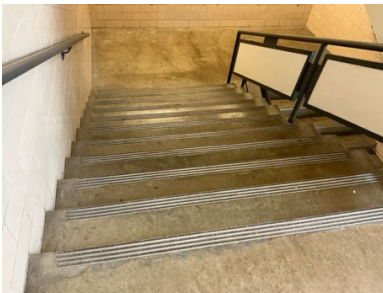
Stairs in Poor condition.

Concrete/Masonry, Interior
Cummings Elementary School Throughout
Building

Stairs are stained. - AssetCALC ID: 8310819

Uniformat Code: B1080
Recommendation: **Repair in 2028**

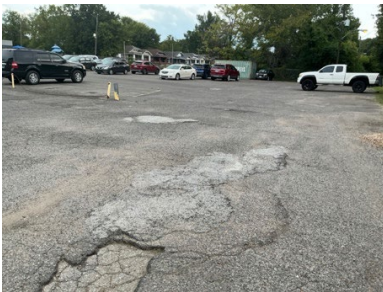
Parking Lots in Poor condition.

Pavement, Asphalt
Cummings Elementary School Site

Parking lot has damage - AssetCALC ID: 8310818

Uniformat Code: G2020
Recommendation: **Mill and Overlay in 2026**

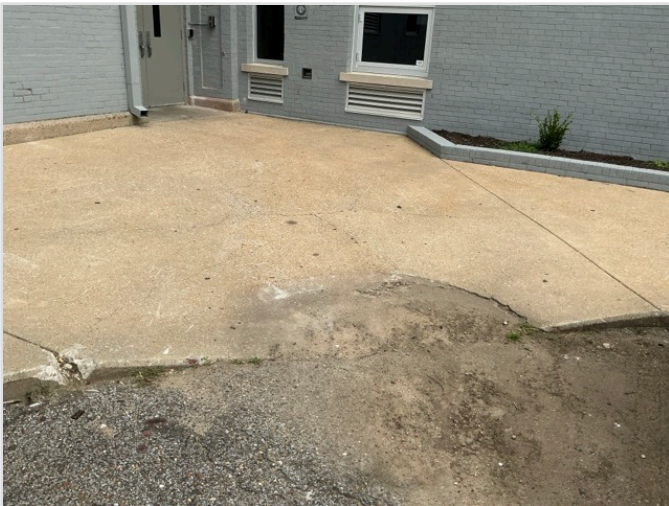
CURB CUT

Category	Major Issues (ADA study recommended)	Moderate Issues (ADA study recommended)	Minor Issues	None*
Parking				X
Exterior Accessible Route			Curb is damaged and needs to be repaired	
Building Entrances				X
Interior Accessible Route				X
Elevators	NA			
Public Restrooms				X
Kitchens/Kitchenettes				X
Playgrounds and Swimming Pools				X
Other	NA
