FACILITY CONDITION ASSESSMENT

Delano Elementary School
1716 Delano Avenue
Memphis, Tennessee 38127

163745.23R000-043.354

April 19, 2024

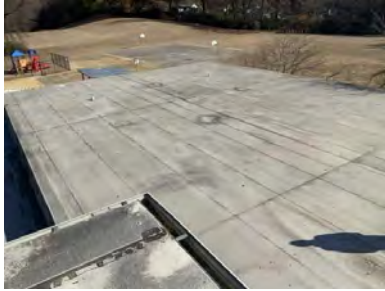
Roofing in Poor condition.

Single-Ply Membrane, TPO/PVC
Main School Building Delano Elementary
School Roof

Numerous areas of ponding stains observed - AssetCALC ID: 7191524

Unimat Code: B3010
Recommendation: **Replace in 2025**

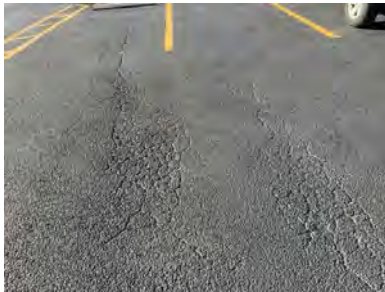
Parking Lots in Poor condition.

Pavement, Asphalt
Main School Building Delano Elementary
School Site

Large areas of alligator cracking - AssetCALC ID: 7191540

Unimat Code: G2020
Recommendation: **Cut and Patch in 2023**

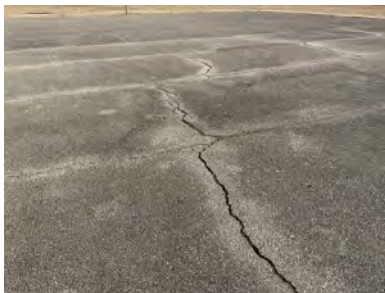
Athletic Surfaces and Courts in Poor condition.

Basketball/General, Asphalt Pavement
Main School Building Delano Elementary
School Site

Widespread surface degradation observed - AssetCALC ID: 7191523

Unimat Code: G2050
Recommendation: **Seal and Stripe in 2024**

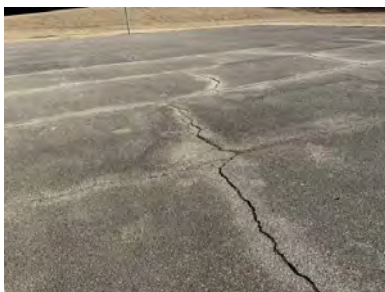
Athletic Surfaces and Courts in Poor condition.

Basketball/General, Asphalt Pavement
Main School Building Delano Elementary
School Site

Large cracks observed - AssetCALC ID: 7191506

Unimat Code: G2050
Recommendation: **Mill and Overlay in 2025**

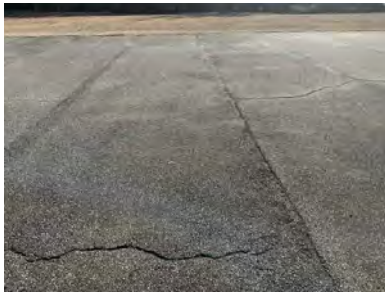
Athletic Surfaces and Courts in Poor condition.

Basketball/General, Asphalt Pavement
Main School Building Delano Elementary
School Site

Longitudinal, transverse cracking - AssetCALC ID: 7191447

Uniformat Code: G2050
Recommendation: **Replace in 2025**

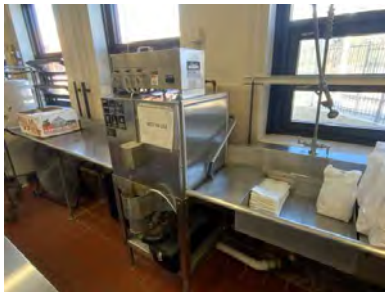
Foodservice Equipment in Poor condition.

Dishwasher Commercial
Main School Building Delano Elementary
School Kitchen

Uniformat Code: E1030
Recommendation: **Replace in 2023**
