FACILITY CONDITION ASSESSMENT

Shelby County Board of Education
160 South Hollywood Street
Memphis, Tennessee 38112-4892
Michelle Stuart

Double Tree Elementary School
4560 Double Tree Street
Memphis, Tennessee 38109

September 30, 2024

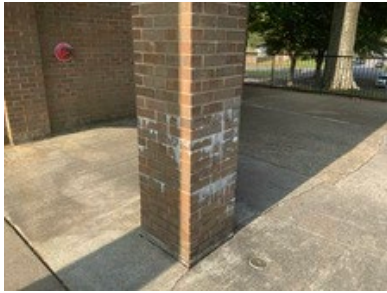
Exterior Walls in Poor condition.

Brick/Masonry/Stone, Clean and Seal
Double Tree Elementary School Building
Exterior

Extensive cracking, salt staining - AssetCALC ID: 8137685

Uniformat Code: B2010
Recommendation: **Maintain in 2026**

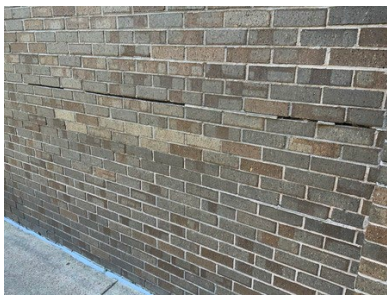
Exterior Walls in Poor condition.

Brick
Double Tree Elementary School Building
Exterior

Main areas of mortar joints falling out - AssetCALC ID: 8111439

Uniformat Code: B2010
Recommendation: **Repair/Repoint in 2026**

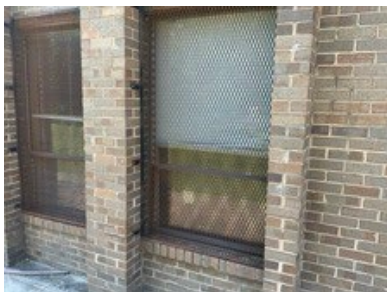
Window in Poor condition.

Aluminum Double-Glazed, 16-25 SF
Double Tree Elementary School Building
Exterior

Windows discolored, can't see out - AssetCALC ID: 8111398

Uniformat Code: B2020
Recommendation: **Replace in 2026**

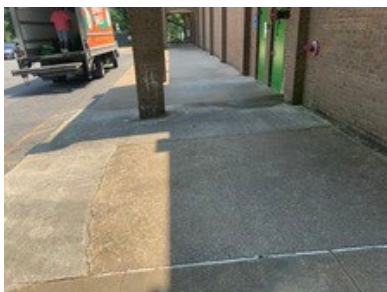
Sidewalk in Poor condition.

Concrete, Large Areas
Double Tree Elementary School Site

Spalling behind kitchen - AssetCALC ID: 8111409

Uniformat Code: G2030
Recommendation: **Replace in 2026**

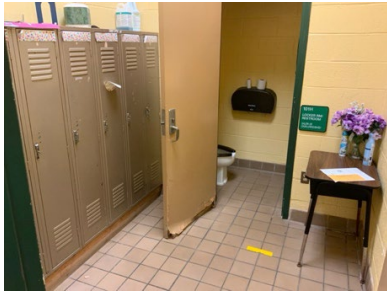
Interior Door in Failed condition.

Wood, Solid-Core
Double Tree Elementary School Commercial Kitchen

Wood delaminating Frame rusting out - AssetCALC ID: 8111435

Uniformat Code: C1030
Recommendation: **Replace in 2026**

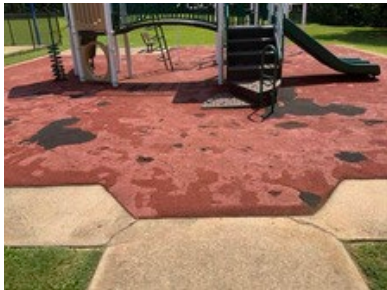
Playfield Surfaces in Poor condition.

Rubber, Poured-in-Place
Double Tree Elementary School Site

Wear surface breaking up, needs patches - AssetCALC ID: 8111453

Uniformat Code: G2050
Recommendation: **Replace in 2026**

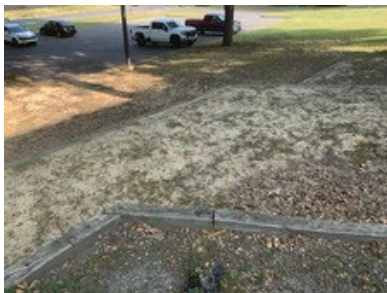
ID	Location	Location Description	UF Code	Description	Condition	Plan Type	Cost
8137686	Double Tree Elementary School	Site	G2080	Landscaping, Eroded Areas, Sodding, Repair	Poor	Performance/Integrity	\$1,000
Total (1 items)							\$1,000

Landscaping in Poor condition.

Eroded Areas, Sodding
Double Tree Elementary School Site

Washed out - AssetCALC ID: 8137686

Uniformat Code: G2080
Recommendation: **Repair in 2024**

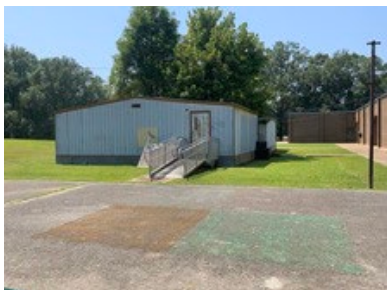
Ancillary Building in Poor condition.

Classroom/Office Module, Basic/Portable
Double Tree Elementary School Site

Not in use - AssetCALC ID: 8111379

Uniformat Code: F1020
Recommendation: **Replace in 2026**

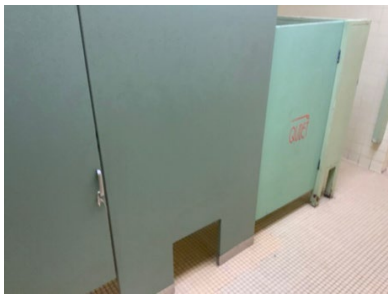
Toilet Partitions in Poor condition.

Metal
Double Tree Elementary School Restrooms

Rusting out - AssetCALC ID: 8111444

Uniformat Code: C1090
Recommendation: **Replace in 2026**
