# FACILITY CONDITION ASSESSMENT

**Shelby County Board of Education**  
160 South Hollywood Street  
Memphis, Tennessee 38112-4892  
Michelle Stuart

Douglass High School  
3200 Mt. Olive Road  
Memphis, Tennessee 38108

April 29, 2024

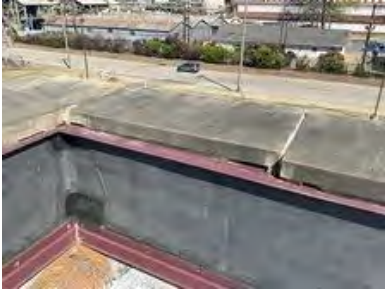
| ID | Location | Location Description | UF Code | Description | Condition | Plan Type | Cost |
|---|---|---|---|---|---|---|---|
| 7509069 | Douglass High School | Roof | B3010 | Roofing, any type, Repairs per Man-Day, Repair | Failed | Performance/Integrity | \$1,100 |

**Roofing in Failed condition.**

any type, Repairs per Man-Day  
Douglass High School Roof

Reattach loose cap stone - AssetCALC ID: 7509069

| UF L3 Code | Location | Condition | Asset/Component/Repair | Quantity | RUL | ID |
|---|---|---|---|---|---|---|
| B3010 | Roof | Failed | Roofing, any type, Repairs per Man-Day, Repair | 1 | 0 | 7509069 |

Uniformat Code: B3010  
Recommendation: **Repair in 2024**

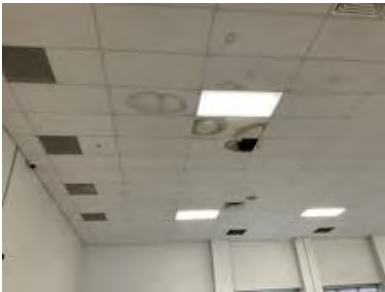
| ID | Location | Location Description | UF Code | Description | Condition | Plan Type | Cost |
|---|---|---|---|---|---|---|---|
| 7509147 | Douglass High School | Cafeteria | B3010 | Roofing, any type, Repairs per Man-Day, Repair | Poor | Performance/Integrity | \$2,200 |

**Roofing in Poor condition.**

any type, Repairs per Man-Day  
Douglass High School Cafeteria

Repair roof leaks above cafeteria - AssetCALC ID: 7509147

| UF L3 Code | Location | Condition | Asset/Component/Repair | Quantity | RUL | ID |
|---|---|---|---|---|---|---|
| B3010 | Cafeteria | Poor | Roofing, any type, Repairs per Man-Day, Repair | 2 | 0 | 7509147 |

Uniformat Code: B3010  
Recommendation: **Repair in 2024**

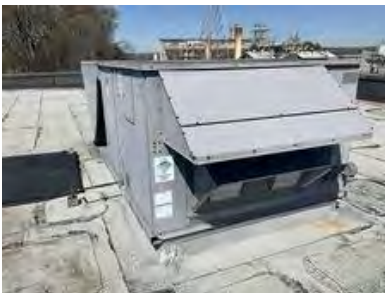
| ID | Location | Location Description | UF Code | Description | Condition | Plan Type | Cost |
|---|---|---|---|---|---|---|---|
| 7509112 | Douglass High School | Roof | D3050 | Packaged Unit, RTU, Pad or Roof-Mounted, Replace | Failed | Performance/Integrity | \$9,000 |

**Packaged Unit in Failed condition.**

RTU, Pad or Roof-Mounted  
Douglass High School Roof

Reportedly not functional - AssetCALC ID: 7509112

| UF L3 Code | Location | Condition | Asset/Component/Repair | Quantity | RUL | ID |
|---|---|---|---|---|---|---|
| D3050 | Roof | Failed | Packaged Unit, RTU, Pad or Roof-Mounted | 1 | 0 | 7509112 |

Uniformat Code: D3050  
Recommendation: **Replace in 2024**

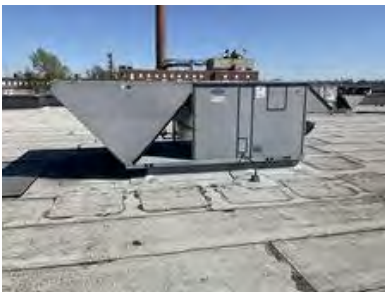
| ID | Location | Location Description | UF Code | Description | Condition | Plan Type | Cost |
|---|---|---|---|---|---|---|---|
| 7509020 | Douglass High School | Roof | D3050 | Packaged Unit, RTU, Pad or Roof-Mounted, Replace | Failed | Performance/Integrity | \$9,000 |

**Packaged Unit in Failed condition.**

RTU, Pad or Roof-Mounted  
Douglass High School Roof

Reportedly not functional - AssetCALC ID: 7509020

| UF L3 Code | Location | Condition | Asset/Component/Repair | Quantity | RUL | ID |
|---|---|---|---|---|---|---|
| D3050 | Roof | Failed | Packaged Unit, RTU, Pad or Roof-Mounted | 1 | 0 | 7509020 |

Uniformat Code: D3050  
Recommendation: **Replace in 2024**

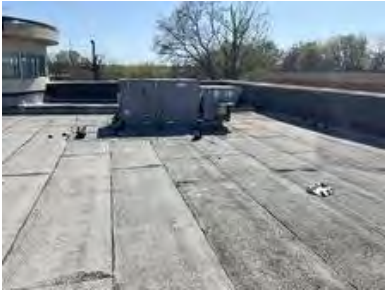
| ID | Location | Location Description | UF Code | Description | Condition | Plan Type | Cost |
|---|---|---|---|---|---|---|---|
| 7509036 | Douglass High School | Roof | D3050 | Packaged Unit, RTU, Pad or Roof-Mounted, Replace | Failed | Performance/Integrity | \$9,000 |

**Packaged Unit in Failed condition.**

RTU, Pad or Roof-Mounted  
Douglass High School Roof

Reportedly not functional - AssetCALC ID: 7509036

| UF L3 Code | Location | Condition | Asset/Component/Repair | Quantity | RUL | ID |
|---|---|---|---|---|---|---|
| D3050 | Roof | Failed | Packaged Unit, RTU, Pad or Roof-Mounted | 1 | 0 | 7509036 |

Uniformat Code: D3050  
Recommendation: **Replace in 2024**

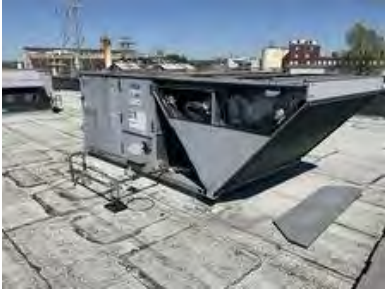
| ID | Location | Location Description | UF Code | Description | Condition | Plan Type | Cost |
|---|---|---|---|---|---|---|---|
| 7508997 | Douglass High School | Roof | D3050 | Packaged Unit, RTU, Pad or Roof-Mounted, Replace | Failed | Performance/Integrity | \$9,000 |

**Packaged Unit in Failed condition.**

RTU, Pad or Roof-Mounted  
Douglass High School Roof

Reportedly not functional - AssetCALC ID: 7508997

| UF L3 Code | Location | Condition | Asset/Component/Repair | Quantity | RUL | ID |
|---|---|---|---|---|---|---|
| D3050 | Roof | Failed | Packaged Unit, RTU, Pad or Roof-Mounted | 1 | 0 | 7508997 |

Uniformat Code: D3050  
Recommendation: **Replace in 2024**

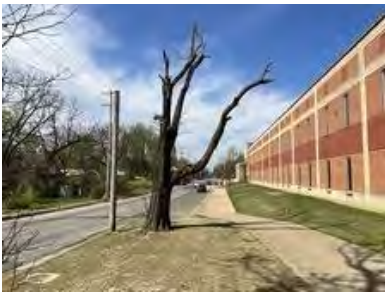
| ID | Location | Location Description | UF Code | Description | Condition | Plan Type | Cost |
|---|---|---|---|---|---|---|---|
| 7509045 | Douglass High School | Site | G2080 | Landscaping, Mature Trees, Removal/Trimming, Repair | Failed | Performance/Integrity | \$1,200 |

**Landscaping in Failed condition.**

Mature Trees, Removal/Trimming  
Douglass High School Site

Uniformat Code: G2080  
Recommendation: **Repair in 2024**
