FACILITY CONDITION ASSESSMENT

Douglass K-8
1650 Ash Street
Memphis, Tennessee 38108

163745.23R000-012.354

April 25, 2024

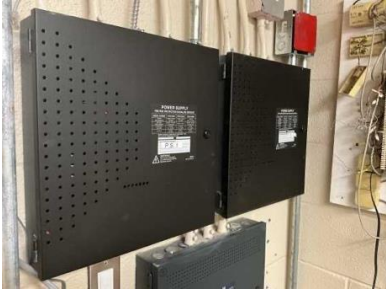
Fire Alarm System in Poor condition.

Full System Upgrade, Standard Addressable
Douglass K-8 Throughout building

Various pull stations not working properly - AssetCALC ID: 7491772

Uniformat Code: D7050
Recommendation: **Upgrade/Install in 2025**

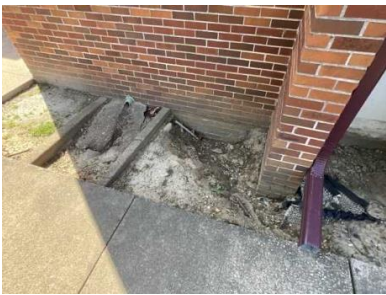
Sidewalk in Poor condition.

any pavement type, Sectional Repairs (per
Man-Day)
Douglass K-8 Site

Damaged walkways causing water erosion @ SE building corner - AssetCALC ID: 7491721

Uniformat Code: G2030
Recommendation: **Repair in 2024**

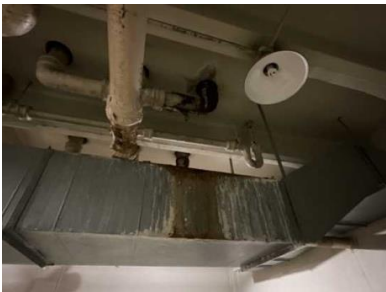
Plumbing System in Failed condition.

any type, Repairs per Man-Day
Douglass K-8 Boiler room

Active sewer leak - AssetCALC ID: 7491797

Uniformat Code: D2010
Recommendation: **Repair in 2024**

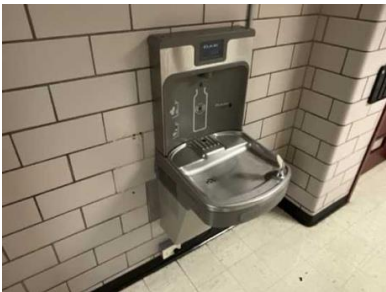
Drinking Fountain in Failed condition.

Wall-Mounted, Single-Level
Douglass K-8 Hallways

Not working - AssetCALC ID: 7491762

Uniformat Code: D2010
Recommendation: **Replace in 2024**

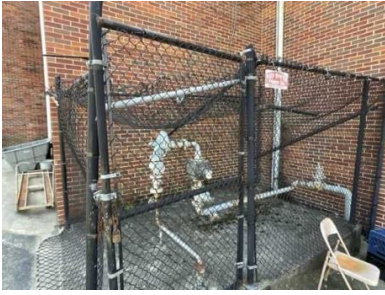
Fences and Gates in Failed condition.

Fence, Chain Link 6'
Douglass K-8 Site

Damaged fencing around gas meters - AssetCALC ID: 7491783

Uniformat Code: G2060
Recommendation: **Replace in 2024**

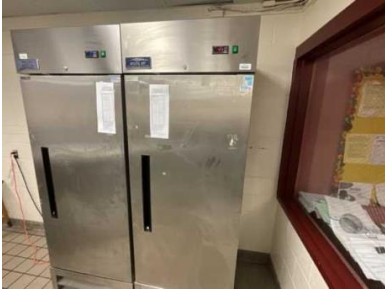
Foodservice Equipment in Poor condition.

Refrigerator, 1-Door Reach-In
Douglass K-8 Kitchen

Has trouble keeping correct temp. Work order placed for new door gaskets that are missing - AssetCALC ID: 7491792

Uniformat Code: E1030
Recommendation: **Replace in 2025**

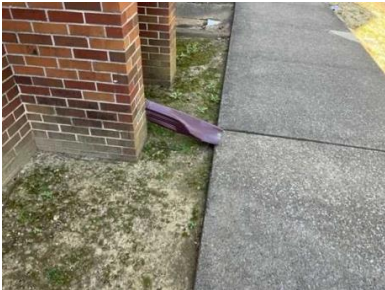
Roof Appurtenances in Poor condition.

Gutters and Downspouts, Aluminum with Fittings
Douglass K-8 Roof

Uniformat Code: B3020
Recommendation: **Replace in 2025**
