FACILITY CONDITION ASSESSMENT

Shelby County Board of Education
160 South Hollywood Street
Memphis, Tennessee 38112-4892
Michelle Stuart

Dunbar Elementary School
2606 Select Avenue
Memphis, Tennessee 38114

April 19, 2024

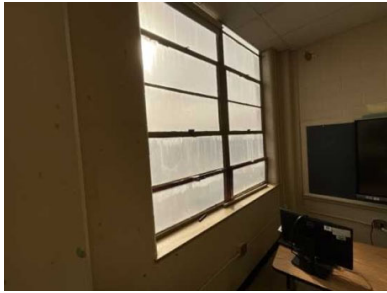
Glazing in Poor condition.

any type by SF
Dunbar Elementary School Throughout building

The building windows were observed to have deteriorated seals, cracking and leaking windows. - AssetCALC ID: 7158163

Uniformat Code: B2020
Recommendation: **Replace in 2024**

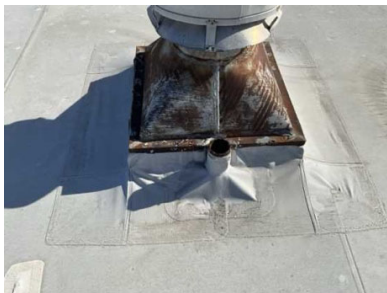
Exhaust Fan in Poor condition.

Propeller, 0.75 HP Motor
Dunbar Elementary School Roof

Exhaust fan were observed to have rusting, corrosion and broken parts - AssetCALC ID: 7158158

Uniformat Code: D3060
Recommendation: **Replace in 2025**

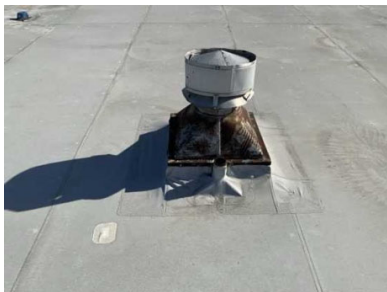
Exhaust Fan in Poor condition.

Propeller, 0.75 HP Motor
Dunbar Elementary School Roof

Exhaust fan were observed to have rusting, corrosion and broken parts . - AssetCALC ID: 7158181

Uniformat Code: D3060
Recommendation: **Replace in 2025**

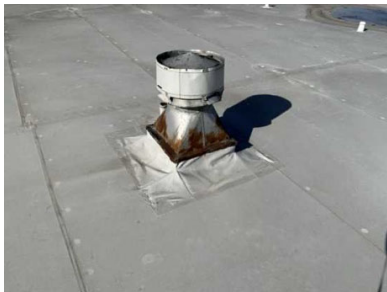
Exhaust Fan in Poor condition.

Propeller, 0.75 HP Motor
Dunbar Elementary School Roof

Exhaust fan were observed to have rusting, corrosion and broken parts - AssetCALC ID: 7158195

Uniformat Code: D3060
Recommendation: **Replace in 2025**

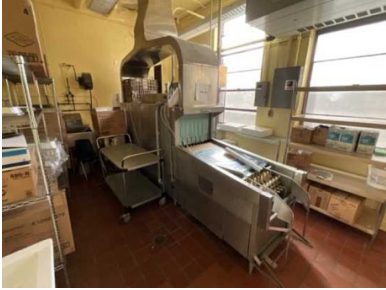
ID	Location	Location Description	UF Code	Description	Condition	Plan Type	Cost
7158143	Dunbar Elementary School	Kitchen	E1030	Foodservice Equipment, Dishwasher Commercial, Replace	Failed	Performance/Integrity	\$21,500
Total (1 items)							\$21,500

Foodservice Equipment in Failed condition.

Dishwasher Commercial
Dunbar Elementary School Kitchen

Equipment was not in operable conditions. - AssetCALC ID: 7158143

Uniformat Code: E1030
Recommendation: **Replace in 2023**

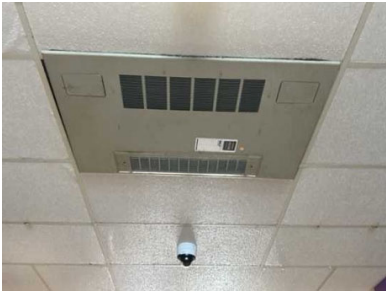
Fan Coil Unit in Poor condition.

Hydronic Terminal
Dunbar Elementary School Throughout building

Units were observed to be very old units. - AssetCALC ID: 7158189

Uniformat Code: D3050
Recommendation: **Replace in 2025**

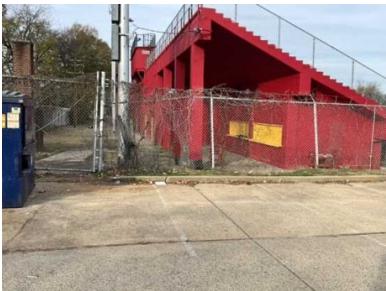
Fences and Gates in Poor condition.

Fence, Chain Link 8'
Dunbar Elementary School Parking lot

The chain link fencing was observed to be in poor condition. - AssetCALC ID: 7158177

Uniformat Code: G2060
Recommendation: **Replace in 2025**

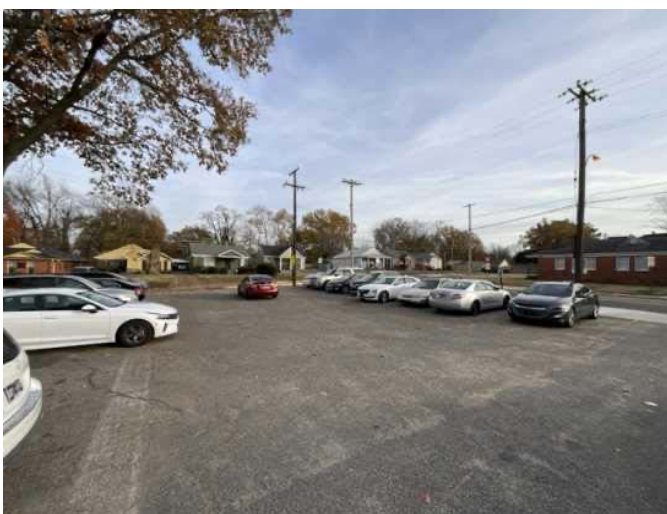
23 - PARKING LOT

The parking lots and sidewalks have been periodically repaved and sectionally replaced as needed over the years. The west parking lot has developed numerous potholes and heavy surface wear and should be sealed and striped. The playgrounds and sport courts are generally in good condition.
