# FACILITY CONDITION ASSESSMENT

**Egypt Elementary**  
4160 Karen Cove  
Memphis, Tennessee 38128

**DATE OF REPORT:**  
*September 30, 2024*

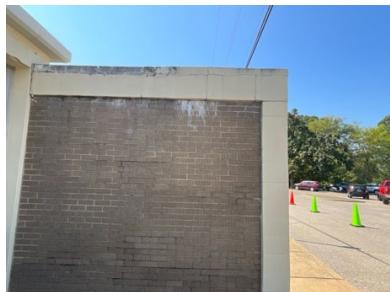
### Exterior Walls in Poor condition.

Brick  
Main Building Egypt Elementary Site

The small brick wall has cracking and missing mortar. - AssetCALC ID: 8109939

Uniformat Code: B2010  
Recommendation: **Repair/Repoint in 2024**

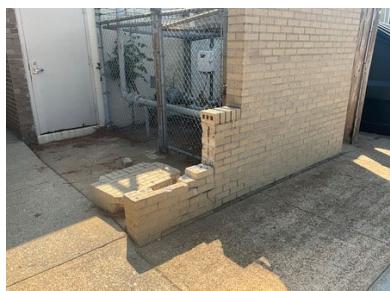
### Exterior Walls in Poor condition.

any type, Repairs per Man-Day  
Main Building Egypt Elementary Building  
Exterior

Cost allowance for repairs of broken brick - AssetCALC ID: 8109969

Uniformat Code: B2010  
Recommendation: **Repair in 2024**

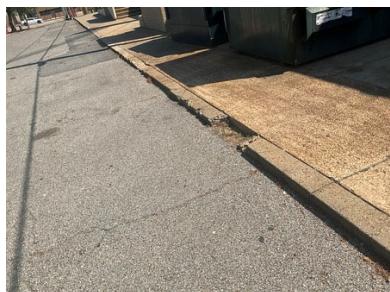
### Parking Lots in Poor condition.

Curb and Gutter, Concrete  
Main Building Egypt Elementary Site

Some sections of the curbs are broken and heavily deteriorated - AssetCALC ID: 8109934

Uniformat Code: G2020  
Recommendation: **Repair in 2025**

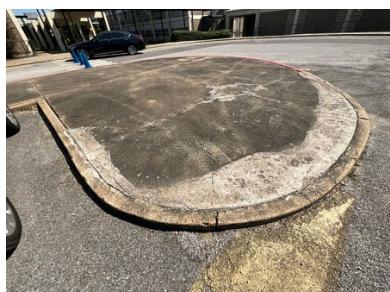
### Sidewalk in Poor condition.

Concrete, Small Areas/Sections  
Main Building Egypt Elementary Site

Cost allowance for repairs of the cracked side walks - AssetCALC ID: 8109928

Uniformat Code: G2030  
Recommendation: **Replace in 2026**

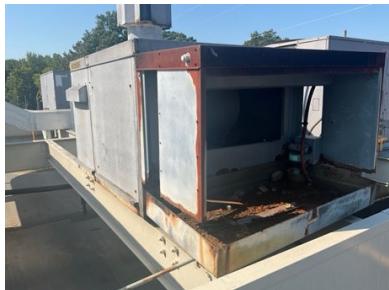
## Make-Up Air Unit in Poor condition.

MUA or MAU  
Main Building Egypt Elementary Roof  
Uniformat Code: D3050  
Recommendation: **Replace in 2025**

The unit is in poor condition - AssetCALC ID: 8109931

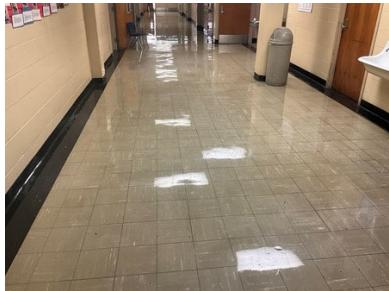
The VCT flooring is in poor condition. Throughout the hallways and various rooms, it was reported that there is 9x9 asbestos tiles in the facility A professional consultant must be retained to analyze the existing condition, provide recommendations and, if necessary, estimate the scope and cost of any required repairs. The cost of this study is included in the cost tables. A budgetary cost allowance to replace the asbestos tiles is also included.

## Recommended Follow-up Study: Environmental, Asbestos (ACM) and Lead Base Paint (LBP)

Environmental, Asbestos (ACM) and Lead Base Paint (LBP)  
Main Building Egypt Elementary Throughout Building

Uniformat Code: P2030  
Recommendation: **Evaluate/Report in 2024**
