# FACILITY CONDITION ASSESSMENT

**Shelby County Board of Education**  
160 South Hollywood Street  
Memphis, Tennessee 38112-4892  
Michelle Stuart

Fairley High ASD  
4950 Fairley Road  
Memphis, Tennessee 38109

*September 30, 2024*

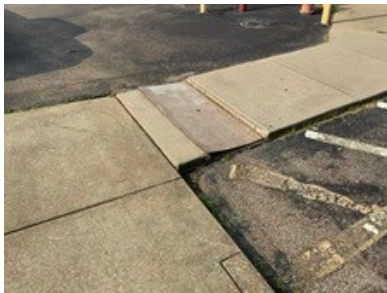
### Supplemental Components in Poor condition.

Drains, Trench  
Fairley High ASD Site

Cover failed - AssetCALC ID: 8099100

Unimat Code: D2020  
Recommendation: **Replace in 2025**

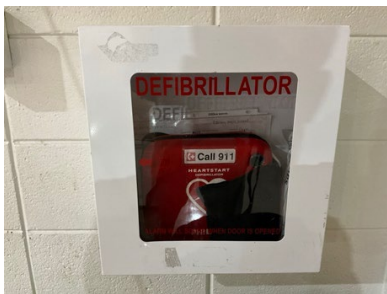
### Healthcare Equipment in Poor condition.

Defibrillator (AED), Cabinet-Mounted  
Fairley High ASD Gymnasium

Kept beeping - AssetCALC ID: 8099150

Unimat Code: E1040  
Recommendation: **Replace in 2025**

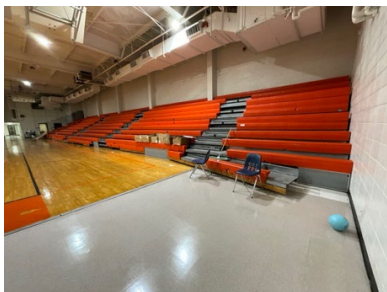
### Bleachers in Poor condition.

Telescoping Manual, up to 15 Tier (per Seat)  
Fairley High ASD Gymnasium

Broken bleachers - AssetCALC ID: 8099152

Unimat Code: E2010  
Recommendation: **Replace in 2025**

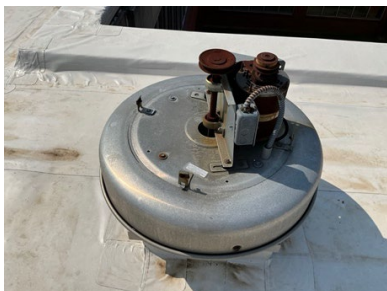
### Exhaust Fan in Failed condition.

Centrifugal, 12" Damper  
Building Fairley High ASD Main Classroom  
Roof

belt and cover missing - AssetCALC ID: 8092451

Unimat Code: D3060  
Recommendation: **Replace in 2024**

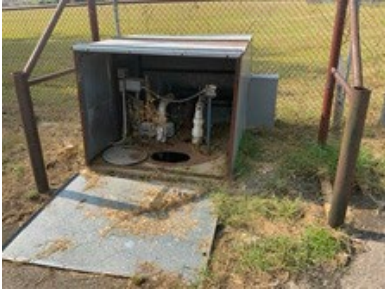
### Pump in Failed condition.

Sump  
Fairley High ASD Site General

Sump full - AssetCALC ID: 8099002

Uniformat Code: D2030  
Recommendation: **Replace in 2024**

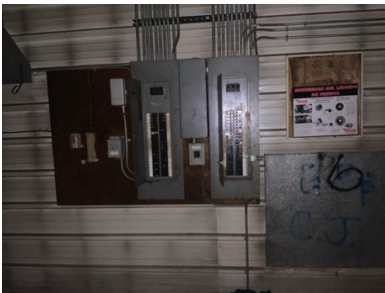
### Electrical System in Poor condition.

Wiring and Switches, High Density/Complexity  
Fairley High ASD Auto Shop Building  
Throughout Building

Clean up and rework for new use. Lifts removed, yet power there - AssetCALC ID: 8085643

Uniformat Code: D5030  
Recommendation: **Replace in 2025**

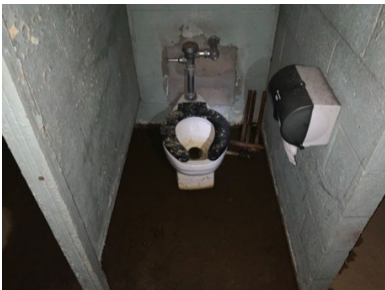
### Toilet in Failed condition.

Commercial Water Closet  
Fairley High ASD Auto Shop Building  
Restrooms

Building closed, everything dry - AssetCALC ID: 8085650

Uniformat Code: D2010  
Recommendation: **Replace in 2024**

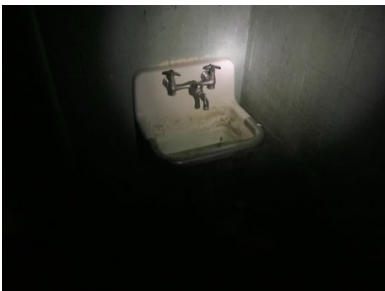
### Sink/Lavatory in Failed condition.

Service Sink, Wall-Hung  
Fairley High ASD Auto Shop Building  
Classrooms Industrial Arts

Building has been closed - AssetCALC ID: 8085644

Uniformat Code: D2010  
Recommendation: **Replace in 2024**

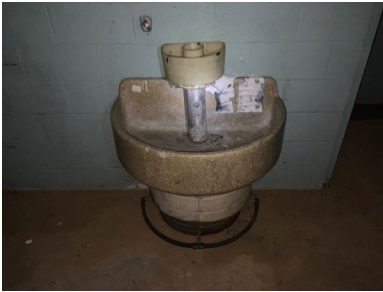
**Sink/Lavatory in Failed condition.**

Trough Style, Solid Surface  
Fairley High ASD Auto Shop Building  
Classrooms Industrial Arts

Building has been closed - AssetCALC ID: 8085642

Uniformat Code: D2010  
Recommendation: **Replace in 2024**

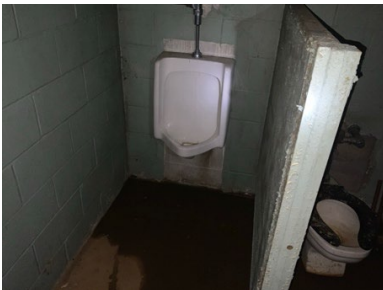
**Urinal in Failed condition.**

Standard  
Fairley High ASD Auto Shop Building  
Restrooms

Building has been closed everything dry - AssetCALC ID: 8085646

Uniformat Code: D2010  
Recommendation: **Replace in 2024**

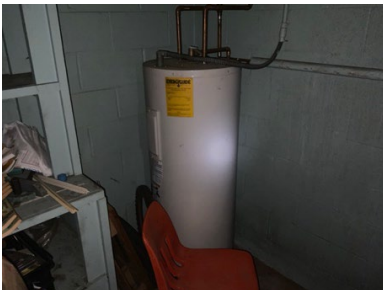
**Water Heater in Failed condition.**

Electric, Residential  
Fairley High ASD Auto Shop Building  
Classrooms Industrial Arts

Building has been closed - AssetCALC ID: 8085655

Uniformat Code: D2010  
Recommendation: **Replace in 2024**

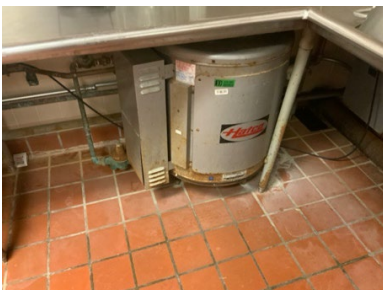
**Water Heater in Poor condition.**

Electric, Commercial ( 12 kW)  
Fairley High ASD Main Classroom Building  
Kitchen

Rusted - AssetCALC ID: 8099077

Uniformat Code: D2010  
Recommendation: **Replace in 2024**

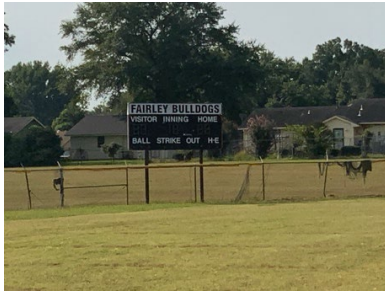
### Sports Apparatus in Poor condition.

Scoreboard, Electronic Basic  
Fairley High ASD Site

Not sure in use - AssetCALC ID: 8099024

Uniformat Code: G2050  
Recommendation: **Replace in 2025**

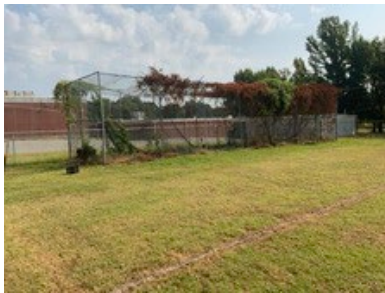
### Sports Apparatus in Poor condition.

Baseball, Batting Cage  
Fairley High ASD Site

Falling apart - AssetCALC ID: 8099061

Uniformat Code: G2050  
Recommendation: **Replace in 2025**

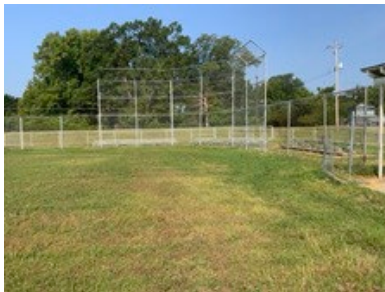
### Sports Apparatus in Poor condition.

Baseball, Backstop Chain-Link  
Fairley High ASD Site

Does not appear used at this time - AssetCALC ID: 8099059

Uniformat Code: G2050  
Recommendation: **Replace in 2026**

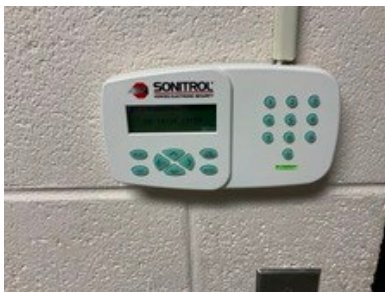
### Security Panel in Failed condition.

Annunciator  
Fairley High ASD Main Classroom Building  
Office Areas

re-cabling in process - AssetCALC ID: 8099086

Uniformat Code: D7030  
Recommendation: **Replace in 2024**

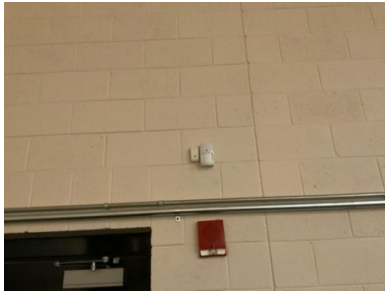
### Intrusion Detection System in Failed condition.

Full Alarm System Renovation/Upgrade  
Fairley High ASD Main Classroom Building  
Throughout Building

Being recabled - AssetCALC ID: 8099010

Recommendation: **Upgrade/Install in 2024**

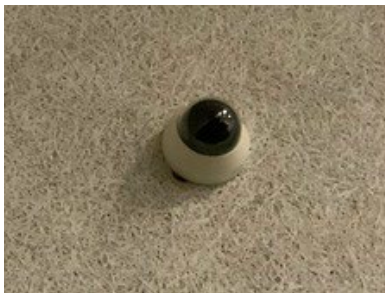
### Security/Surveillance System in Failed condition.

Full System Upgrade, Average Density  
Fairley High ASD Main Classroom Building  
Throughout Building

Being recabled - AssetCALC ID: 8099044

Recommendation: **Replace in 2025**

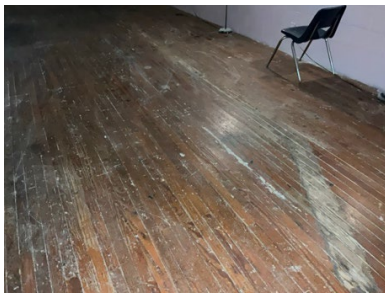
### Flooring in Poor condition.

Wood, Strip  
Fairley High ASD Gymnasium

surface is chipped discolored - AssetCALC ID: 8099161

Recommendation: **Refinish in 2025**

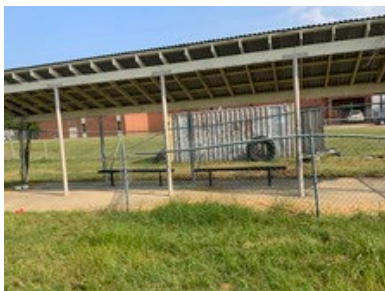
### Shed/Gazebo/Shade Structure in Poor condition.

Wood or Metal-Framed, Basic/Minimal  
Fairley High ASD Site

Roof rusting out - AssetCALC ID: 8099097

Recommendation: **Replace in 2026**

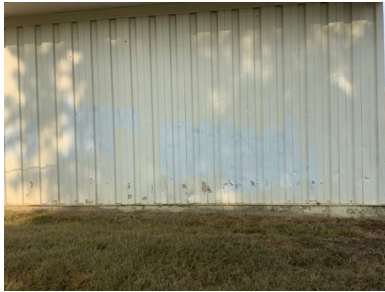
### Exterior Walls in Poor condition.

Metal/Insulated Sandwich Panels  
Fairley High ASD Auto Shop Building Exterior

Needs painting, bottom of panels Dave mower damage - AssetCALC ID: 8085653

Uniformat Code: B2010  
Recommendation: **Replace in 2026**

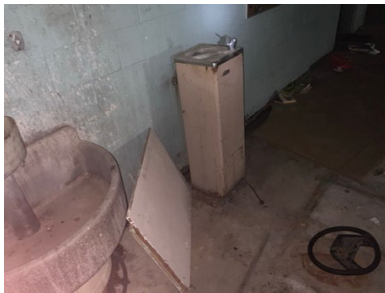
### Drinking Fountain in Failed condition.

Wall-Mounted, Single-Level  
Fairley High ASD Auto Shop Building Shop

Age - AssetCALC ID: 8085651

Uniformat Code: D2010  
Recommendation: **Replace in 2024**

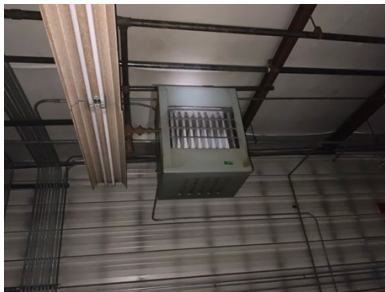
### Unit Heater in Poor condition.

Natural Gas  
Fairley High ASD Auto Shop Building Shop

Replace with more efficient units, building closed - AssetCALC ID: 8085638

Uniformat Code: D3020  
Recommendation: **Replace in 2024**

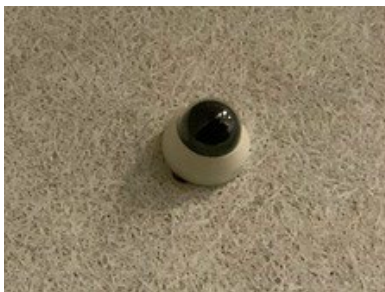
### Security/Surveillance System in Failed condition.

Full System Upgrade, Average Density  
Fairley High ASD ROTC Building Throughout Building

Campus being recabled - AssetCALC ID: 8086064

Uniformat Code: D7030  
Recommendation: **Replace in 2025**

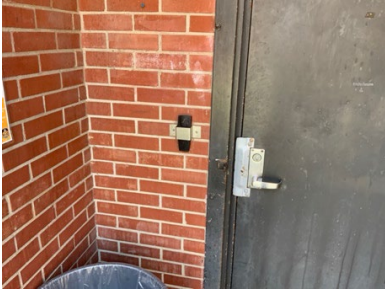
### Intrusion Detection System in Failed condition.

Full Alarm System Renovation/Upgrade  
Fairley High ASD ROTC Building Throughout Building

Campus being recabled - AssetCALC ID: 8086040

Uniformat Code: D7010  
Recommendation: **Upgrade/Install in 2025**

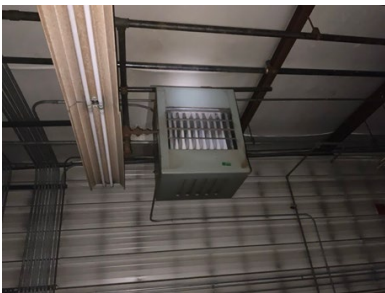
### Interior Lighting System in Failed condition.

Full Upgrade, Medium Density and Standard Fixtures  
Fairley High ASD Auto Shop Building Throughout Building

None working - AssetCALC ID: 8085637

Uniformat Code: D5040  
Recommendation: **Replace in 2025**

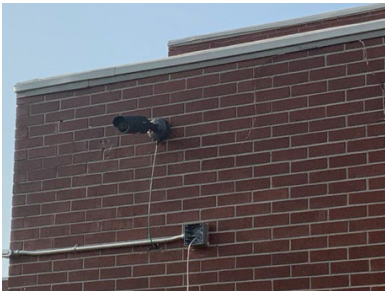
### Security/Surveillance System in Poor condition.

Full System Upgrade, Average Density  
Fairley High ASD Gymnasium Throughout Building

Campus being recabled - AssetCALC ID: 8084936

Uniformat Code: D7030  
Recommendation: **Replace in 2025**

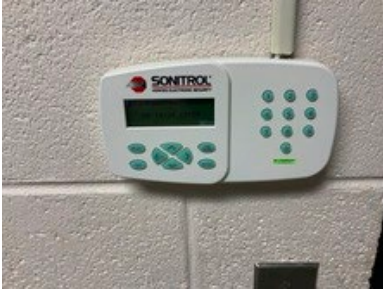
### Intrusion Detection System in Poor condition.

Full Alarm System Renovation/Upgrade  
Fairley High ASD Gymnasium Throughout Building

Campus being recabled - AssetCALC ID: 8084940

Uniformat Code: D7010  
Recommendation: **Upgrade/Install in 2025**

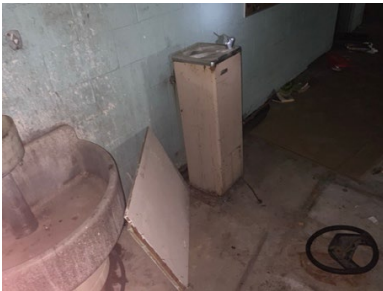
### Wall Finishes in Failed condition.

Any Surface  
Fairley High ASD Auto Shop Building Classrooms Industrial Arts

Uniformat Code: C2010  
Recommendation: **Prep and Paint in 2025**

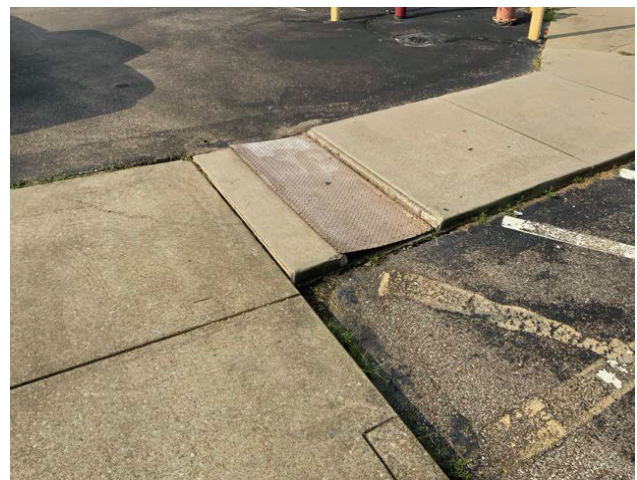
54 - CONCRETE SIDEWALK WITH DAMAGED DRAIN COVER
