FACILITY CONDITION ASSESSMENT

Shelby County Board of Education
160 South Hollywood Street
Memphis, Tennessee 38112-4892
Michelle Stuart

Ford Road Elementary
3336 Ford Road
Memphis, Tennessee 38109

October 1, 2024

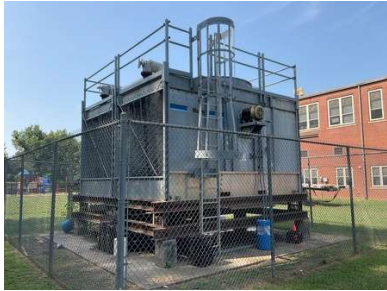
Cooling Tower in Failed condition.

(Typical) Open Circuit
2 Story Building Ford Road Elementary Rear elevation

Not functional - AssetCALC ID: 7974804

Uniformat Code: D3030
Recommendation: **Replace in 2024**

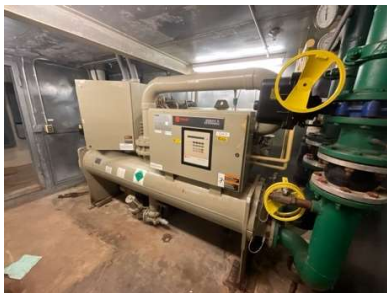
Chiller in Failed condition.

Water-Cooled
2 Story Building Ford Road Elementary Boiler Room

Not functional - AssetCALC ID: 7974806

Uniformat Code: D3030
Recommendation: **Replace in 2024**

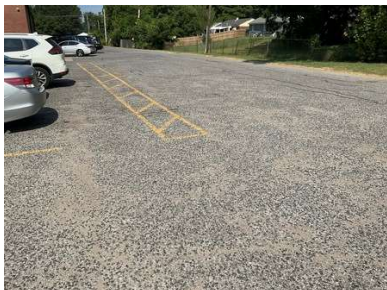
Parking Lots in Failed condition.

Pavement, Asphalt
Site Ford Road Elementary Site

Restripe after overlay - AssetCALC ID: 7974602

Uniformat Code: G2020
Recommendation: **Seal & Stripe in 2024**

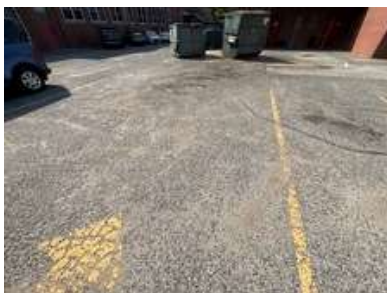
Parking Lots in Failed condition.

Pavement, Asphalt
Site Ford Road Elementary Site

Severely worn and damaged - AssetCALC ID: 7974590

Uniformat Code: G2020
Recommendation: **Mill & Overlay in 2024**

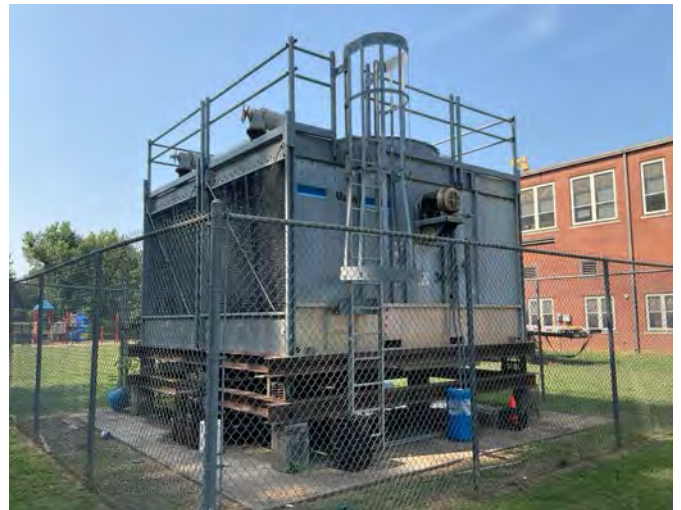
9 - CHILLER

Electrical	Source & Distribution: Main switchboard with copper wiring Interior Lighting: Linear fluorescent Emergency Power: None	Fair
Fire Alarm	Alarm panel located in the main building with smoke detectors, heat detectors, alarms, strobes, pull stations, back-up emergency lights, and exit signs	Fair
Equipment/Special	None	--
Accessibility	Presently it does not appear an accessibility study is needed for this building. See Appendix D.	
Key Issues and Findings	Chiller and cooling tower not functional
