FACILITY CONDITION ASSESSMENT

Frayser-Corning Elementary School
1602 Dellwood Avenue
Memphis, Tennessee 38127

April 19, 2024

December 14, 2023

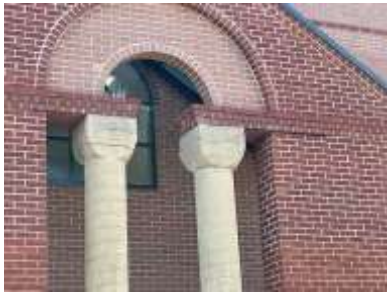
Exterior Walls in Poor condition.

Brick
Frayser - Corning Elementary School Building
Exterior

Some areas of brick need repointing - AssetCALC ID: 7183961

Uniformat Code: B2010
Recommendation: **Repair/Repoint in 2024**

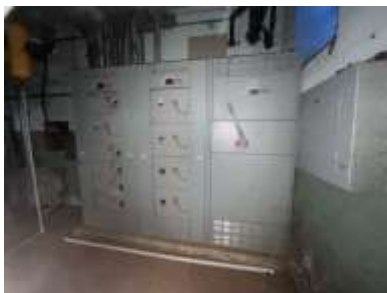
Switchboard in Poor condition.

120/208 V
Frayser - Corning Elementary School Boiler
room

Federal Pacific at end of useful life - AssetCALC ID: 7183965

Uniformat Code: D5020
Recommendation: **Replace in 2025**

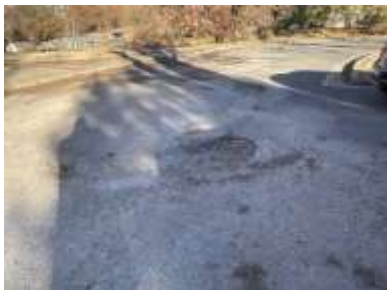
Parking Lots in Poor condition.

Pavement, Asphalt
Frayser - Corning Elementary School Site

Asphalt pavement cracked and potholed - AssetCALC ID: 7183940

Uniformat Code: G2020
Recommendation: **Mill and Overlay in 2023**

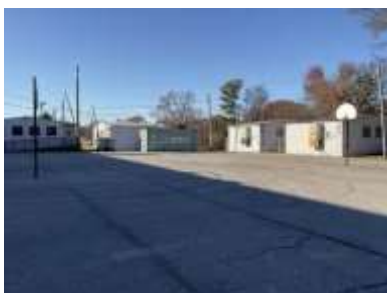
Sports Apparatus in Failed condition.

Basketball, Backboard/Rim/Pole
Frayser - Corning Elementary School Site

Basketball hoops broken - AssetCALC ID: 7183994

Uniformat Code: G2050
Recommendation: **Replace in 2023**

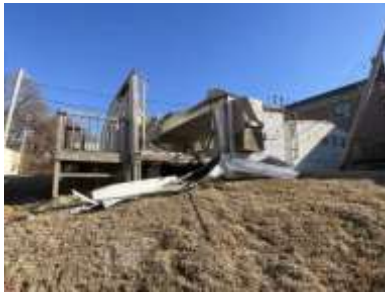
Ancillary Building in Failed condition.

Classroom/Office Module, Standard/Permanent
Frayser - Corning Elementary School Site

Storm damaged - AssetCALC ID: 7183977

Uniformat Code: F1020
Recommendation: **Replace in 2024**

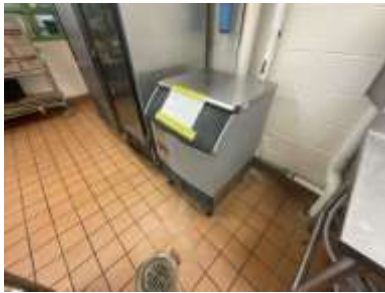
Foodservice Equipment in Failed condition.

Icemaker, Freestanding
Frayser - Corning Elementary School Kitchen

Out of service - AssetCALC ID: 7183996

Uniformat Code: E1030
Recommendation: **Replace in 2023**

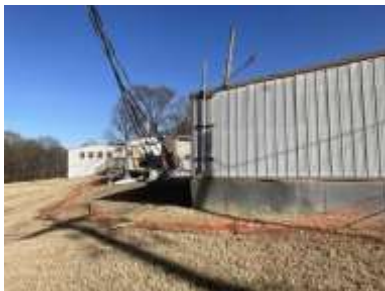
Ancillary Building in Failed condition.

Classroom/Office Module, Standard/Permanent
Frayser - Corning Elementary School Site

Storm damaged - AssetCALC ID: 7183960

Uniformat Code: F1020
Recommendation: **Replace in 2024**

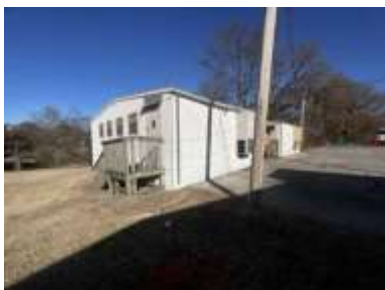
Ancillary Building in Poor condition.

Classroom/Office Module, Standard/Permanent
Frayser - Corning Elementary School Site

Slated for removal - AssetCALC ID: 7183923

Uniformat Code: F1020
Recommendation: **Replace in 2024**

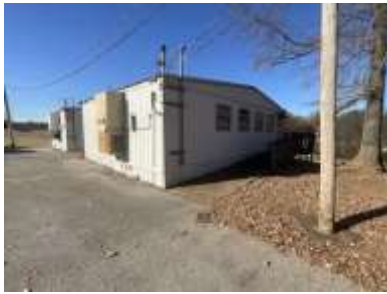
**Ancillary Building in Poor condition.**

Classroom/Office Module, Standard/Permanent
Frayser - Corning Elementary School Site

Slated for removal - AssetCALC ID: 7183985

Uniformat Code: F1020
Recommendation: **Replace in 2024**

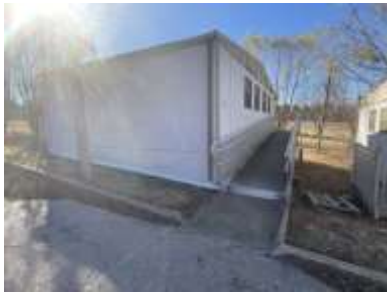
**Ancillary Building in Poor condition.**

Classroom/Office Module, Standard/Permanent
Frayser - Corning Elementary School Site

Slated for removal - AssetCALC ID: 7183931

Uniformat Code: F1020
Recommendation: **Replace in 2024**

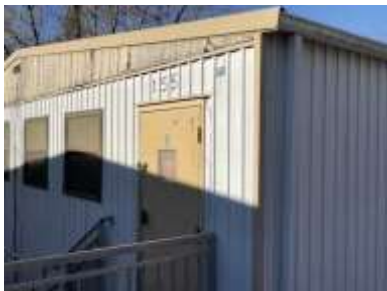
**Ancillary Building in Poor condition.**

Classroom/Office Module, Standard/Permanent
Frayser - Corning Elementary School Site

Slated for removal - AssetCALC ID: 7183979

Uniformat Code: F1020
Recommendation: **Replace in 2024**

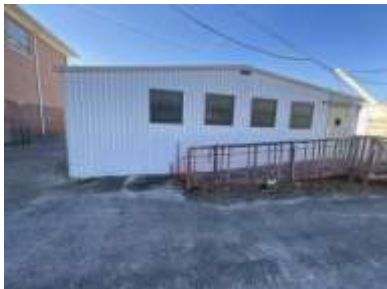
**Ancillary Building in Poor condition.**

Classroom/Office Module, Standard/Permanent
Frayser - Corning Elementary School Site

Slated for removal - AssetCALC ID: 7184003

Uniformat Code: F1020
Recommendation: **Replace in 2024**

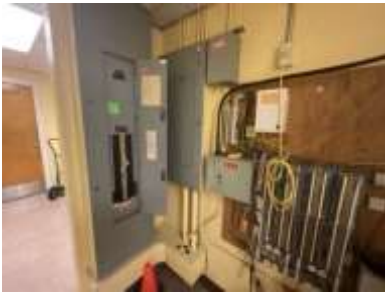
Distribution Panel in Poor condition.

120/208 V
Frayser - Corning Elementary School Office

Federal Pacific panels well beyond their useful life. - AssetCALC ID: 7183982

Uniformat Code: D5020
Recommendation: **Replace in 2025**

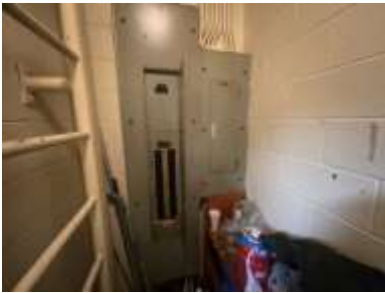
Distribution Panel in Poor condition.

120/208 V
Frayser - Corning Elementary School Utility closet

Federal Pacific panel beyond useful life - AssetCALC ID: 7183934

Uniformat Code: D5020
Recommendation: **Replace in 2025**

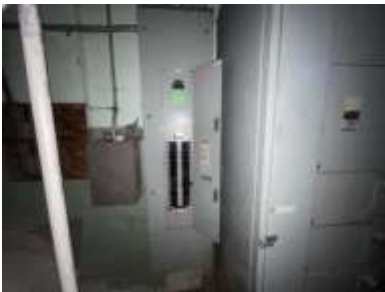
Distribution Panel in Poor condition.

120/208 V
Frayser - Corning Elementary School Boiler room

Federal Pacific past useful life - AssetCALC ID: 7183988

Uniformat Code: D5020
Recommendation: **Replace in 2025**

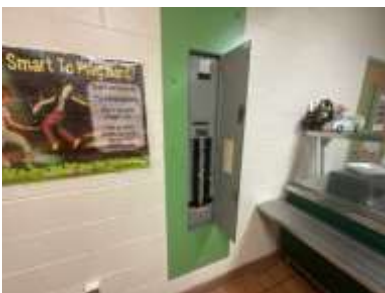
Distribution Panel in Poor condition.

120/208 V
Frayser - Corning Elementary School Kitchen

Federal Pacific past useful life - AssetCALC ID: 7183938

Uniformat Code: D5020
Recommendation: **Replace in 2025**

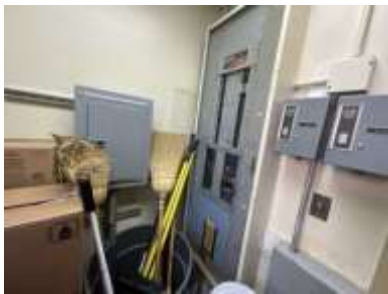
Distribution Panel in Poor condition.

120/208 V
Frayser - Corning Elementary School Kitchen

Uniformat Code: D5020
Recommendation: **Replace in 2025**

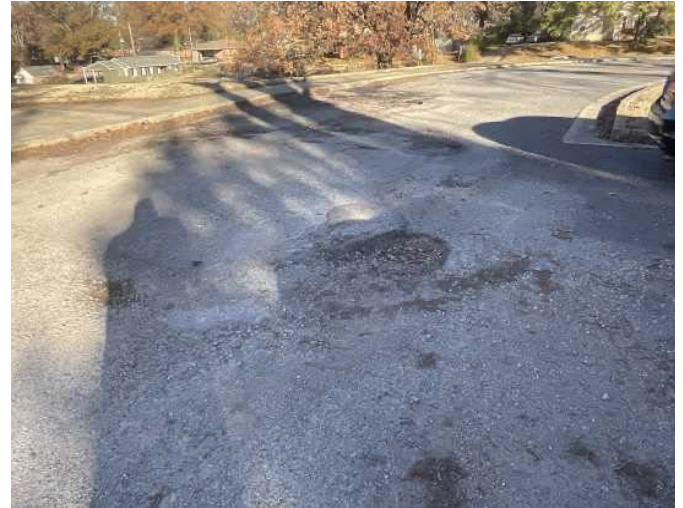
The site has a moderate slope from front to rear. Asphalt pavement is very worn and has potholed areas primarily in the front drive and parking area. There are several unused modular classroom buildings, some of which have storm damage, which are reported slated for removal without any specific date. There is a basketball court on the playground with both goal hoops damaged or missing.

26 - ASPHALT POTHOLE

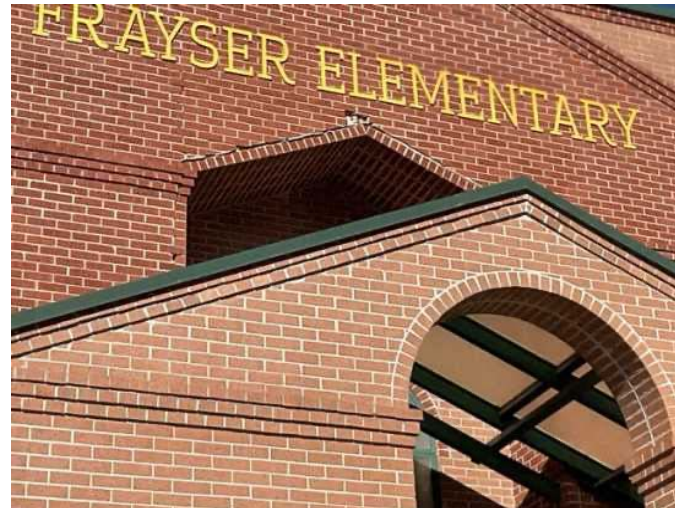
28 - EXTERIOR WALLS

Exterior walls are brick with some areas needing repair and repointing. Exterior windows and doors also appear to date to the 1986 renovation and are nearing the end of their typical useful life.
