# FACILITY CONDITION ASSESSMENT

**Shelby County Board of Education**  
160 South Hollywood Street  
Memphis, Tennessee 38112-4892  
Michelle Stuart

Gardenvue Elementary  
4075 Hartz Drive  
Memphis, Tennessee 38116

*August 9, 2024*

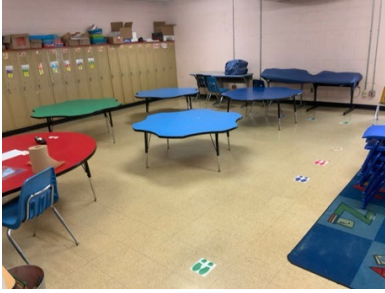
### Recommended Follow-up Study: Environmental, Asbestos (ACM) and Lead Base Paint (LBP)

Environmental, Asbestos (ACM) & Lead Base  
Paint (LBP)  
Gardenview Elementary Throughout building

Based on age asbestos mastic, insulation and lead based paints may have been used - AssetCALC ID: 7795755

Recommendation: **Evaluate/Report in 2024**

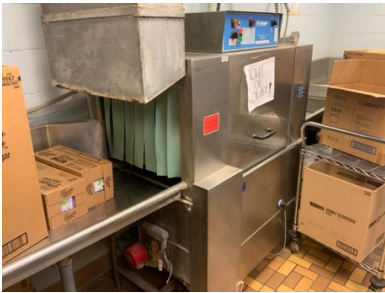
### Foodservice Equipment

Dishwasher Commercial  
Gardenview Elementary Kitchen

Out of service - AssetCALC ID: 7795762

Recommendation: **Replace in 2024**

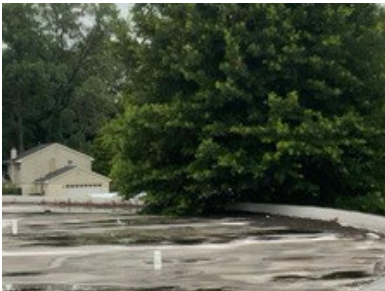
### Landscaping in Poor condition.

Mature Trees, Removal/Trimming  
Gardenview Elementary Site

Rubs on roofing - AssetCALC ID: 7795840

Recommendation: **Repair in 2025**

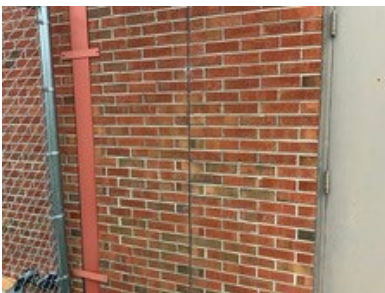
### Caulking in Poor condition.

Cold Joints, 1/2" to 1"  
Gardenview Elementary Building Exterior

Joints have opened up with missing gaps - AssetCALC ID: 7795847

Recommendation: **Replace in 2026**

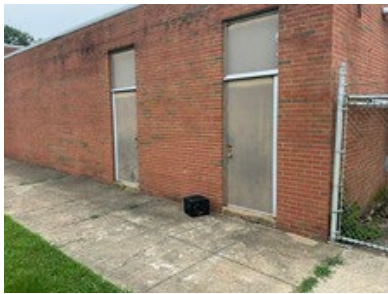
Exterior Door in Poor condition.

Steel, Standard  
Gardenview Elementary Building Exterior

Door faces starting to rust out - AssetCALC ID: 7795797

Uniformat Code: B2050  
Recommendation: **Replace in 2026**

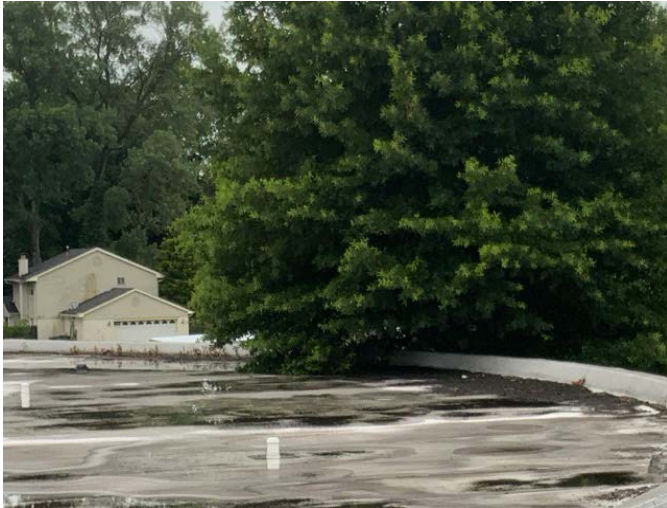
19 - TRIM MATURE TREE

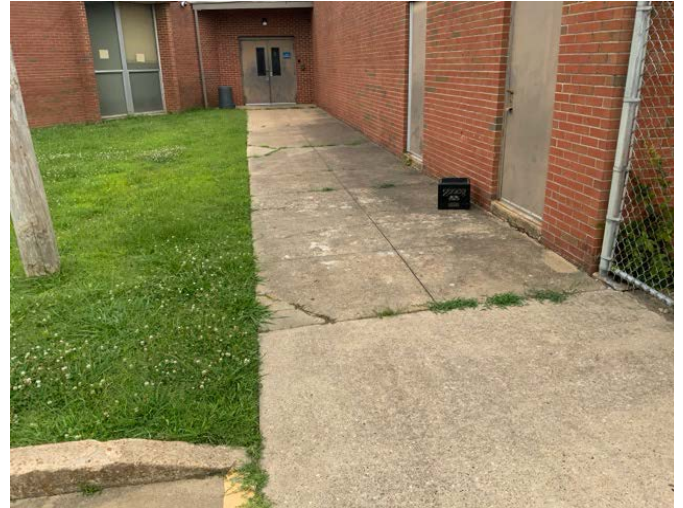
The asphalt paving has cracking with weeds and will require a mill and overlay. The ADA parking does not have a Van stall or wall lanes between stalls. The sidewalks are spalling, and future replacement should be planned. The tree overhanging the school should be trimmed back.

20 - SIDEWALK
