FACILITY CONDITION ASSESSMENT

Shelby County Board of Education
160 South Hollywood Street
Memphis, Tennessee 38112-4892
Michelle Stuart

Geeter School
4649 Horn Lake Road
Memphis, Tennessee 38109

September 30, 2024

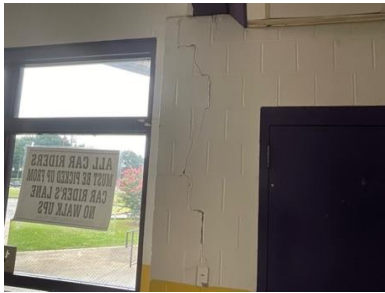
Structural Elements in Poor condition.

any type, Repairs per Man-Day
Main Building Geeter School Throughout

Cost allowance provided for repairs of cracks on interior walls - AssetCALC ID: 8000933

Uniformat Code: B1010
Recommendation: **Repair in 2024**

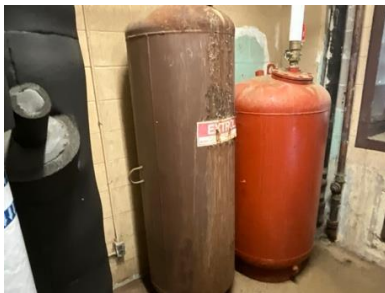
Boiler Supplemental Components in Poor condition.

Expansion Tank
Main Building Geeter School Boiler Room

The tank is rusted - AssetCALC ID: 7975741

Uniformat Code: D3020
Recommendation: **Replace in 2026**

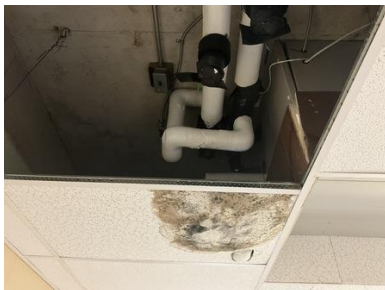
Piping and Valves in Poor condition.

Fiberglass Insulation, HVAC Chilled Water
Main Building Geeter School Throughout Building

Piping is still has condensation with insulation isolated areas throughout the facility were new units are installed - AssetCALC ID: 7975770

Uniformat Code: D3050
Recommendation: **Replace in 2026**

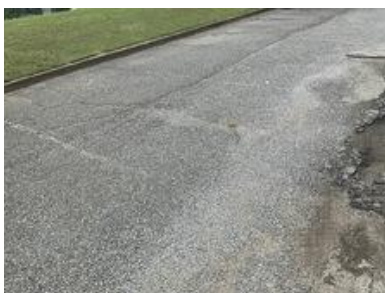
Parking Lots in Poor condition.

Pavement, Asphalt
Main Building Geeter School Site

The striping is badly worn. Repairs are recommended - AssetCALC ID: 7975765

Uniformat Code: G2020
Recommendation: **Seal and Stripe in 2025**

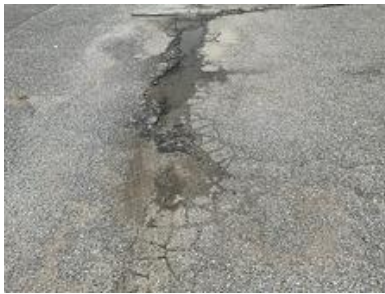
Parking Lots in Poor condition.

Pavement, Asphalt
Main Building Geeter School Site

The parking lot has heavy weathering and potholes throughout its surface - AssetCALC ID: 7975701

Uniformat Code: G2020
Recommendation: **Mill and Overlay in 2026**

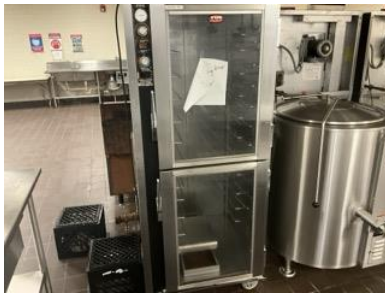
Foodservice Equipment in Failed condition.

Food Warmer, Proofing Cabinet on Wheels
Main Building Geeter School Kitchen

According to the sign posted the equipment is not in service - AssetCALC ID: 7975716

Uniformat Code: E1030
Recommendation: **Replace in 2024**

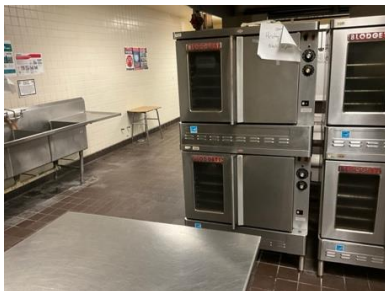
Foodservice Equipment in Failed condition.

Convection Oven, Double
Main Building Geeter School Kitchen

The oven is in need of repair - AssetCALC ID: 7975742

Uniformat Code: E1030
Recommendation: **Replace in 2024**

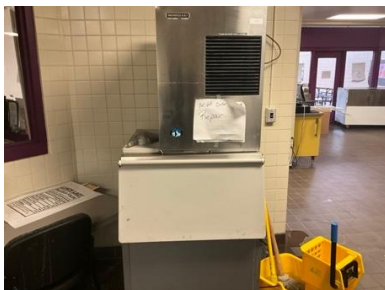
Foodservice Equipment in Failed condition.

Icemaker, Freestanding
Main Building Geeter School Kitchen

According the to the sign post the equipment is not in service - AssetCALC ID: 7975729

Uniformat Code: E1030
Recommendation: **Replace in 2024**

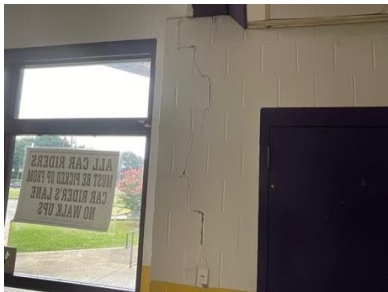
Recommended Follow-up Study:
Building Envelope, Façade

Building Envelope, Façade
Main Building Geeter School Throughout Building

The building has cracking in isolated areas throughout the facility - AssetCALC ID: 7975713

Uniformat Code: P2030
Recommendation: **Evaluate/Report in 2024**
