FACILITY CONDITION ASSESSMENT

Getwell Elementary
2795 Getwell Road
Memphis, Tennessee 38118

April 22, 2024

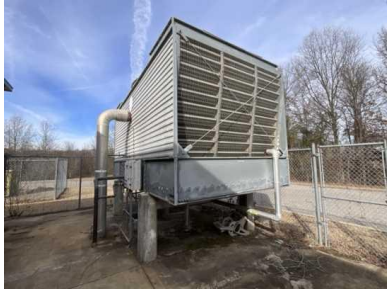
Cooling Tower in Poor condition.

(Typical) Open Circuit
Getwell Elementary School Site

In need of repair. The buildings ability to control climate in hot months has been impaired. - AssetCALC ID: 7341961

Uniformat Code: D3030
Recommendation: **Replace in 2026**

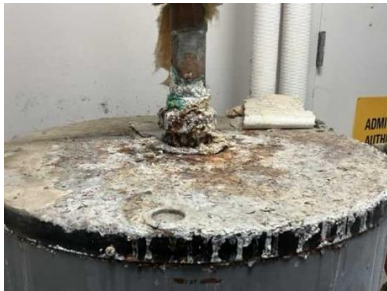
Storage Tank in Poor condition.

Domestic Water, 80 to 150 GAL
Getwell Elementary School Boiler room

Rusting - AssetCALC ID: 7341954

Uniformat Code: D2010
Recommendation: **Replace in 2024**

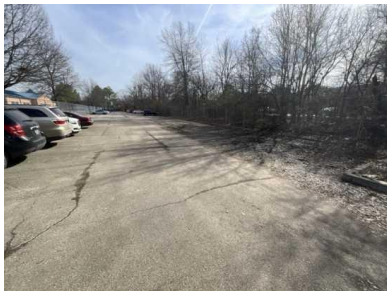
Parking Lots in Poor condition.

Pavement, Asphalt
Getwell Elementary School Site

Potholes, ponding, alligator and; edge cracking observed. - AssetCALC ID: 7362735

Significant deterioration was observed in the asphalt parking lots. As such it is recommended that parking lots be milled and overlayed. The earth along the northern perimeter of the building should be regraded in order to protect the foundation from erosion by directing water away from the building.

Uniformat Code: G2020
Recommendation: **Mill and Overlay in 2026**

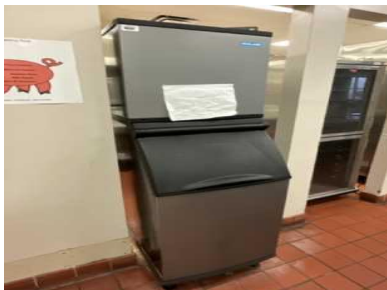
Foodservice Equipment in Failed condition.

Icemaker, Freestanding
Getwell Elementary School Kitchen

Unit no longer producing ice. - AssetCALC ID: 7341817

Uniformat Code: E1030
Recommendation: **Replace in 2024**

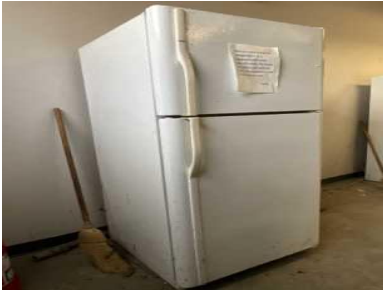
**Foodservice Equipment in Failed condition.**

Refrigerator, 1-Door Reach-In
Getwell Elementary School Boiler room

No longer used - AssetCALC ID: 7341814

Uniformat Code: E1030
Recommendation: **Replace in 2024**

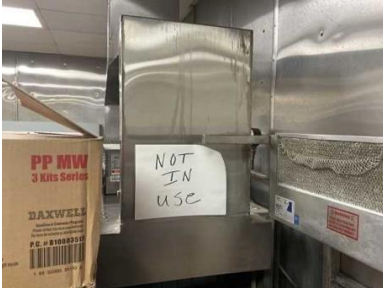
**Foodservice Equipment in Failed condition.**

Dishwasher Commercial
Getwell Elementary School Kitchen

Uniformat Code: E1030
Recommendation: **Replace in 2024**

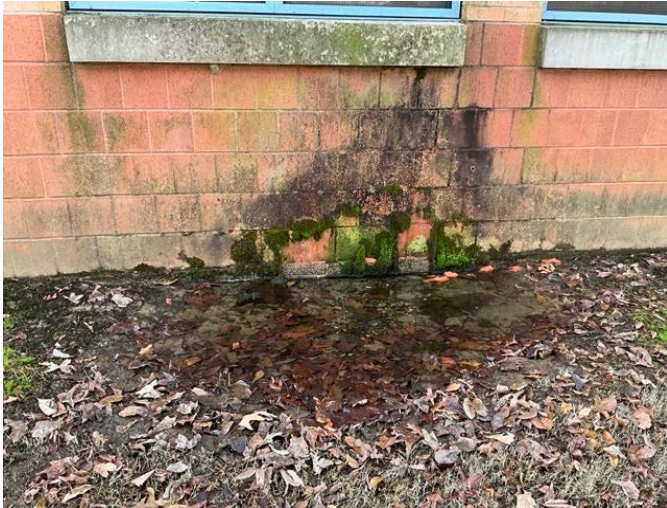
Immediate attention is required at the northern face of the building. A portion of the foundation has been exposed due to erosion caused by water and previously attempted repairs. This has caused a pool of water to form at the point of excavation/erosion. Similar pools have formed along the base of the north facing exterior wall. The roof gutter system should be assessed and replaced in relation to erosion issues around the exterior wall. No other issues were reported or observed in relation to the exterior envelope of the building. New acoustic ceiling tiles are required within the kitchen. Interior finishes are in generally good condition and well maintained.

7 - DRAINAGE ISSUE AT FOUNDATION
