# FACILITY CONDITION ASSESSMENT

**Shelby County Board of Education**  
160 South Hollywood Street  
Memphis, Tennessee 38112-4892  
Michelle Stuart

Hamilton High School  
1363 East Person Avenue  
Memphis, Tennessee 38106

*April 12, 2024*

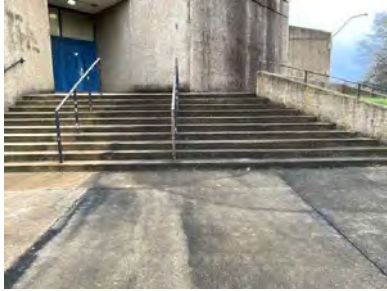
### Pressure Wash Exterior in Poor condition.

Building and Sidewalks need to be pressure washed - AssetCALC ID: 7415782

Uniformat Code: A1010  
Recommendation: **in 2024**

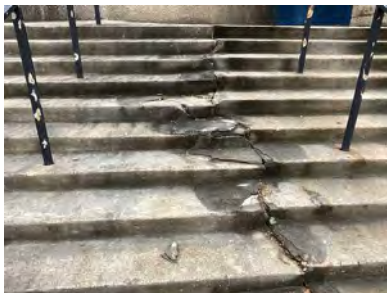
### Stairs in Failed condition.

Cracks observed at stairs. Foundation settling probable cause. Tripping hazard. - AssetCALC ID: 7415858

Uniformat Code: B1080  
Recommendation: **Replace in 2024**

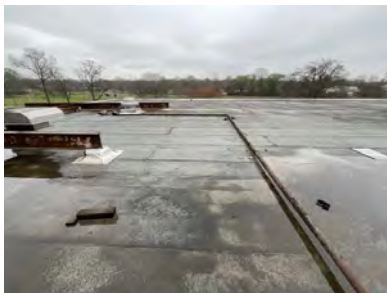
### Roofing in Poor condition.

Water ponding observed; leaks reported - AssetCALC ID: 7427445

Uniformat Code: B3010  
Recommendation: **Replace in 2024**

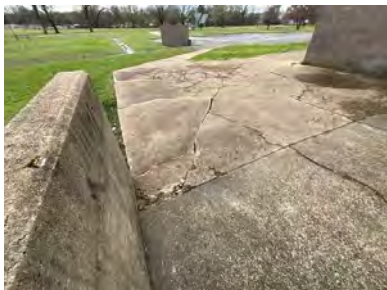
### Sidewalk in Failed condition.

Severe cracks in sidewalks throughout site - AssetCALC ID: 7415846

Uniformat Code: G2030  
Recommendation: **Replace in 2024**

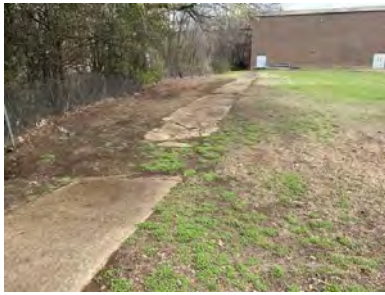
### Sidewalk in Failed condition.

Ruined sidewalks observed - AssetCALC ID: 7415406

Unifomat Code: G2030  
Recommendation: **Replace in 2024**

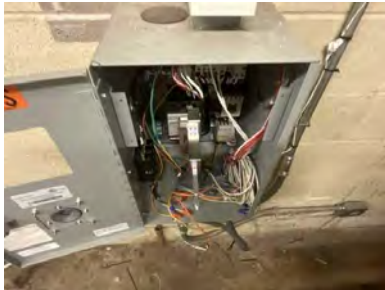
### Variable Frequency Drive in Failed condition.

Seemed not in use - AssetCALC ID: 7415401

Unifomat Code: D5030  
Recommendation: **Replace/Install in 2024**

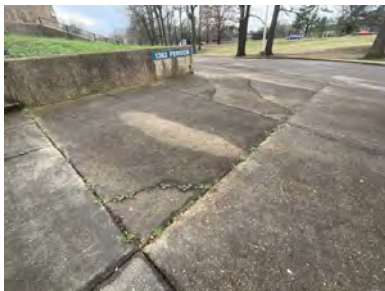
### Sidewalk in Poor condition.

Many cracks observed at several locations. - AssetCALC ID: 7415373

Unifomat Code: G2030  
Recommendation: **Replace in 2024**

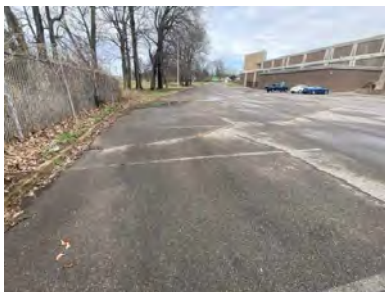
### Parking Lots in Poor condition.

Several cracks observed - AssetCALC ID: 7415356

Unifomat Code: G2020  
Recommendation: **Seal and Stripe in 2024**

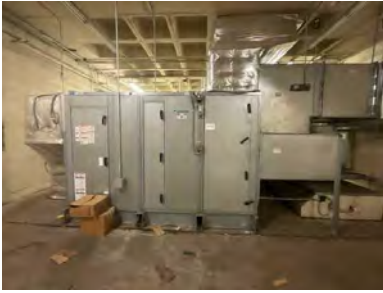
Most of the heating, cooling, and ventilating big-ticket equipment is less than 10 years old, but inadequately heated/cooled spaces were noticed throughout the building, meaning balance or controls issues seem to be present.

### Recommended Follow-up Study: Mechanical, HVAC Controls/Rebalance

HVAC system was upgraded around 6 years ago, but most of the building is inadequately cooled/heated, per POC comments. - AssetCALC ID: 7427447

The HVAC system is not working properly as it's evident no adequate cooling/heating is provided to the building at most areas. A professional engineer must be retained to analyze the existing condition, provide recommendations and, if necessary, estimate the scope and cost of any required repairs. The cost of this study is included in the cost tables.

Recommendation: **Evaluate/Report in 2024**

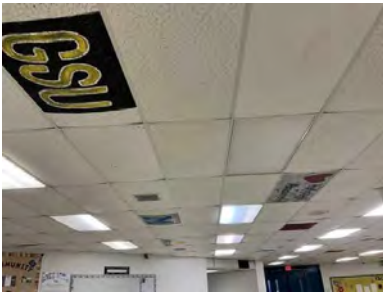
### Suspended Ceilings in Poor condition.

Ceiling tiles damaged by roof leaks; stains and missed tiles observed. - AssetCALC ID: 7415820

Recommendation: **Replace in 2024**

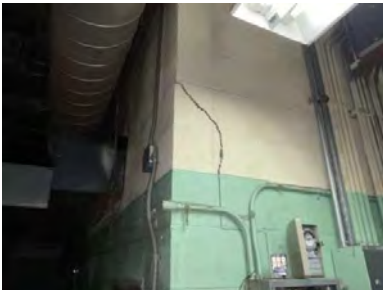
### Recommended Follow-up Study: Structural, Superstructure

Interior walls cracks observed at several locations (i.e. chiller room) Sidewalks and exterior stairs settlement issues observed - AssetCALC ID: 7427444

Interior settling issues were observed at several locations (i.e. chiller room). A professional engineer must be retained to analyze the existing condition, provide recommendations and, if necessary, estimate the scope and cost of any required repairs. The cost of this study is included in the cost tables.

Recommendation: **Evaluate/Report in 2024**

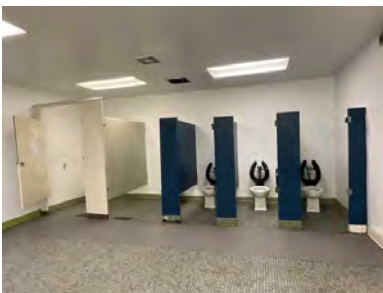
### Recommended Follow-up Study: Plumbing, Sanitary Sewer System

Repetitive sanitary sewer system clogging issues reported in the past per POC comments. - AssetCALC ID: 7427437

It has been frequently reported that the restrooms plumbing system have clogging issues. A professional engineer must be retained to analyze the existing condition, provide recommendations and, if necessary, estimate the scope and cost of any required repairs. The cost of this study is included in the cost tables.

Recommendation: **Evaluate/Report in 2024**

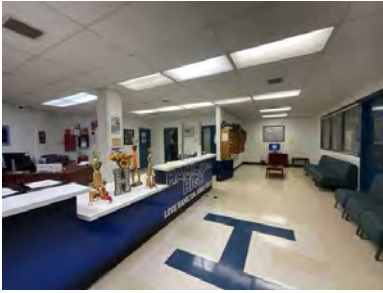
## Recommended Follow-up Study: Electrical, General Design

Power outages reported during extreme storms at several building areas (1st and; 2nd floors) - AssetCALC ID: 7427435

The electrical system infrastructure works intermittently during severe weather events. Related issues have been reported at 1st floor (all spaces) and 2nd floor (half floor). A professional engineer must be retained to analyze the existing condition, provide recommendations and, if necessary, estimate the scope and cost of any required repairs. The cost of this study is included in the cost tables.

Uniformat Code: P2030  
Recommendation: **Design in 2024**

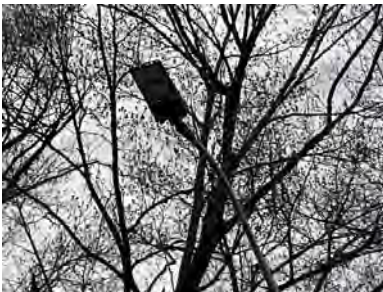
## Parking/Roadway Lighting in Poor condition.

Only 5 out of 14 are operational per point of contact reports. - AssetCALC ID: 7415410

Uniformat Code: G4050  
Recommendation: **Replace in 2024**

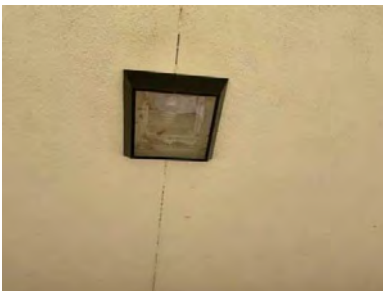
## Exterior Fixture with Lamp in Poor condition.

Dated CFL lighting fixtures will need to be replaced soon. - AssetCALC ID: 7415331

Uniformat Code: G4050  
Recommendation: **Replace in 2026**

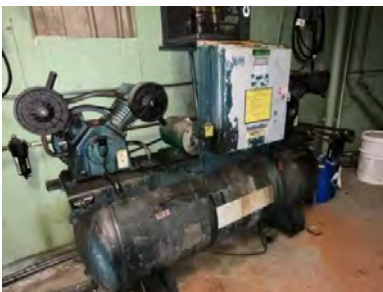
## Air Compressor in Poor condition.

Oil leaks evident; corrosion observed. - AssetCALC ID: 7415784

Uniformat Code: D2060  
Recommendation: **Replace in 2026**

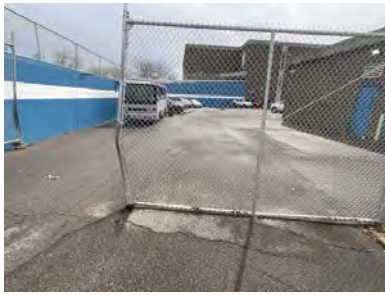
## Fences and Gates in Poor condition.

Some structural damage observed - AssetCALC ID: 7415339

Uniformat Code: G2060  
Recommendation: **Replace in 2026**

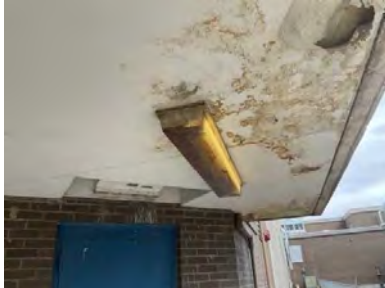
## Exterior Site Lighting in Poor condition.

Lighting fixtures covers are stained and aren't bright enough. - AssetCALC ID: 7415403

Uniformat Code: G4050  
Recommendation: **Replace in 2026**

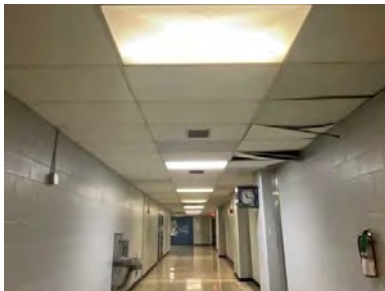
## Recommended Follow-up Study: Environmental, Analysis of Suspect Fungal Growth

Mold suspected throughout caused by roof leaks, per POC comments. - AssetCALC ID: 7427438

It was reported that the roof leaks combined with HVAC issues could be a cause of mold. A professional engineer must be retained to analyze the existing condition, provide recommendations and, if necessary, estimate the scope and cost of any required repairs. The cost of this study is included in the cost tables.

Uniformat Code: P2030  
Recommendation: **Evaluate/Report in 2024**

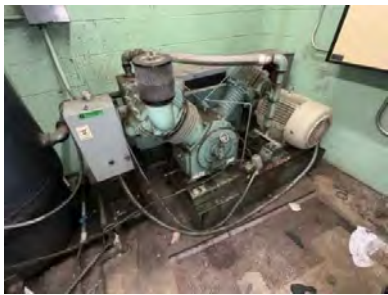
**Air Compressor in Failed condition.**

Seems to not be in use. - AssetCALC ID: 7415815

Uniformat Code: D2060  
Recommendation: **Replace in 2024**

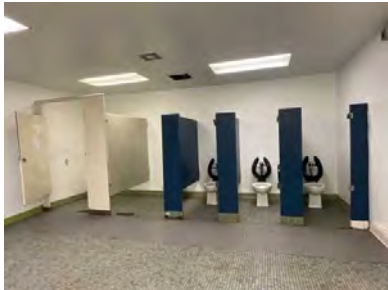
**Toilet Partitions in Poor condition.**

Seems to be dated, damaged and missing doors - AssetCALC ID: 7415790

Uniformat Code: C1090  
Recommendation: **Replace in 2024**
