FACILITY CONDITION ASSESSMENT

Shelby County Board of Education
160 South Hollywood Street
Memphis, TN 38112-4892
Michelle Stuart

Havenview Middle School
1481 Hester Road
Memphis, TN 38116

September 30, 2024

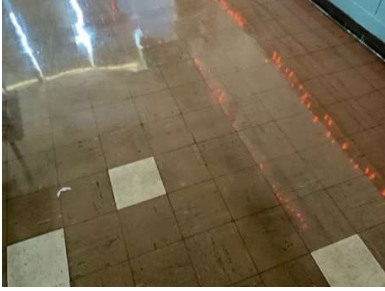
Recommended Follow-up Study: Environmental, Asbestos (ACM) & Lead Base Paint (LBP)

Environmental, Asbestos (ACM) & Lead Base
Paint (LBP)
Havenview Middle School Throughout

Insulation, ceiling tiles, floor tiles and mastic could contain asbestos - AssetCALC ID: 8056207

Recommendation: **Evaluate/Report in 2024**

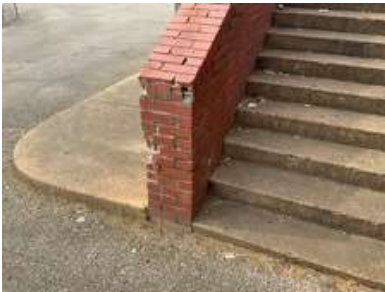
Exterior Walls in Poor condition.

Brick
Havenview Middle School Building Exterior

Broken out on stairs - AssetCALC ID: 8052351

Recommendation: **Repair/Repoint in 2025**

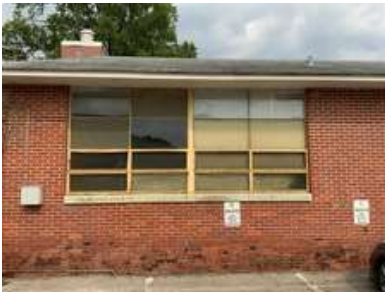
Window in Poor condition.

Steel, 16-25 SF
Havenview Middle School Building Exterior

Cracked, seals broken, not efficient - AssetCALC ID: 8052353

Recommendation: **Replace in 2026**

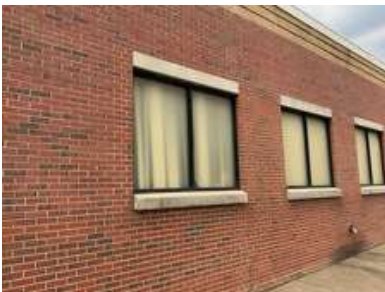
Window in Poor condition.

Aluminum Double-Glazed, 16-25 SF
Havenview Middle School Building Exterior

Some broken seals - AssetCALC ID: 8052315

Recommendation: **Replace in 2026**

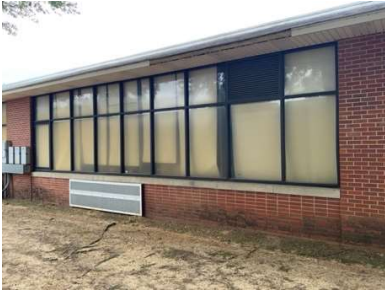
Storefront in Poor condition.

Glazing & Framing
Havenview Middle School Building Exterior

Broken seals on glazing - AssetCALC ID: 8052314

Uniformat Code: B2020
Recommendation: **Replace in 2026**

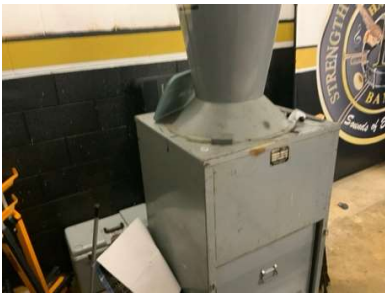
Exhaust Fan

Industrial Dust Collection, 7.5 HP Motor
Havenview Middle School Classrooms Music

Out of service - AssetCALC ID: 8052263

Uniformat Code: D3060
Recommendation: **Replace in 2024**

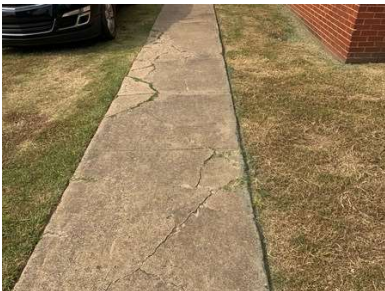
Sidewalk in Poor condition.

Concrete, Small Areas/Sections
Havenview Middle School Site

Breaking up - AssetCALC ID: 8052295

Uniformat Code: G2030
Recommendation: **Replace in 2026**

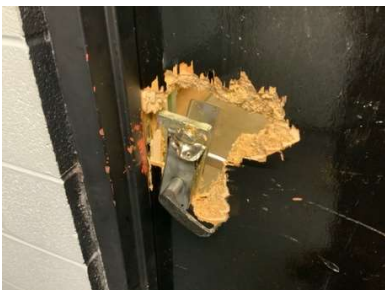
Interior Door in Failed condition.

Wood, Solid-Core
Havenview Middle School Locker Rooms

Broken out at lockset - AssetCALC ID: 8052249

Uniformat Code: C1030
Recommendation: **Replace in 2024**

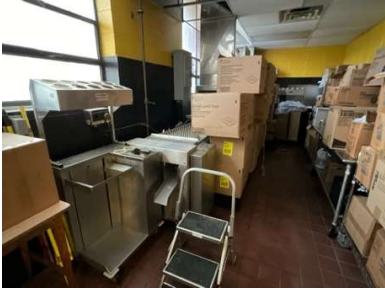
Commercial Kitchen Line

Dishwashing Equipment
Havenview Middle School Cafeteria

Out of service - AssetCALC ID: 8043114

Uniformat Code: E1030
Recommendation: **Replace in 2024**

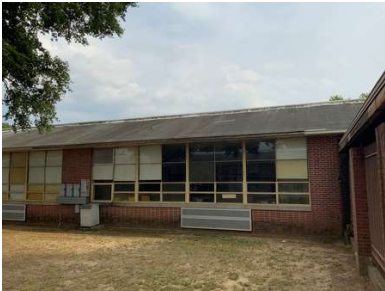
Soffit/Fascia in Poor condition.

Stucco
Havenview Middle School Roof

Fascia and soffit damaged in multiple areas - AssetCALC ID: 8055438

Uniformat Code: B3080
Recommendation: **Repair in 2025**

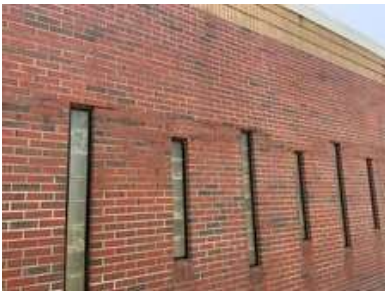
Caulking in Poor condition.

Window Edge/Trim, per LF
Havenview Middle School Building Exterior

Cracked - AssetCALC ID: 8052296

Uniformat Code: B2010
Recommendation: **Replace in 2026**

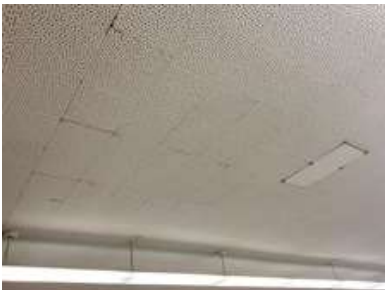
Suspended Ceilings in Poor condition.

Hard Tile, Replacement w/ ACT
Havenview Middle School Classrooms
General

Could contain asbestos - AssetCALC ID: 8052379

Uniformat Code: C1070
Recommendation: **Replace in 2026**

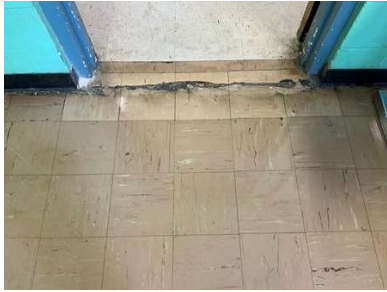
Flooring in Poor condition.

Vinyl Tile (VCT), w/ Asbestos Abatement
Havenview Middle School Throughout Building

Uniformat Code: C2030
Recommendation: **Replace in 2026**
