FACILITY CONDITION ASSESSMENT

Hawkins Mill Elementary School
4295 Mountain Trail
Memphis, Tennessee 38127

163745.23R000-047.354

January 16, 2024

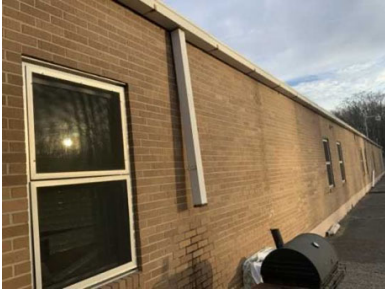
**Roofing in Failed condition.**

any type, Repairs per Man-Day
Annex Hawkins Mill Elementary School
Building exterior
Uniformat Code: B3010
Recommendation: **Repair in 2023**

Broken and missing downspouts observed - AssetCALC ID: 7170360

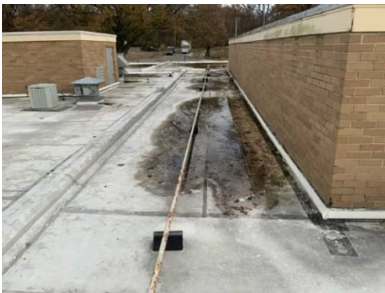
**Roofing in Poor condition.**

Single-Ply Membrane, TPO/PVC
Main School Building Hawkins Mill Elementary
School Roof
Uniformat Code: B3010
Recommendation: **Replace in 2025**

Numerous large areas of ponding observed - AssetCALC ID: 7170347

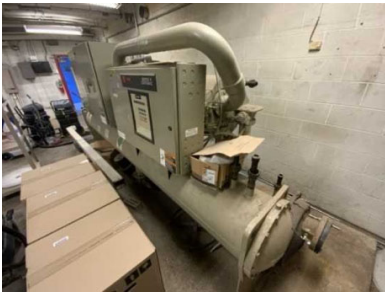
**Chiller in Failed condition.**

Water-Cooled
Main School Building Hawkins Mill Elementary
School Mechanical room
Uniformat Code: D3030
Recommendation: **Replace in 2023**

Disconnected - AssetCALC ID: 7171452

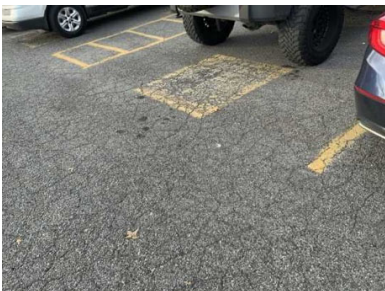
**Parking Lots in Failed condition.**

Pavement, Asphalt
Main School Building Hawkins Mill Elementary
School Site
Uniformat Code: G2020
Recommendation: **Seal and Stripe in 2023**

Striping is worn out - AssetCALC ID: 7170329

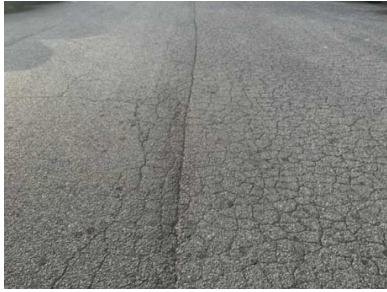
**Parking Lots in Poor condition.**

Pavement, Asphalt
Main School Building Hawkins Mill Elementary
School Site
Uniformat Code: G2020
Recommendation: **Cut and Patch in 2023**

Severe alligator cracking and potholes Les - AssetCALC ID: 7170342

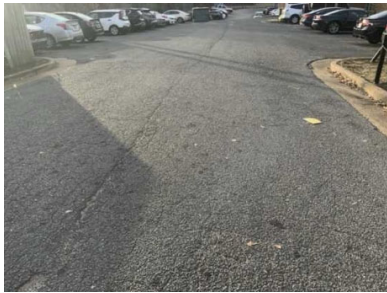
**Parking Lots in Poor condition.**

Pavement, Asphalt
Main School Building Hawkins Mill Elementary
School Site
Uniformat Code: G2020
Recommendation: **Mill and Overlay in 2025**

Widespread alligator cracking - AssetCALC ID: 7170321

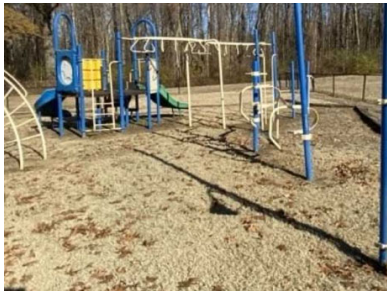
**Playfield Surfaces in Failed condition.**

Chips Rubber, 3" Depth
Main School Building Hawkins Mill Elementary
School Site
Uniformat Code: G2050
Recommendation: **Replace in 2023**

Missing play surface - AssetCALC ID: 7188458

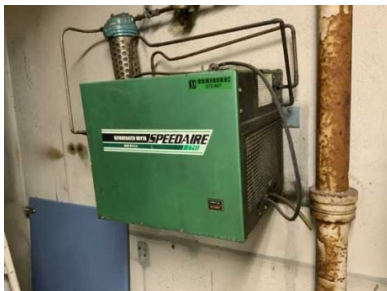
**Supplemental Components in Failed condition.**

Compressed Air Dryer, Process Support
Main School Building Hawkins Mill Elementary
School Throughout building
Uniformat Code: D2060
Recommendation: **Replace in 2023**

Disconnected - AssetCALC ID: 7171409

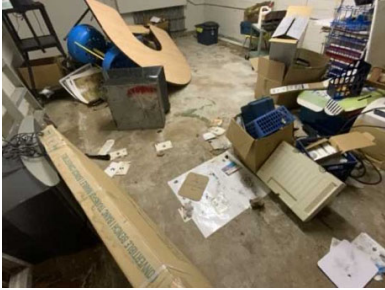
**Recommended Follow-up Study:
Environmental, Remediation of
Suspect Fungal Growth**

Strong odor of mold detected - AssetCALC ID: 7188512

Recommendation: **Remove in 2023**Priority Score: **72.9**

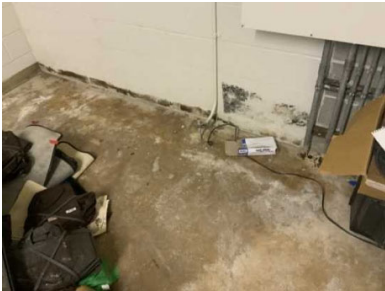
**Recommended Follow-up Study:
Environmental, Analysis of
Suspect Fungal Growth**

Recommendation: **Evaluate/Report in 2023**Priority Score: **72.9**

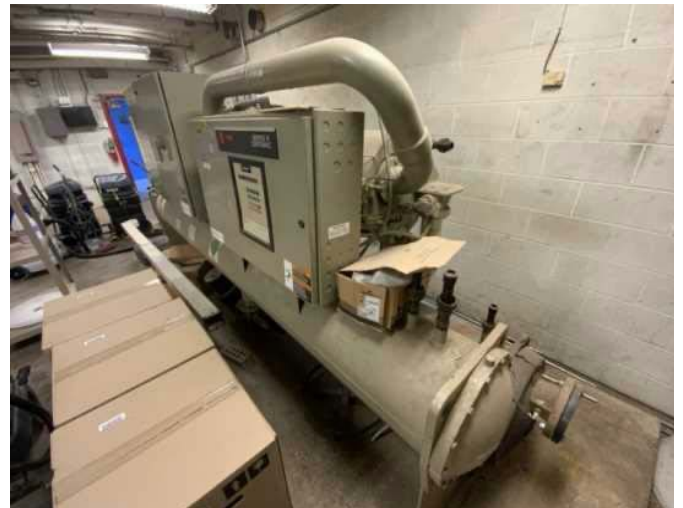
22 - WATER COOLED CHILLER (DISCONNECTED)

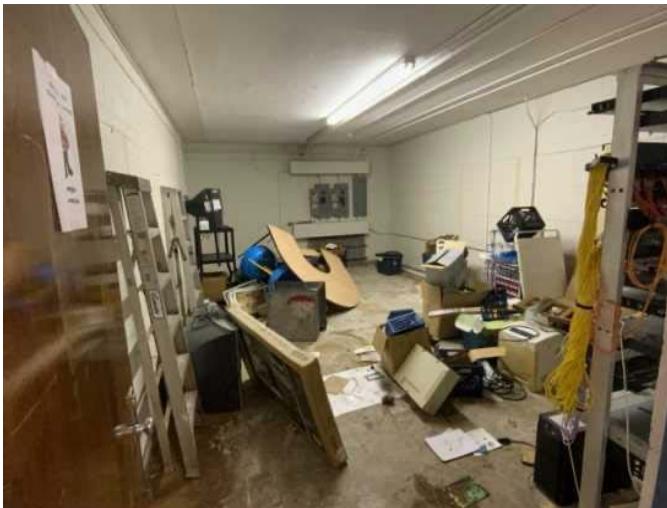
27 - ANNEX ELECTRICAL ROOM

The Electrical Room in the Annex building has a suspect fungal growth condition. A strong odor of mold was detected in the Annex Electrical Room. A professional environmental consultant must be retained to analyze the existing condition, provide recommendations and, if necessary, estimate the scope and cost of any required repairs. The cost of this study is included in the cost tables. A budgetary cost allowance to remediate the mold growth condition is also included.
