FACILITY CONDITION ASSESSMENT

Shelby County Board of Education
160 South Hollywood Street
Memphis, Tennessee 38112-4892
Michelle Stuart

Holmes Road Elementary
1083 East Holmes Road
Memphis, Tennessee 38116

DATE OF REPORT:
September 30, 2024

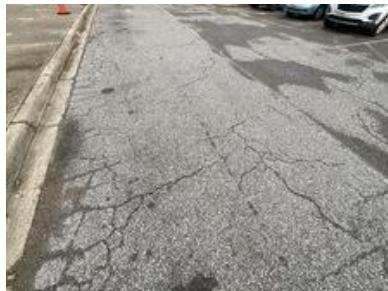
Pavement, Asphalt
Holmes Road Elementary Site

Parking Lots in Poor condition.

Very worn and in some areas completely missing. - AssetCALC ID: 8000327

Uniformat Code: G2020
Recommendation: **Seal and Stripe in 2025**

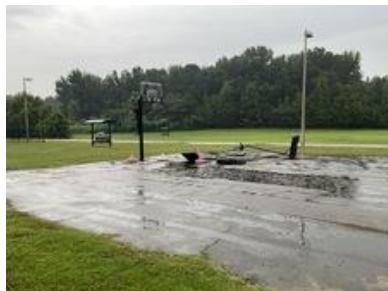
Basketball, Backboard/Rim/Pole
Holmes Road Elementary Site

Sports Apparatus in Failed condition.

Net and rim missing. - AssetCALC ID: 8068495

Uniformat Code: G2050
Recommendation: **Replace in 2026**

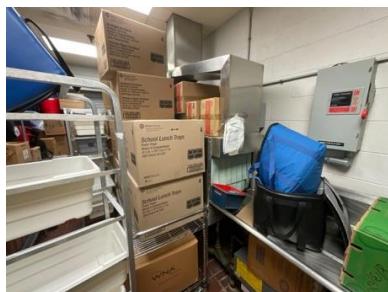
Dishwasher Commercial
Holmes Road Elementary Kitchen

Foodservice Equipment in Failed condition.

Uniformat Code: E1030
Recommendation: **Replace in 2024**
