# FACILITY CONDITION ASSESSMENT

Ida B. Wells Elementary School  
995 South Lauderdale Street  
Memphis, Tennessee 38126

*March 5, 2024*

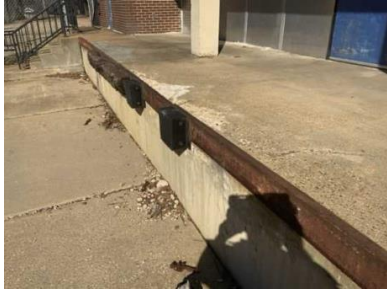
**Parking Lots in Poor condition.**

Pavement, Concrete  
Ida B Wells Elementary Site

Hazard with gaps - AssetCALC ID: 7337718

Uniformat Code: G2020  
Recommendation: **Replace in 2025**

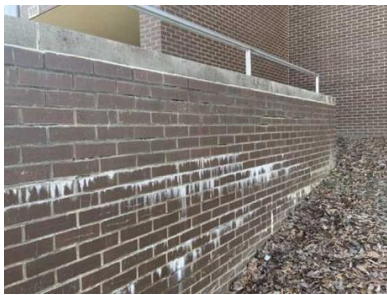
**Exterior Walls in Poor condition.**

Brick  
Ida B Wells Elementary Site

Mortar joints have failed - AssetCALC ID: 7337736

Uniformat Code: B2010  
Recommendation: **Repair/Repoint in 2024**

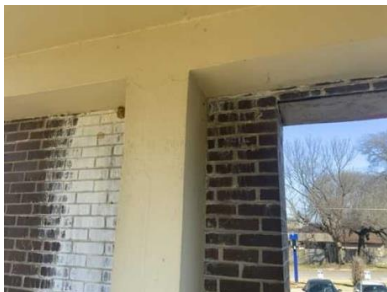
**Exterior Walls in Poor condition.**

any surface  
Ida B Wells Elementary Building Exterior

Efflorescence that is concentrated - AssetCALC ID: 7337753

Uniformat Code: B2010  
Recommendation: **Clean in 2024**

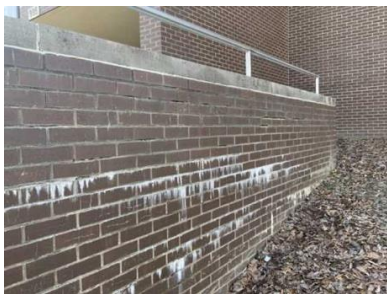
**Basement Wall in Poor condition.**

any type, Waterproofing of Exterior Face  
Ida B Wells Elementary Building Exterior

Efflorescence on walls - AssetCALC ID: 7385728

Uniformat Code: A2010  
Recommendation: **Replace in 2024**

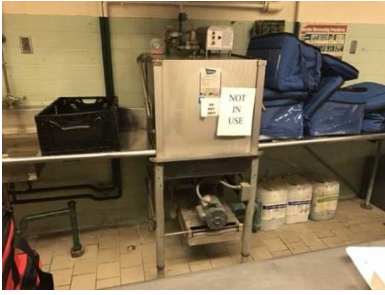
**Foodservice Equipment in Failed condition.**

Dishwasher Commercial  
Ida B Wells Elementary Kitchen

out of service - AssetCALC ID: 7368524

Uniformat Code: E1030  
Recommendation: **Replace in 2024**

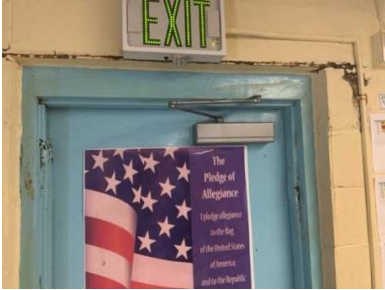
**Exterior Door in Poor condition.**

Steel, Standard  
Ida B Wells Elementary Building Exterior

Door and frame rusted out - AssetCALC ID: 7337704

Uniformat Code: B2050  
Recommendation: **Replace in 2025**

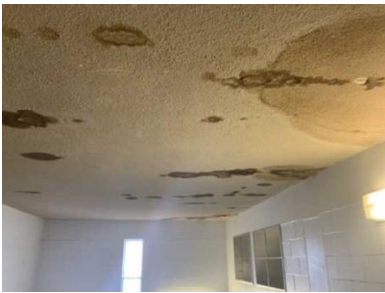
**Ceiling Finishes in Poor condition.**

Textured Spray Coating  
Ida B Wells Elementary Stairwell

Water damage - AssetCALC ID: 7337757

Uniformat Code: C2050  
Recommendation: **Replace in 2026**

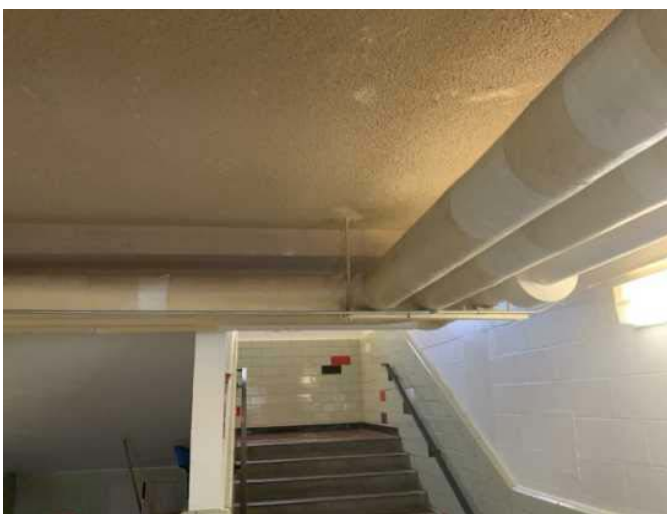
The mechanical system was upgraded in about 2018 including the chiller, boiler, cooling tower and fan coils. The hydronic piping is end of life and future replacement should be planned. The electrical system is near end of life and replacement of the wiring and distribution panels should be considered. The lighting interior and exterior has not been upgraded to LED lamps. The plumbing is nearing end of life and replacement should be considered. The fixtures are generally original, drinking fountains have been upgraded to bottle fillers. Fire protection for the building is limited to portable fire extinguishers and an automatic system for the kitchen exhaust hood. There is a complete fire alarm system with horns, strobes and an annunciator panel in the main vestibule.

17 - HYDRONIC PIPING

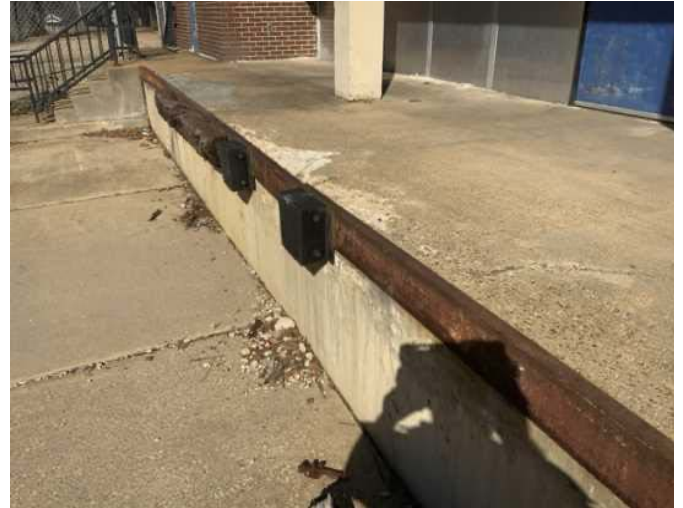
The concrete dock has areas that are broken out and spalling. The older sidewalks are starting to break up. The playground paving is cracking up and should be replaced. The parking lot is cracked, and an overlay and striping should be planned. The original playground fence is leaning and rusty. The steel railings should be painted.

20 - CONCRETE DOCK BREAKOUT

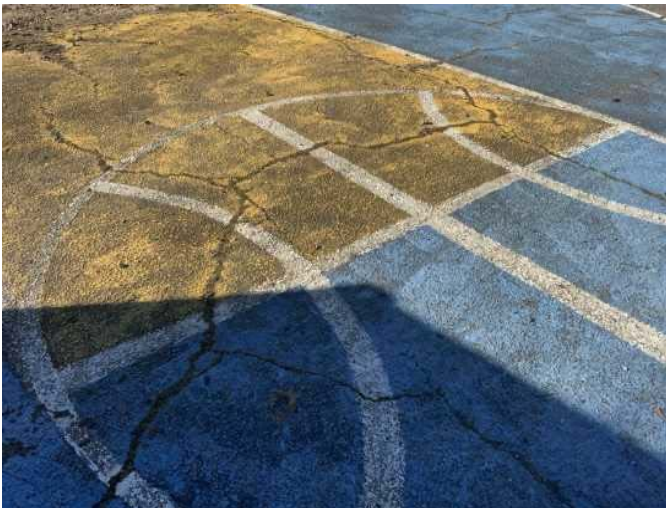
21 - PLAYGROUND ASPHALT
