FACILITY CONDITION ASSESSMENT

Shelby County Board of Education
160 South Hollywood Street
Memphis, Tennessee 38112-4892
Michelle Stuart

Idlewild Elementary School
1950 Linden Avenue
Memphis, Tennessee 38104

March 7, 2024

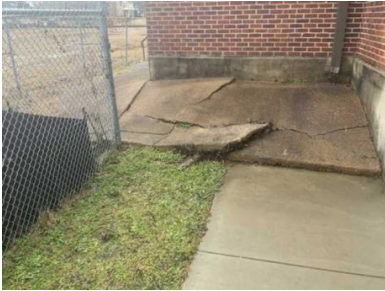
Sidewalk in Failed condition.

Concrete, Large Areas
Idlewild Elementary School Gymnasium Site

Broken up, steep slope - AssetCALC ID: 7389758

Uniformat Code: G2030
Recommendation: **Replace in 2025**

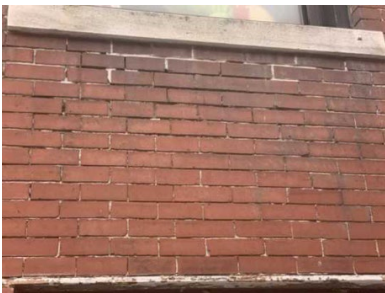
Exterior Walls in Poor condition.

Brick
Idlewild Elementary School Building Exterior

Mortar failed on upper walls - AssetCALC ID: 7391907

Uniformat Code: B2010
Recommendation: **Repair/Repoint in 2024**

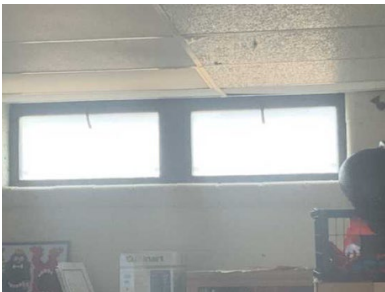
Window in Poor condition.

Aluminum Double-Glazed, up to 15 SF
Idlewild Elementary School Gymnasium
Building Exterior

Old windows - AssetCALC ID: 7389761

Uniformat Code: B2020
Recommendation: **Replace in 2026**

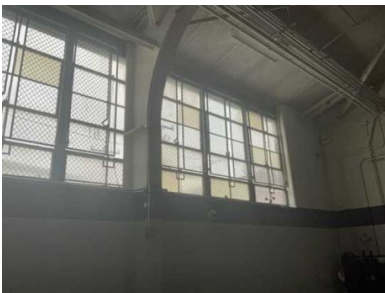
Window in Poor condition.

Steel, 16-25 SF
Idlewild Elementary School Gymnasium
Building Exterior

Rusting frame, single pane - AssetCALC ID: 7389769

Uniformat Code: B2020
Recommendation: **Replace in 2026**

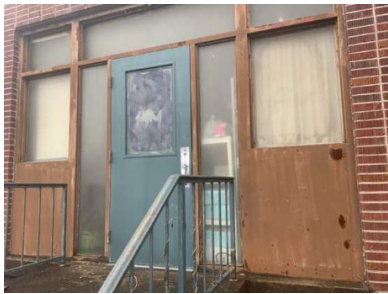
Window in Poor condition.

Steel, 28-40 SF
Idlewild Elementary School Gymnasium
Building Exterior

Rusting frames, not clear - AssetCALC ID: 7389776

Uniformat Code: B2020
Recommendation: **Replace in 2026**

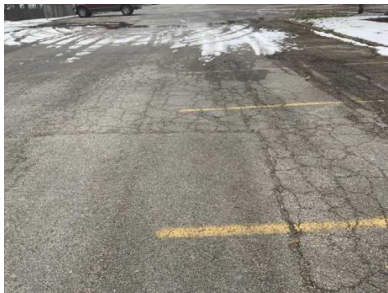
Parking Lots in Poor condition.

Pavement, Asphalt
Idlewild Elementary School Site

Potholes, breaking up - AssetCALC ID: 7391914

Uniformat Code: G2020
Recommendation: **Mill and Overlay in 2026**

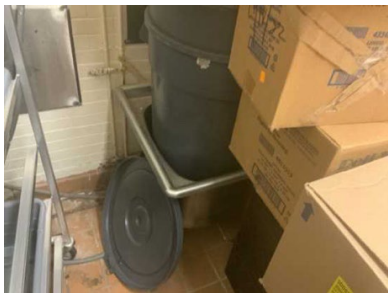
Sink/Lavatory in Poor condition.

Commercial Kitchen, 1-Bowl
Idlewild Elementary School Kitchen

Out of service - AssetCALC ID: 7391889

Uniformat Code: D2010
Recommendation: **Replace in 2024**

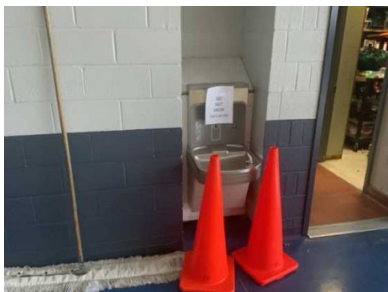
Drinking Fountain in Poor condition.

Wall-Mounted, Single-Level
Idlewild Elementary School Gymnasium

Out of service - AssetCALC ID: 7389736

Uniformat Code: D2010
Recommendation: **Replace in 2024**

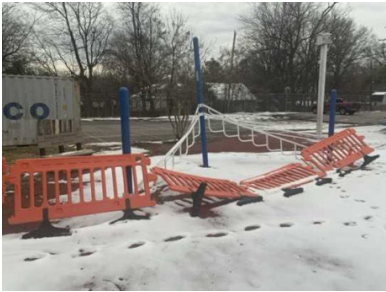
Play Structure in Failed condition.

Multipurpose, Small
Idlewild Elementary School Site

Fenced off - AssetCALC ID: 7391893

Uniformat Code: G2050
Recommendation: **Replace in 2024**

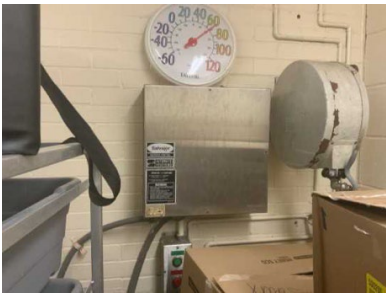
Foodservice Equipment in Poor condition.

Garbage Disposal, 1 to 3 HP
Idlewild Elementary School Kitchen

Out of service - AssetCALC ID: 7391933

Uniformat Code: E1030
Recommendation: **Replace in 2025**

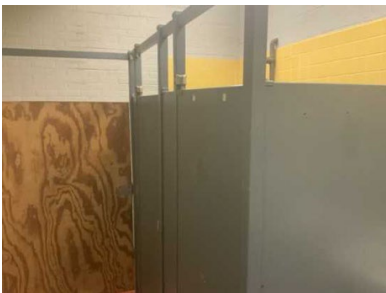
Toilet Partitions in Poor condition.

Metal
Idlewild Elementary School Gymnasium
Restrooms

Rusting out - AssetCALC ID: 7389750

Uniformat Code: C1090
Recommendation: **Replace in 2025**

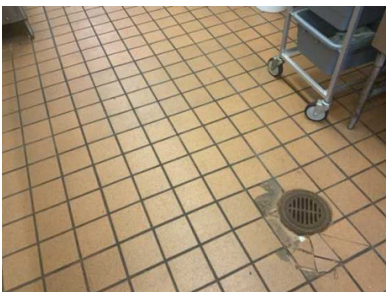
Flooring in Poor condition.

Quarry Tile
Idlewild Elementary School Kitchen

Cracked and broken tiles, areas seem to move vertically - AssetCALC ID: 7391857

Uniformat Code: C2030
Recommendation: **Replace in 2026**

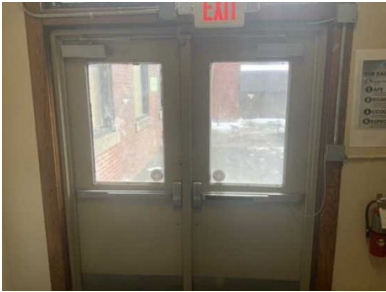
Exterior Door in Poor condition.

Steel, Standard
Idlewild Elementary School Building Exterior

Head clearance and rusted out frames and door skins - AssetCALC ID: 7391918

Uniformat Code: B2050
Recommendation: **Replace in 2026**

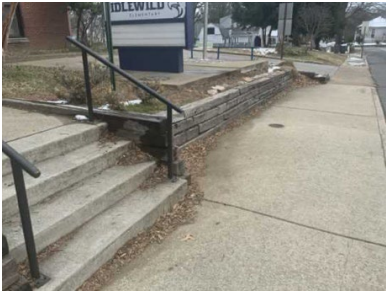
Retaining Wall in Poor condition.

Treated Timber
Idlewild Elementary School Site

Rotted out missing - AssetCALC ID: 7391871

Uniformat Code: G2060
Recommendation: **Replace in 2026**

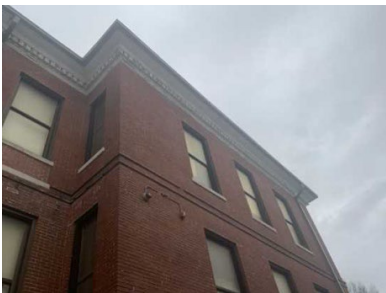
Soffit in Poor condition.

Wood
Idlewild Elementary School Building Exterior

Possibly rotting - AssetCALC ID: 7391941

Uniformat Code: B3080
Recommendation: **Replace in 2026**

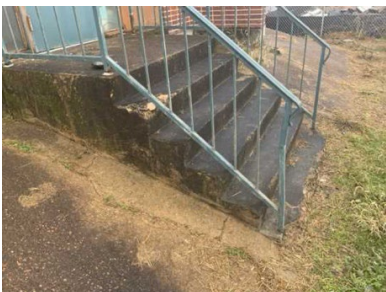
Stairs in Poor condition.

Concrete, Exterior
Idlewild Elementary School Gymnasium Site

Breaking up rails loose - AssetCALC ID: 7389745

Uniformat Code: B1080
Recommendation: **Replace in 2026**

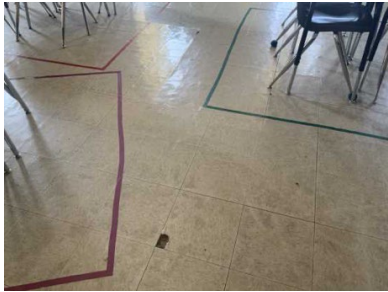
Flooring in Poor condition.

Vinyl Tile (VCT)
Idlewild Elementary School Throughout Building

Broken tiles, cracking on raised areas of subflooring - AssetCALC ID: 7391939

Uniformat Code: C2030
Recommendation: **Replace in 2026**

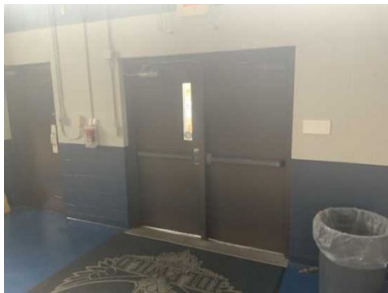
Exterior Door in Poor condition.

Steel, Standard
Idlewild Elementary School Gymnasium Building Exterior

Frames and doors rusting out - AssetCALC ID: 7389744

Uniformat Code: B2050
Recommendation: **Replace in 2026**

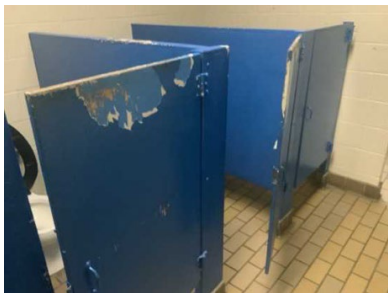
Toilet Partitions in Poor condition.

Wood
Idlewild Elementary School Restrooms

Worn, failed paint - AssetCALC ID: 7391953

Uniformat Code: C1090
Recommendation: **Replace in 2026**

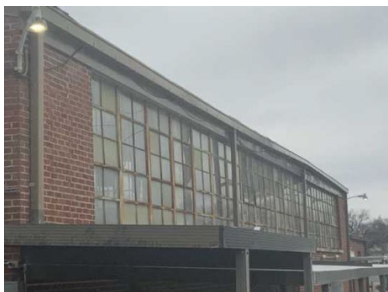
Roof Appurtenances in Poor condition.

Gutters and Downspouts, Aluminum with Fittings
Idlewild Elementary School Gymnasium Roof

End of life - AssetCALC ID: 7389738

Uniformat Code: B3020
Recommendation: **Replace in 2026**

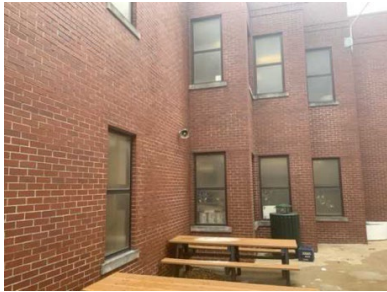
Glazing in Poor condition.

Any Type, by SF
Idlewild Elementary School Building Exterior

Being replaced. Test window completed. Schedule for Jan 29th - AssetCALC ID: 7391870

Uniformat Code: B2020
Recommendation: **Replace in 2024**
