# FACILITY CONDITION ASSESSMENT

**Shelby County Board of Education**  
160 South Hollywood Street  
Memphis, Tennessee 38112-4892  
Michelle Stuart

Jackson Elementary School  
3925 Wales Avenue  
Memphis, Tennessee 38108

July 26, 2024

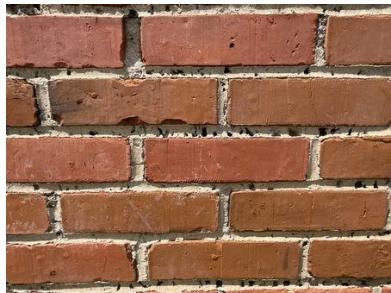
**Exterior Walls in Poor condition.**

Brick  
Main Building Jackson Elementary School  
Building Exterior  
Uniformat Code: B2010  
Recommendation: **Repair/Repoint in 2024**

Majority of exterior walls require repointing. - AssetCALC ID: 7638849

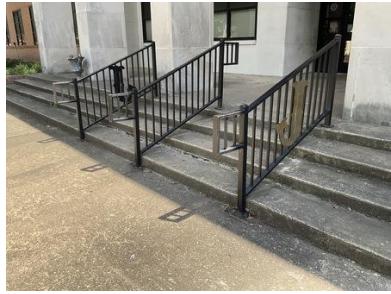
**Sidewalk in Poor condition.**

any pavement type, Sectional Repairs (per  
Man-Day)  
Site Jackson Elementary School Site  
Uniformat Code: G2030  
Recommendation: **Repair in 2024**

Several crack, repairs towing tread on stairs and small section replacement needed. - AssetCALC ID: 7638861

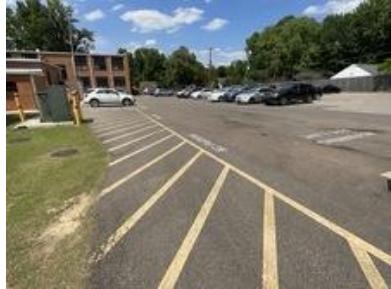
**Parking Lots in Poor condition.**

Pavement, Asphalt  
Site Jackson Elementary School Site  
Uniformat Code: G2020  
Recommendation: **Seal and Stripe in 2024**

Seal is depleted and striping worn up to end of useful life expectancy. - AssetCALC ID: 7641733

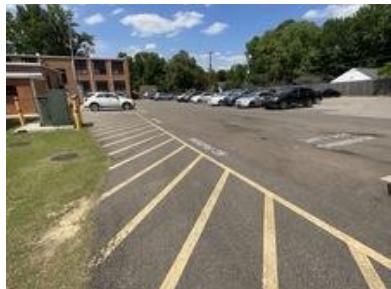
**Parking Lots in Poor condition.**

Pavement, Asphalt  
Site Jackson Elementary School Site  
Uniformat Code: G2020  
Recommendation: **Mill and Overlay in 2025**

Seal is depleted and striping worn up to end of useful life expectancy. - AssetCALC ID: 7647558

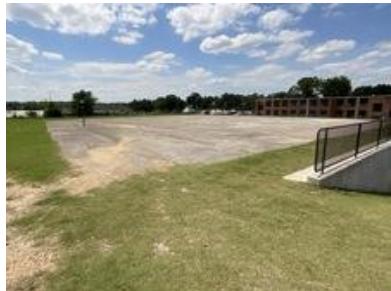
## Athletic Surfaces and Courts in Poor condition.

Basketball/General, Asphalt Pavement  
Site Jackson Elementary School Site

Uniformat Code: G2050  
Recommendation: **Seal and Stripe in 2024**

Severely worn asphalt and striping for play areas are not visible. - AssetCALC ID: 7641728

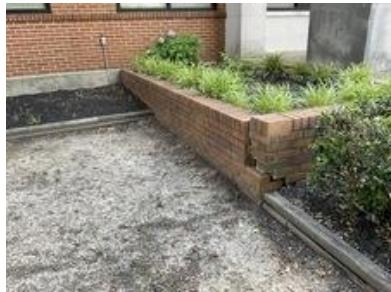
## Retaining Wall in Failed condition.

Brick/Stone  
Site Jackson Elementary School Site

Uniformat Code: G2060  
Recommendation: **Repair in 2024**

Planter boxes need brick work repair. - AssetCALC ID: 7638844

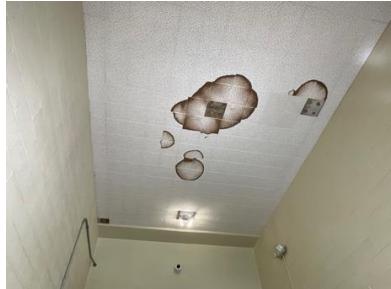
## Suspended Ceilings in Poor condition.

Hard Tile, ACM Abatement and Replacement with ACT  
Main Building Jackson Elementary School Cafeteria

Uniformat Code: C1070  
Recommendation: **Replace in 2024**

Water damage - AssetCALC ID: 7651493

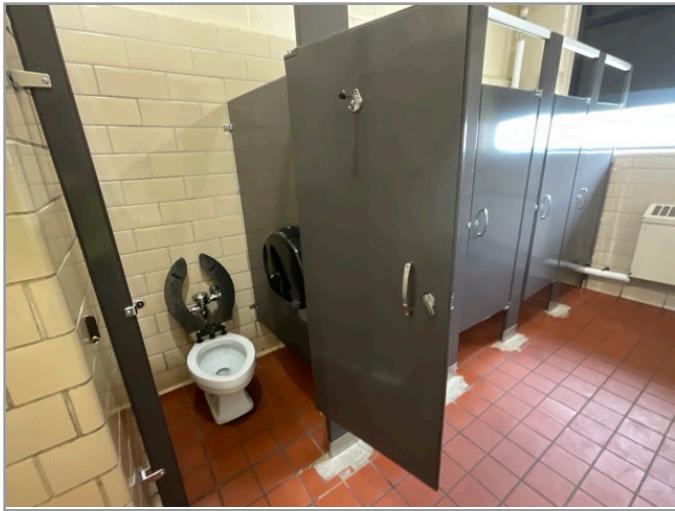
TOILET STALL OVERVIEW

Question		Yes	No	NA	Comments
1	Do publicly accessible toilet rooms appear to have a minimum compliant floor area ?		✗		There are no assessable toilet stalls
2	Does the lavatory appear to be mounted at a compliant height and with compliant knee area ?	✗			
3	Does the lavatory faucet have compliant handles ?	✗			
4	Is the plumbing piping under lavatories configured to protect against contact ?		✗		No need protection for plumbing under sinks
5	Are grab bars provided at compliant locations around the toilet ?			✗	
6	Do toilet stall doors appear to provide the minimum compliant clear width ?			✗
