# FACILITY CONDITION ASSESSMENT

**Shelby County Board of Education**  
160 South Hollywood Street  
Memphis, Tennessee 38112-4892  
Michelle Stuart

*September 30, 2024*

John P Freeman  
5250 Tulane Road  
Memphis, Tennessee 38109

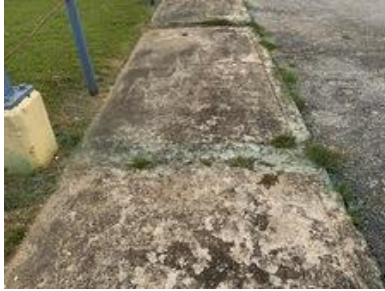
**Sidewalk in Poor condition.**

Concrete, Small Areas/Sections  
John P Freeman Site

Cracked, spalling, settling - AssetCALC ID: 8079980

Uniformat Code: G2030  
Recommendation: **Replace in 2026**

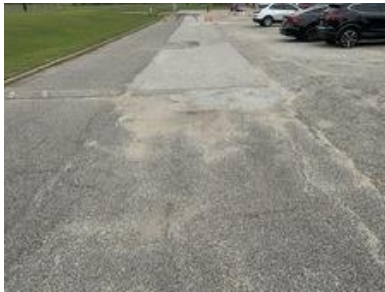
**Parking Lots in Poor condition.**

Pavement, Asphalt  
John P Freeman Site

The asphalt pavement is failing. - AssetCALC ID: 8080023

Uniformat Code: G2020  
Recommendation: **Mill & Overlay in 2026**

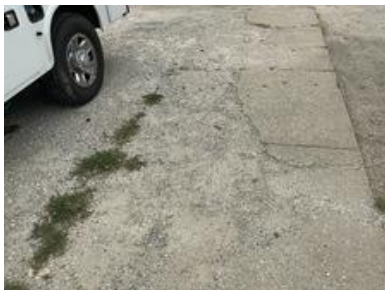
**Parking Lots in Poor condition.**

Pavement, Concrete  
John P Freeman Site

Spalling and cracking - AssetCALC ID: 8079986

Uniformat Code: G2020  
Recommendation: **Replace in 2026**

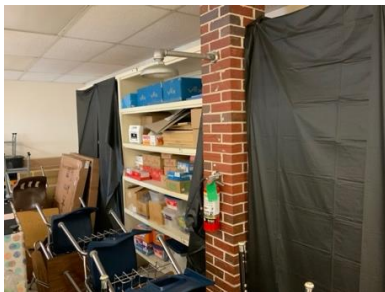
**Emergency Plumbing Fixtures in Failed condition.**

Shower Station  
John P Freeman Classrooms Science

No pull - AssetCALC ID: 8080034

Uniformat Code: D2010  
Recommendation: **Replace in 2024**

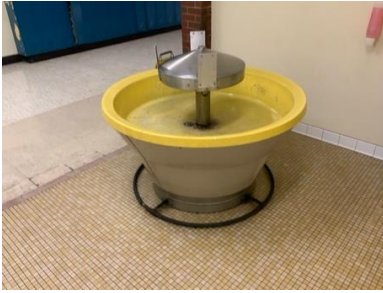
### Sink/Lavatory in Poor condition.

Trough Style, Solid Surface  
John P Freeman Restrooms

Foot peddles limited areas function - AssetCALC ID: 8079988

Uniformat Code: D2010  
Recommendation: **Replace in 2026**

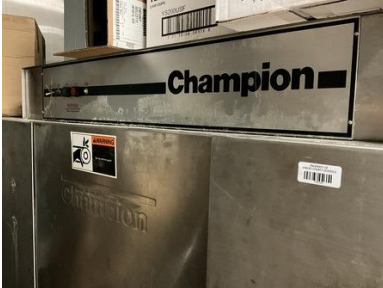
### Commercial Kitchen Line

Dishwashing Equipment  
John P Freeman Kitchen

Item does not work and no longer in use. - AssetCALC ID: 8068130

Uniformat Code: E1030  
Recommendation: **Replace in 2024**

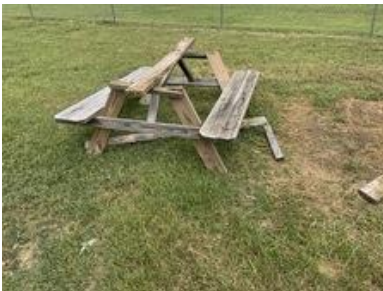
### Picnic Table in Failed condition.

Wood/Composite/Fiberglass  
John P Freeman Site

Damaged - AssetCALC ID: 8079952

Uniformat Code: G2060  
Recommendation: **Replace in 2024**

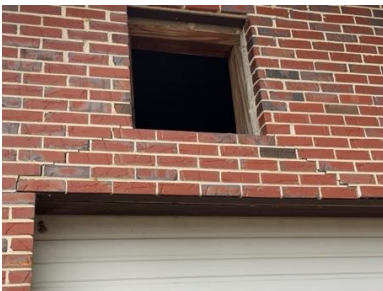
### Ancillary Building in Poor condition.

Garage  
John P Freeman Site

Excessive settling, cracked walls, not accessible trees - AssetCALC ID: 8079987

Uniformat Code: F1020  
Recommendation: **Replace in 2024**

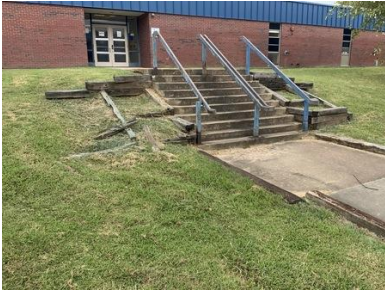
### Retaining Wall in Failed condition.

Treated Timber  
John P Freeman Site

Rotted out in areas - AssetCALC ID: 8079972

Uniformat Code: G2060  
Recommendation: **Replace in 2026**

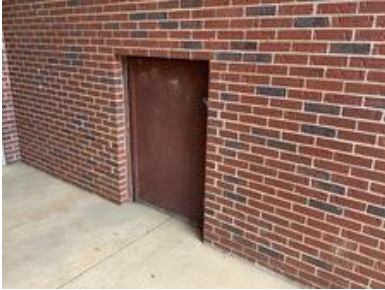
### Exterior Door in Failed condition.

Wood, Solid-Core  
John P Freeman Building Exterior

Peeling, not latching - AssetCALC ID: 8080011

Uniformat Code: B2050  
Recommendation: **Replace in 2026**

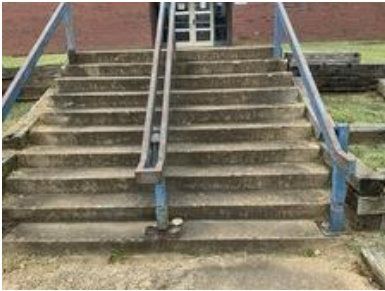
### Stairs in Poor condition.

Concrete, Exterior  
John P Freeman Site

Spalling, chunks missing, cracked - AssetCALC ID: 8079998

Uniformat Code: B1080  
Recommendation: **Replace in 2026**

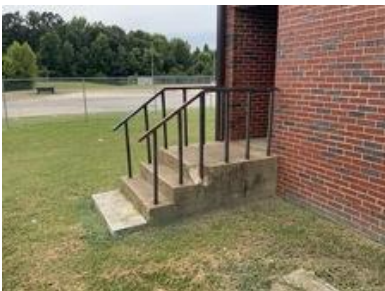
### Stair/Ramp Rails in Poor condition.

Metal  
John P Freeman Site

Posts rusted out, held with tabs - AssetCALC ID: 8080037

Uniformat Code: B1080  
Recommendation: **Refinish in 2026**

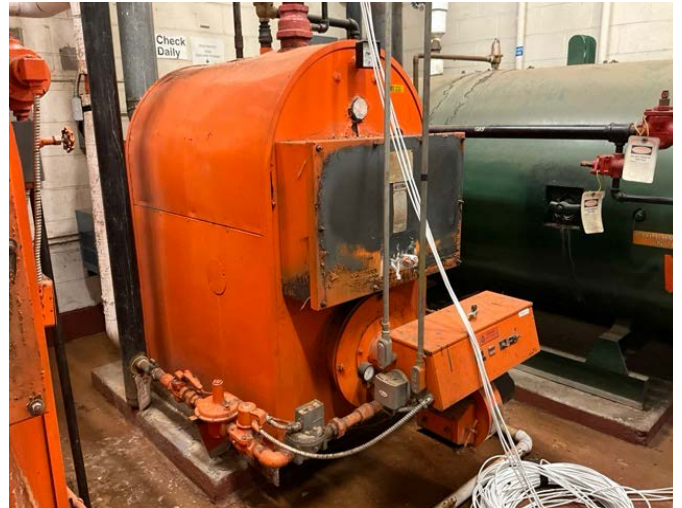
14 - BOILER

The boiler has not been replaced and is likely original to the building. The boiler should be replaced with higher efficient equipment. The Rooftop package units and air handlers have been replaced and are middle of life. The exhaust fans appear original but have likely had repairs made. The electrical system has been expanded at least once. The lighting has not been upgraded to LED. The distribution is older and should be upgraded to reflect the changes in how electricity is used in education. The distribution panels and switchboards are at the end of life or approaching the end of life. The plumbing appears to have had a partial refresh in the past. The restrooms have "Bradley" units' vestibule off the hallway. These units have issues with the foot switches. The emergency showers have had the pull handles removed. Based on the age of the building replacement of the supply and waste piping should be planned for in the future. The hot water boiler appears original and replacement to more energy efficient equipment should be considered. The building is equipped with a wet sprinkler system and portable fire extinguishers. There is a complete fire alarm system, burglar alarm system and camera system interior and exterior. There is a portable AED.
