FACILITY CONDITION ASSESSMENT

Keystone Elementary
4301 Old Allen Road
Memphis, TN 38128

163745.23R000-126.354

March 25, 2024

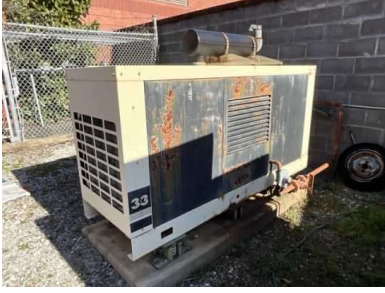
**Generator in Poor condition.**Priority Score: **88.7**Gas or Gasoline
Keystone Elementary Outside near boiler roomPlan Type:
Performance/IntegrityUniformat Code: D5010
Recommendation: **Replace in 2026**

Significant rust on enclosure. - AssetCALC ID: 7401586

Cost Estimate: \$30,000

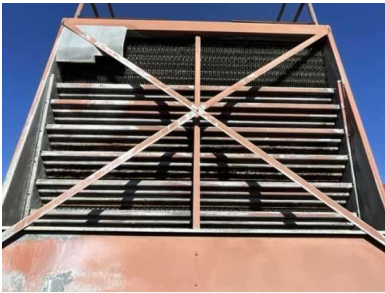
**Cooling Tower in Poor condition.**Priority Score: **85.7**(Typical) Open Circuit
Keystone Elementary SitePlan Type:
Performance/IntegrityUniformat Code: D3030
Recommendation: **Replace in 2026**

Rusted body - AssetCALC ID: 7388434

Cost Estimate: \$53,600

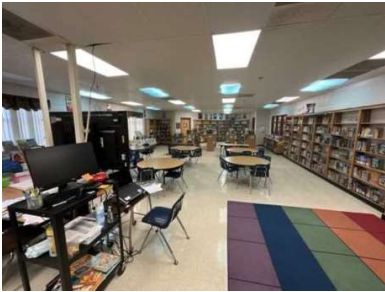
The interior masonry walls at the library display significant cracks throughout indicating possible foundation issues. A professional engineer must be retained to analyze the existing condition, provide recommendations and, if necessary, estimate the scope and cost of any required repairs.

**Recommended Follow-up Study: Structural, Superstructure**Priority Score: **81.9**Structural, Superstructure
Keystone Elementary LibraryPlan Type:
Performance/IntegrityUniformat Code: P2030
Recommendation: **Evaluate/Report in 2024**

The interior masonry walls at the library display significant cracks throughout indicating possible foundation issues. - AssetCALC ID: 7439549

Cost Estimate: \$10,000
