FACILITY CONDITION ASSESSMENT

Shelby County Board of Education
160 South Hollywood Street
Memphis, Tennessee 38112-4892
Michelle Stuart

Kingsbury CTC
1328 North Graham Street
Memphis, Tennessee 38122

July 26, 2024

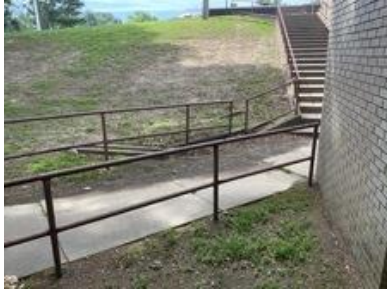
**Plumbing System in Poor condition.**

Rain Water Drainage, High Density
Kingsbury CTC Site

Side of hill not collected - AssetCALC ID: 7637357

Uniformat Code: D2030
Recommendation: **Replace in 2026**

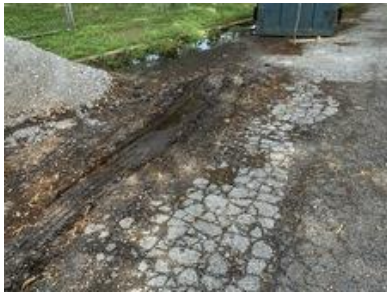
**Parking Lots in Poor condition.**

Pavement, Asphalt
Kingsbury CTC Site

Patched 2019 Dumpster should be replaced in concrete - AssetCALC ID: 7637301

Uniformat Code: G2020
Recommendation: **Mill and Overlay in 2026**

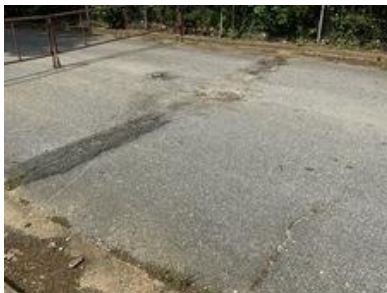
**Parking Lots in Poor condition.**

Pavement, Asphalt
Kingsbury CTC Site

Cracking, patches, weeds - AssetCALC ID: 7637358

Uniformat Code: G2020
Recommendation: **Mill and Overlay in 2026**

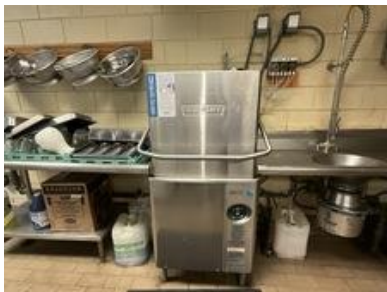
**Foodservice Equipment in Failed condition.**

Dishwasher Commercial
Kingsbury CTC Kitchen

Not in service - AssetCALC ID: 7587812

Uniformat Code: E1030
Recommendation: **Replace in 2024**

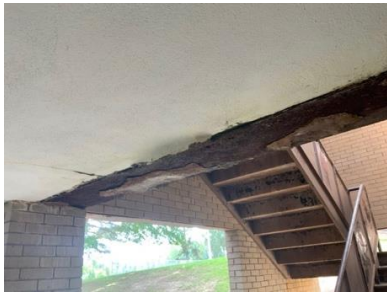
Soffit in Failed condition.

Metal
Kingsbury CTC Roof

Paint coated peeled off extensive rust - AssetCALC ID: 7637340

Uniformat Code: B3080
Recommendation: **Replace in 2024**

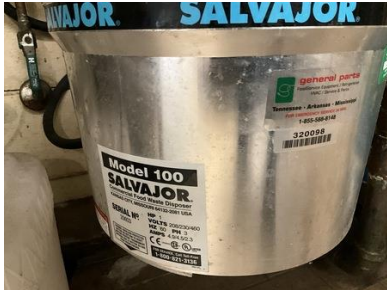
Foodservice Equipment in Failed condition.

Garbage Disposal, 1 to 3 HP
Kingsbury CTC Kitchen

Disposal is out of service - AssetCALC ID: 7587849

Uniformat Code: E1030
Recommendation: **Replace in 2024**

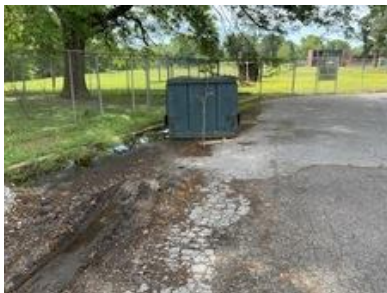
Dumpster Pad in Failed condition.

Concrete
Kingsbury CTC Site

Replace with concrete - AssetCALC ID: 7637306

Uniformat Code: G2060
Recommendation: **Replace/Install in 2024**

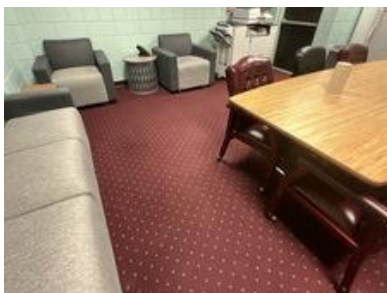
Flooring in Poor condition.

Carpet, Commercial Standard
Kingsbury CTC Throughout building

Carpet is outdated - AssetCALC ID: 7587878

Uniformat Code: C2030
Recommendation: **Replace in 2026**

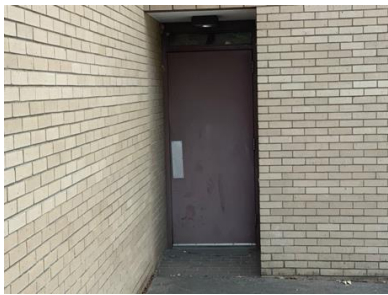
Exterior Door in Poor condition.

Steel, Standard
Kingsbury CTC Building Exterior

Rusting out on frames - AssetCALC ID: 7637349

Unifomat Code: B2050
Recommendation: **Replace in 2026**

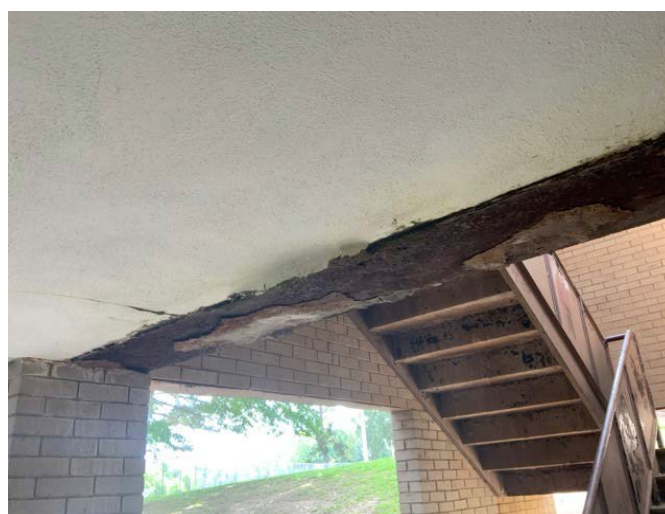
6 - STRUCTURAL DAMAGE
