# FACILITY CONDITION ASSESSMENT

Kingsbury Elementary School  
4055 Bayliss Avenue  
Memphis, Tennessee 38108

*September 30, 2024*

*August 12, 2024*

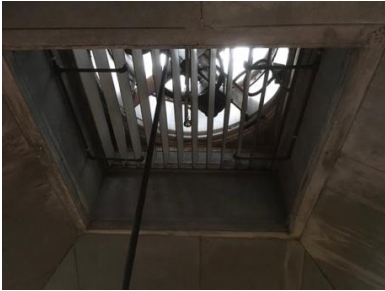
### Foodservice Equipment in Poor condition.

Exhaust Hood, 8 to 10 LF  
Main School Kingsbury Elementary School  
Kitchen

Susceptible to paint chips and rubber from old fan belt falling into food - AssetCALC ID: 8026655

Uniformat Code: E1030  
Recommendation: **Replace in 2024**

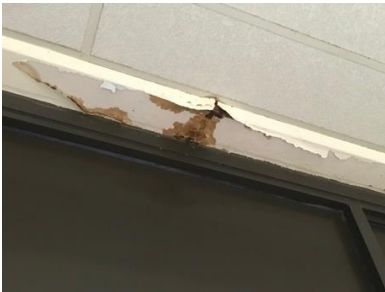
### Exterior Walls in Failed condition.

Concrete Block (CMU)  
Main School Kingsbury Elementary School  
Classrooms General

Cracked concrete above windows leaks when it rains. 4 rooms - AssetCALC ID: 8026679

Uniformat Code: B2010  
Recommendation: **Repair/Repoint in 2024**

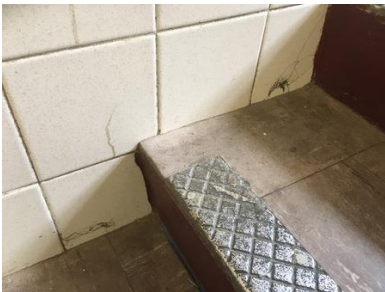
### Wall Finishes in Poor condition.

Ceramic Tile  
Main School Kingsbury Elementary School  
Hallways and Common Areas

Multiple areas of cracking, tiles falling out - AssetCALC ID: 8026561

Uniformat Code: C2010  
Recommendation: **Replace in 2026**

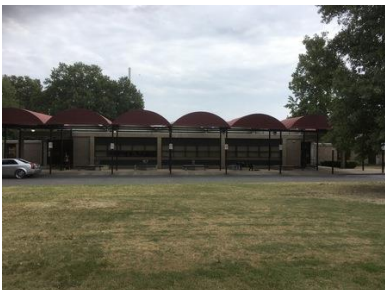
Water ponding issues are common after heavy rainfalls adjacent to the main school. This is partly due to lack of stormwater drains. Reoccurring sinkholes are prevalent in the front drop off area and a small sidewalk area. Playground equipment and surfaces are overall sufficient but will require some new play surfacing in the near term due to advanced wear.

### Recommended Follow-up Study: Civil, Site Drainage

Civil, Site Drainage  
Site Kingsbury Elementary School Site

A civil engineer should be retained to study and report on the drainage issues in the front of the school. At the same time, reoccurring sink holes in the driveway and walk areas should also be studied - AssetCALC ID: 8033565

It is recommended that a civil engineer be retained to study and report on the drainage issues in the front of the school. At the same time, reoccurring sink holes in the driveway and walk areas should also be studied and potential solutions proposed. The cost of an engineering study is included in this report. The cost of potential remediations is not included due to the ambiguity of the final scope of work.

Uniformat Code: P2030  
Recommendation: **Evaluate/Report in 2024**

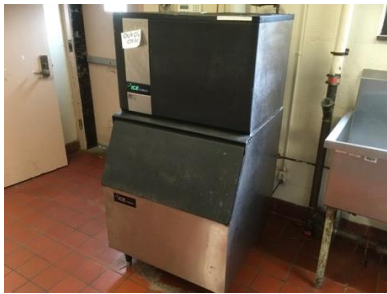
### Foodservice Equipment in Failed condition.

Icemaker, Freestanding  
Main School Kingsbury Elementary School  
Kitchen

Not working - AssetCALC ID: 8026704

Uniformat Code: E1030  
Recommendation: **Replace in 2024**

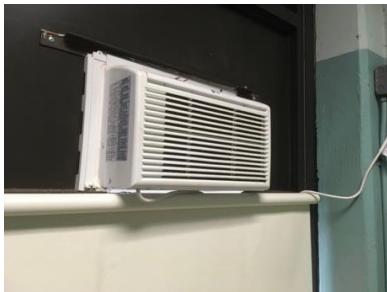
### Air Conditioner in Failed condition.

Window/Thru-Wall  
Main School Kingsbury Elementary School IDF  
closet

Uniformat Code: D3030  
Recommendation: **Replace in 2024**

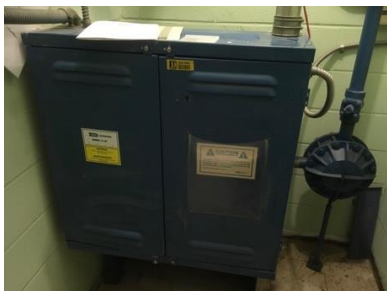
### Passenger Elevator in Poor condition.

Hydraulic, 2 Floors  
Main School Kingsbury Elementary School  
Hallways and Common Areas

Outdated and past the EUL. There are many service calls associated with this elevator. - AssetCALC ID: 8026636

Uniformat Code: D1010  
Recommendation: **Renovate in 2024**

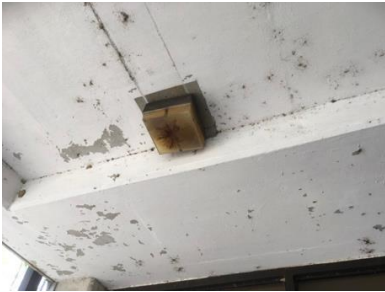
**Exterior Fixture with Lamp in Poor condition.**

any type, with LED Replacement  
Main School Kingsbury Elementary School  
Building Exterior

Disrepair, cracked, ineffective light source, not sufficient for safety/security and inefficient - AssetCALC ID: 8026652

Uniformat Code: D5040  
Recommendation: **Replace in 2024**

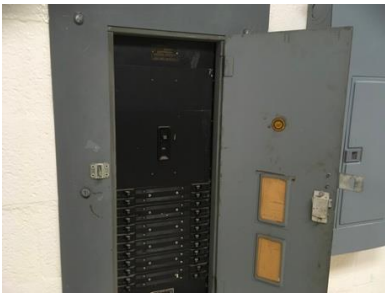
**Electrical System in Poor condition.**

Full System Renovation/Upgrade, Medium  
Density/Complexity  
Main School Kingsbury Elementary School  
Throughout Building

Obsolete equipment increases risk of extended outages due to lack of replacement parts, safety hazard due to increased risk of arc flash - AssetCALC ID: 8026584

Uniformat Code: D5020  
Recommendation: **Replace in 2025**

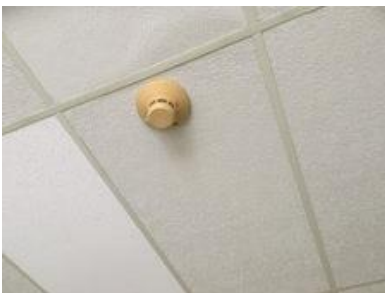
**Fire Alarm System in Poor condition.**

Full System Upgrade, Standard Addressable  
Main School Kingsbury Elementary School  
Throughout Building

Uniformat Code: D7050  
Recommendation: **Upgrade/Install in 2025**
