# FACILITY CONDITION ASSESSMENT

**Shelby County Board of Education**  
160 South Hollywood Street, Room 126  
Memphis, Tennessee 38112-4892  
Mary Taylor

Kingsbury High School  
1270 North Graham Street  
Memphis, Tennessee 38122

*April 19, 2024*

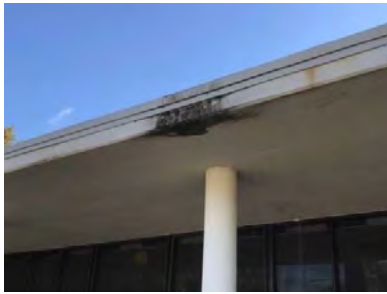
**Exterior Walls in Poor condition.**

any painted surface  
Auditorium Kingsbury High School Exterior trim and soffits

The exterior trim is peeling and requires prep and paint. - AssetCALC ID: 7023509

Recommendation: **Prep and Paint in 2025**

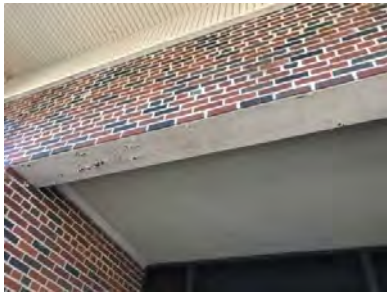
**Exterior Walls in Poor condition.**

any painted surface  
Main Building Kingsbury High School Building Exterior trim and soffits

The exterior paint trim and soffits are peeling and require repainting. - AssetCALC ID: 7023687

Recommendation: **Prep and Paint in 2025**

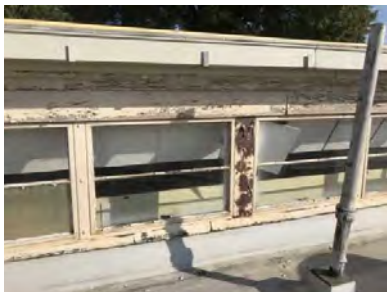
**Exterior Walls in Poor condition.**

any painted surface  
Cafeteria/ROTC Kingsbury High School Building Exterior trim

The exterior paint is peeling and should be refinished to prevent further deterioration. - AssetCALC ID: 7023983

Recommendation: **Prep and Paint in 2025**

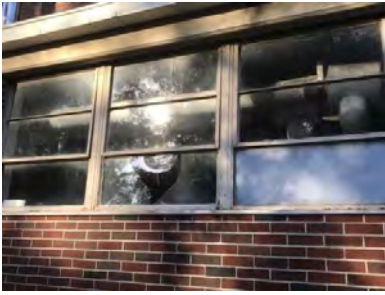
### Window in Poor condition.

Steel, up to 15 SF  
Auditorium Kingsbury High School Auditorium

The antiquated single-pane energy-inefficient windows appear to be original. The windows should be replaced. - AssetCALC ID: 7023506

Uniformat Code: B2020  
Recommendation: **Replace in 2025**

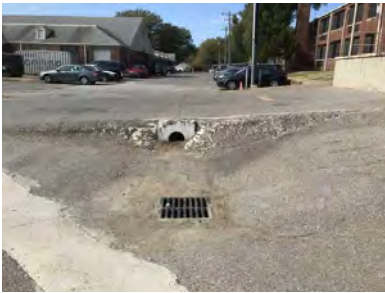
### Roadways in Poor condition.

Guard Rails, Steel  
Site Kingsbury High School Site, cafeteria

There is a significant drop off adjacent to the kitchen loading area. A guardrail should be installed. - AssetCALC ID: 7024048

Uniformat Code: G2010  
Recommendation: **Replace in 2023**

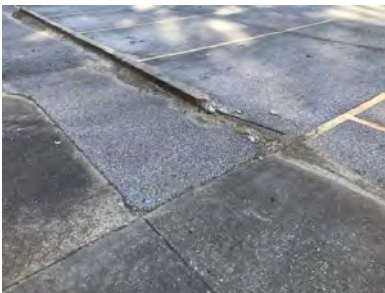
### Parking Lots in Poor condition.

Curb and Gutter, Concrete  
Site Kingsbury High School Auditorium parking lot

Damaged curb has exposed re-bar creating trip hazard. - AssetCALC ID: 7023531

Uniformat Code: G2020  
Recommendation: **Repair in 2023**

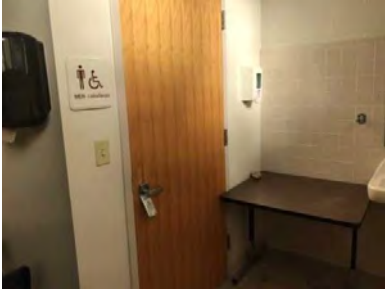
### Door Hardware in Failed condition.

Dressing room toilet door hardware is broken and the door cannot be opened. - AssetCALC ID: 7023535

Uniformat Code: C1030  
Recommendation: **Replace in 2023**

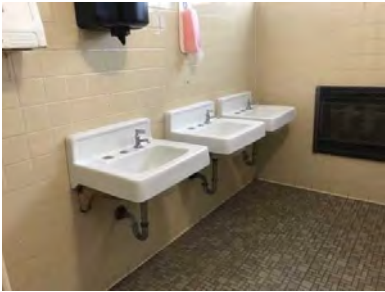
### Plumbing System in Poor condition.

The age of the plumbing could not be determined. A follow up study is recommended to verify condition and age. Area allowed for limited locations of restrooms. - AssetCALC ID: 7026041

Uniformat Code: D2010  
Recommendation: **Replace in 2025**

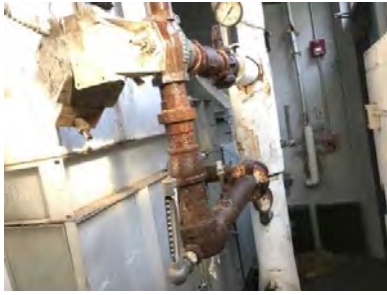
### Plumbing System in Poor condition.

Supply and Sanitary, Very Low Density  
(excludes fixtures)  
Auditorium Kingsbury High School Auditorium-  
boiler room

The supply piping to the boilers is significantly rusted and requires replacement. - AssetCALC ID: 7023481

Uniformat Code: D2010  
Recommendation: **Replace in 2025**

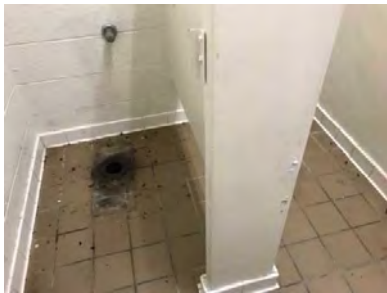
### Toilet in Poor condition.

Commercial Water Closet  
Gymnasium Kingsbury High School  
Restrooms-not used

The east toilet rooms are not in use. - AssetCALC ID: 7024031

Uniformat Code: D2010  
Recommendation: **Replace in 2025**

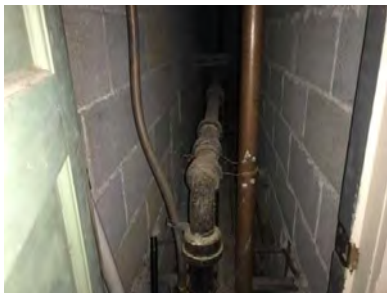
### Recommended Follow-up Study: Plumbing, Video Survey

The concealed plumbing age could not be determined and is likely original. A professional consultant must be retained to analyze the existing condition, provide recommendations and, if necessary, estimate the scope and cost of any required repairs - AssetCALC ID: 7031082

Uniformat Code: P2030  
Recommendation: **Evaluate/Report in 2023**

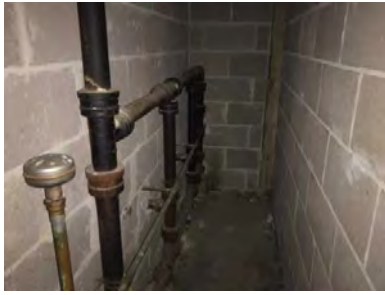
### Recommended Follow-up Study: Plumbing, Video Survey

The plumbing has a history of backups and the age could not be determined. - AssetCALC ID: 7027354

Uniformat Code: P2030  
Recommendation: **Evaluate/Report in 2023**

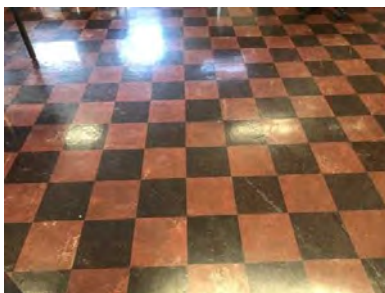
### Flooring in Poor condition.

Vinyl Tile (VCT), with Asbestos Abatement  
Main Building Kingsbury High School  
Classrooms

Classrooms with original VCT should have VCT abated and replaced. - AssetCALC ID: 7023664

Uniformat Code: C2030  
Recommendation: **Replace in 2023**

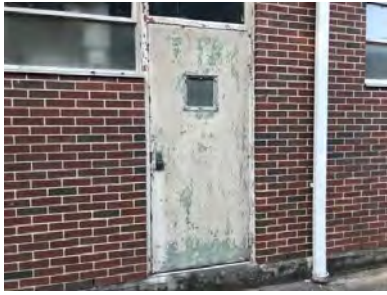
### Exterior Door in Poor condition.

Exterior doors are peeling and require refinishing to prevent deterioration. - AssetCALC ID: 7023504

Uniformat Code: B2050  
Recommendation: **Refinish in 2023**

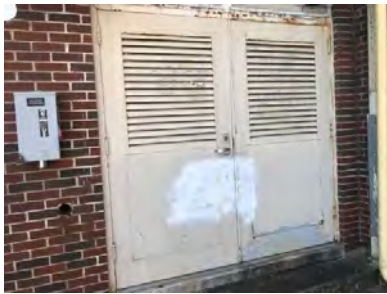
### Exterior Door in Poor condition.

Exterior doors require refinishing. - AssetCALC ID: 7023662

Uniformat Code: B2050  
Recommendation: **Refinish in 2025**

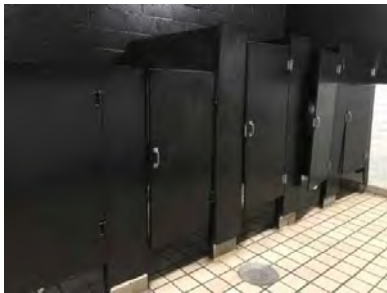
### Toilet Partitions in Poor condition.

Wood  
Main Building Kingsbury High School Restrooms-girls (closed)

The painted wood toilet partitions are significantly aged. - AssetCALC ID: 7023538

Uniformat Code: C1090  
Recommendation: **Replace in 2025**

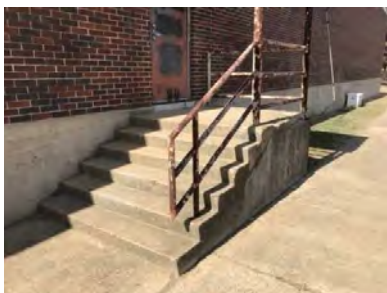
### Stair/Ramp Rails in Poor condition.

Metal  
Site Kingsbury High School Entry balconies

The stair railings are rusting and should be refinished to prevent further deterioration. - AssetCALC ID: 7024084

Uniformat Code: B1080  
Recommendation: **Refinish in 2025**

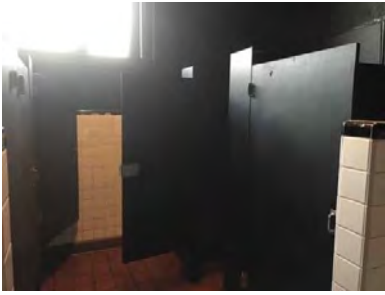
### Toilet Partitions in Poor condition.

The painted plywood toilet partitions are significantly aged. - AssetCALC ID: 7023621

Uniformat Code: C1090  
Recommendation: **Replace in 2025**

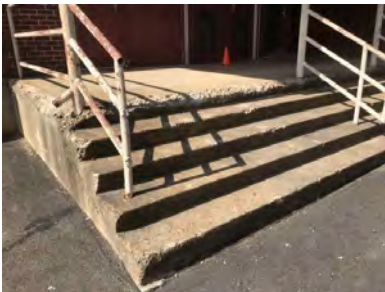
### Stairs in Poor condition.

The east stairs are significantly deteriorated, eroded concrete is a trip hazard. - AssetCALC ID: 7024040

Uniformat Code: B1080  
Recommendation: **Replace in 2025**

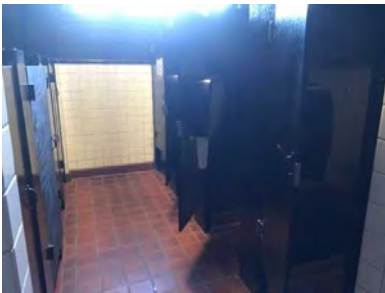
### Toilet Partitions in Poor condition.

The painted plywood toilet partitions are significantly aged. - AssetCALC ID: 7023541

Uniformat Code: C1090  
Recommendation: **Replace in 2025**

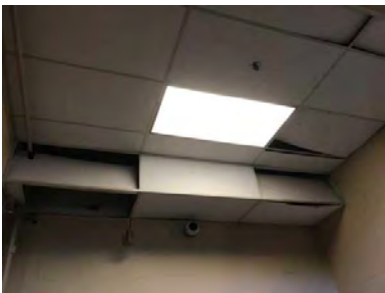
### Suspended Ceilings in Poor condition.

Broken, damaged or stained acoustical ceiling tile should be replaced. - AssetCALC ID: 7023550

Uniformat Code: C1070  
Recommendation: **Replace in 2025**

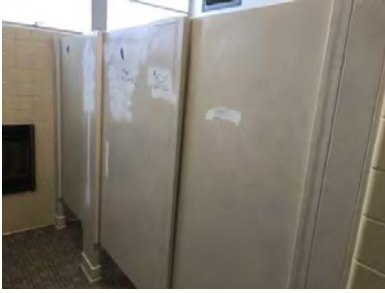
### Toilet Partitions in Poor condition.

Wood  
Auditorium Kingsbury High School Common  
area restrooms

The restroom partitions are significantly aged, bare wood in some instances. - AssetCALC ID: 7023489

Uniformat Code: C1090  
Recommendation: **Replace in 2025**

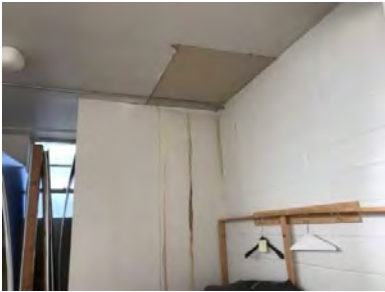
### Ceiling Finishes in Poor condition.

Gypsum Board/Plaster  
Auditorium Kingsbury High School Auditorium-  
dressing room

Damaged ceiling areas require repairs. - AssetCALC ID: 7023527

Uniformat Code: C2050  
Recommendation: **Replace in 2025**

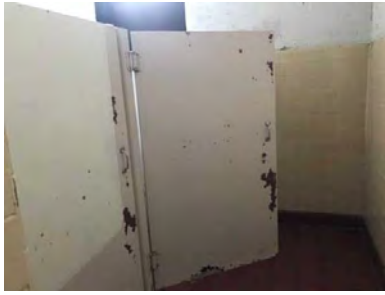
### Toilet Partitions in Poor condition.

Wood  
Gymnasium Kingsbury High School Common  
area restrooms

The painted wood toilet partitions are significantly aged. - AssetCALC ID: 7024044

Uniformat Code: C1090  
Recommendation: **Replace in 2025**

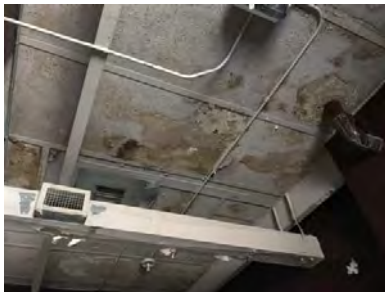
### Ceiling Finishes in Poor condition.

exposed irregular elements  
Gymnasium Kingsbury High School Storage

Water stained ceilings should be painted or retiled. - AssetCALC ID: 7024034

Uniformat Code: C2050  
Recommendation: **Prep and Paint in 2025**

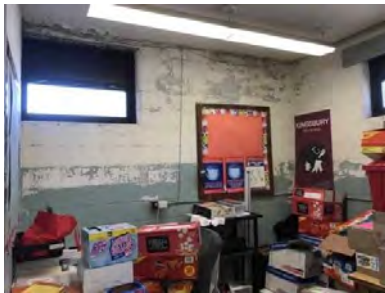
### Wall Finishes in Poor condition.

any surface  
Gymnasium Kingsbury High School Offices

Interior paint is peeling and should be refinished. - AssetCALC ID: 7024064

Uniformat Code: C2010  
Recommendation: **Prep and Paint in 2025**

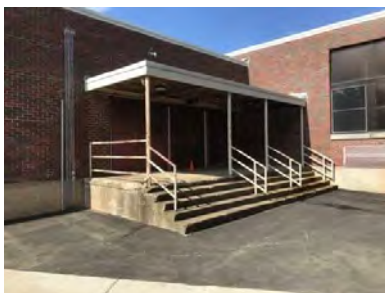
### Ceiling Finishes in Poor condition.

exposed irregular elements  
Gymnasium Kingsbury High School Building  
exterior, canopies

The underside of the canopies are significantly rusted and should be painted/refinished to prevent further deterioration. - AssetCALC ID: 7024059

Uniformat Code: C2050  
Recommendation: **Prep and Paint in 2025**

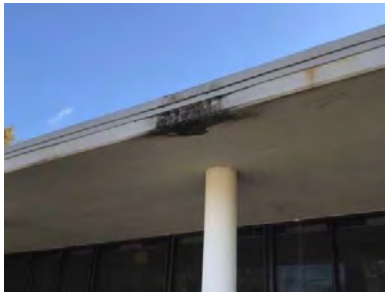
### Exterior Walls in Poor condition.

any painted surface  
Auditorium Kingsbury High School Exterior trim and soffits

The exterior trim is peeling and requires prep and paint. - AssetCALC ID: 7023509

Uniformat Code: B2010  
Recommendation: **Prep and Paint in 2025**

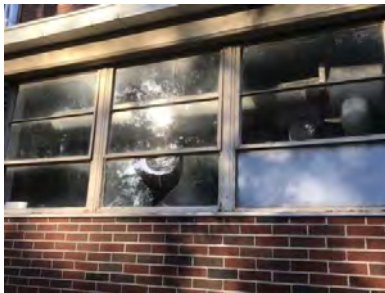
### Window in Poor condition.

Steel, up to 15 SF  
Auditorium Kingsbury High School Auditorium

The antiquated single-pane energy-inefficient windows appear to be original. The windows should be replaced. - AssetCALC ID: 7023506

Uniformat Code: B2020  
Recommendation: **Replace in 2025**

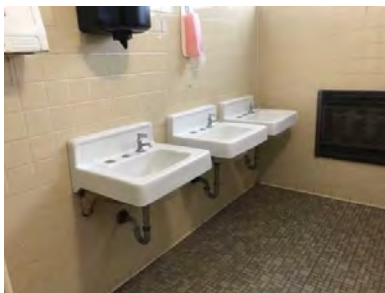
### Plumbing System in Poor condition.

Supply and Sanitary, Low Density (excludes fixtures)  
Auditorium Kingsbury High School Throughout

The age of the plumbing could not be determined. A follow up study is recommended to verify condition and age. Area allowed for limited locations of restrooms. - AssetCALC ID: 7026041

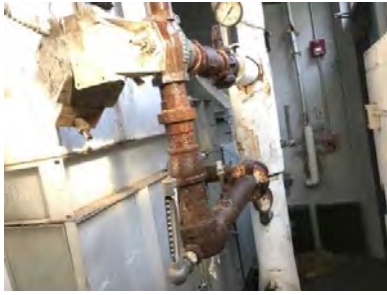
### Plumbing System in Poor condition.

Supply and Sanitary, Very Low Density  
(excludes fixtures)  
Auditorium Kingsbury High School Auditorium-  
boiler room

The supply piping to the boilers is significantly rusted and requires replacement. - AssetCALC ID: 7023481

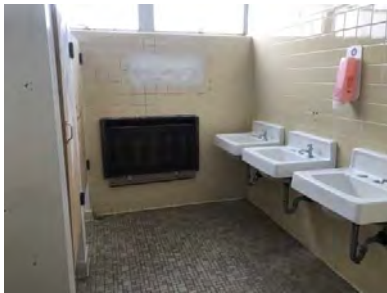
### Recommended Follow-up Study: Plumbing, Video Survey

Plumbing, Video Survey  
Auditorium Kingsbury High School Throughout

Age of existing and concealed plumbing could not be determined. - AssetCALC ID: 7026042

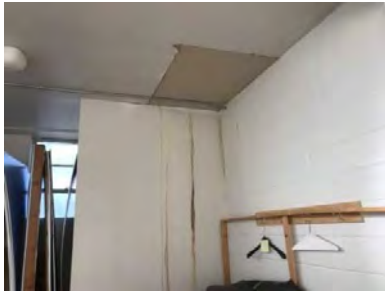
**Ceiling Finishes in Poor condition.**

Gypsum Board/Plaster  
Auditorium Kingsbury High School Auditorium-  
dressing room

Damaged ceiling areas require repairs. - AssetCALC ID: 7023527

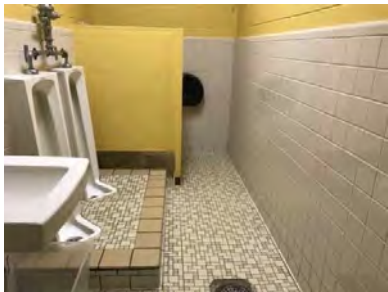
**Recommended Follow-up Study:  
Plumbing, Video Survey**

The concealed plumbing age could not be determined and is likely original. A professional consultant must be retained to analyze the existing condition, provide recommendations and, if necessary, estimate the scope and cost of any required repairs - AssetCALC ID: 7031080

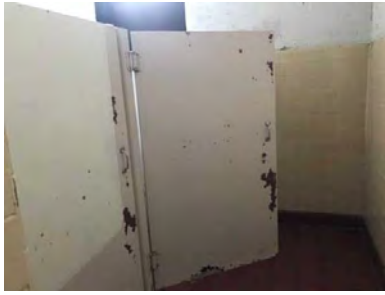
### Toilet Partitions in Poor condition.

The painted wood toilet partitions are significantly aged. - AssetCALC ID: 7024044

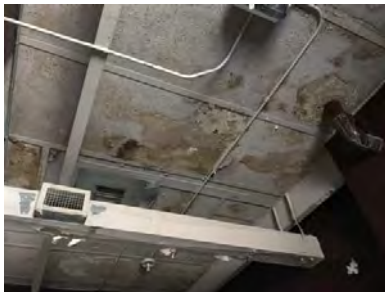
### Ceiling Finishes in Poor condition.

Water stained ceilings should be painted or retiled. - AssetCALC ID: 7024034

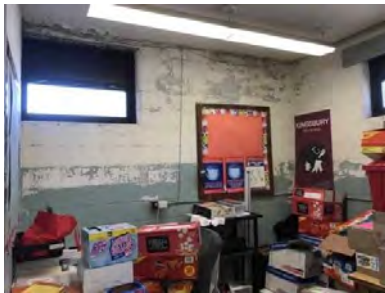
### Wall Finishes in Poor condition.

Interior paint is peeling and should be refinished. - AssetCALC ID: 7024064

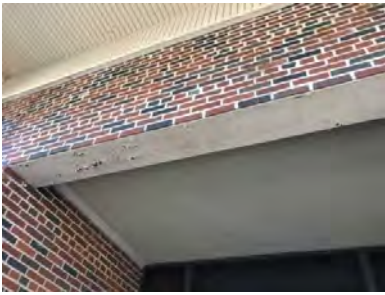
### Exterior Walls in Poor condition.

The exterior paint trim and soffits are peeling and require repainting. - AssetCALC ID: 7023687

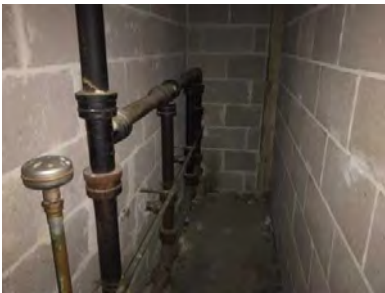
### Plumbing System in Poor condition.

The age of the plumbing could not be determined. A follow up study is recommended to verify condition and age. Area allowed for limited locations of restrooms. - AssetCALC ID: 7031078

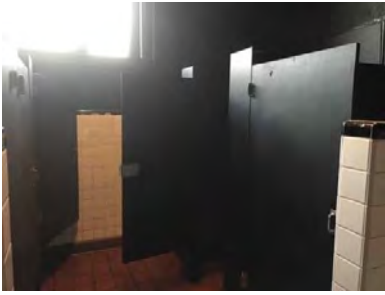
**Toilet Partitions in Poor condition.**Priority Score: **81.7**

The painted plywood toilet partitions are significantly aged. - AssetCALC ID: 7023621

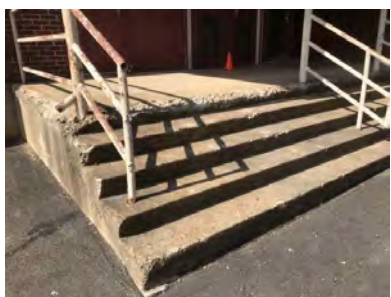
<p><b>Stairs in Poor condition.</b></p> <p>Concrete, Exterior Site Kingsbury High School Site</p> <p>Uniformat Code: B1080 Recommendation: <b>Replace in 2025</b></p>	<p>Priority Score: <b>81.7</b></p> <p>Plan Type: Performance/Integrity</p> <p>Cost Estimate: \$11,000</p> <p><b>\$\$\$\$</b></p>
<p>The east stairs are significantly deteriorated, eroded concrete is a trip hazard. - AssetCALC ID: 7024040</p>
