FACILITY CONDITION ASSESSMENT

prepared for

Kingsbury Middle School
1270 North Graham Street
Memphis, Tennessee 38122

October 1, 2024

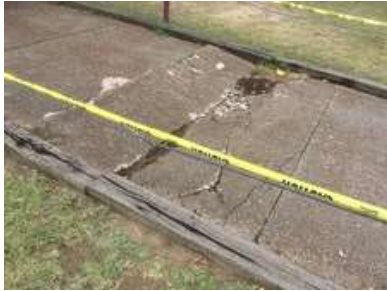
Walkway in Failed condition.

Concrete/Masonry, Exterior
Kingsbury Middle School Site General

Hole in main walkway - AssetCALC ID: 8026253

Uniformat Code: B1080
Recommendation: **Repair in 2024**

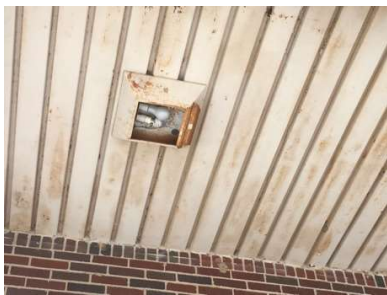
Exterior Fixture w/ Lamp in Poor condition.

any type, w/ LED Replacement
Kingsbury Middle School Building Exterior

Broken and rusted - AssetCALC ID: 8026207

Uniformat Code: D5040
Recommendation: **Replace in 2024**

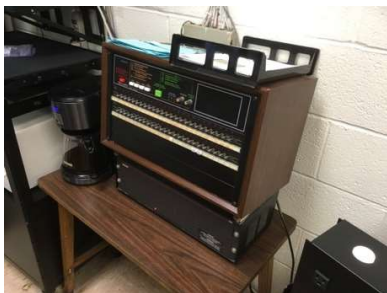
Intercom/PA System in Poor condition.

Public Address Upgrade, Facility-Wide
Kingsbury Middle School Throughout Building

Multiple reliability issues, obsolete equipment - AssetCALC ID: 8026213

Uniformat Code: D6060
Recommendation: **Replace in 2024**

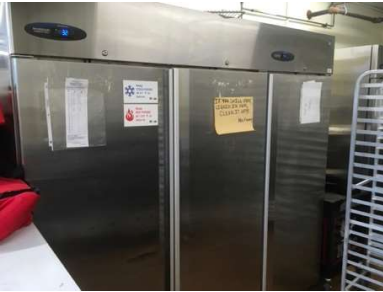
**Foodservice Equipment in Failed condition.**

Refrigerator, 3-Door Reach-In
Kingsbury Middle School Kitchen

1 section not working - AssetCALC ID: 8026226

Uniformat Code: E1030
Recommendation: **Replace in 2025**

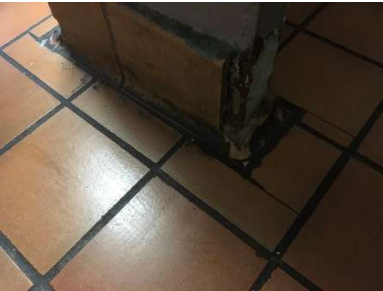
**Flooring in Poor condition.**

Ceramic Tile
Kingsbury Middle School Restrooms

Broken areas, uncleanable - AssetCALC ID: 8026194

Uniformat Code: C2030
Recommendation: **Replace in 2025**

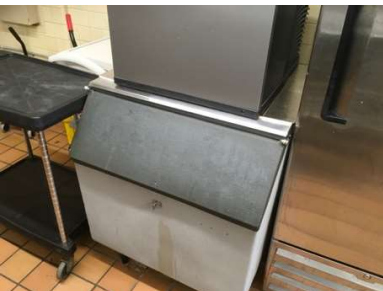
**Foodservice Equipment in Failed condition.**

Icemaker, Freestanding
Kingsbury Middle School Kitchen

Not currently working - AssetCALC ID: 8026203

Uniformat Code: E1030
Recommendation: **Replace in 2024**

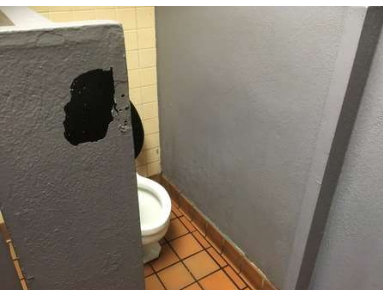
**Toilet Partitions in Poor condition.**

Plastic/Laminate
Kingsbury Middle School Restrooms

Multiple areas of disrepair - AssetCALC ID: 8026250

Uniformat Code: C1090
Recommendation: **Replace in 2024**

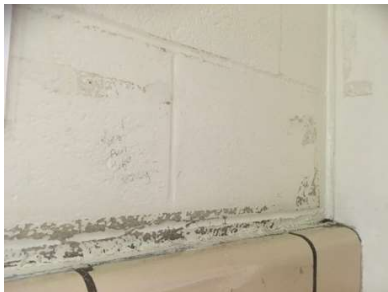
Wall Finishes in Poor condition.

any surface
Kingsbury Middle School Throughout Building

Many areas of chipped and missing paint - AssetCALC ID: 8026185

Uniformat Code: C2010
Recommendation: **Prep & Paint in 2025**

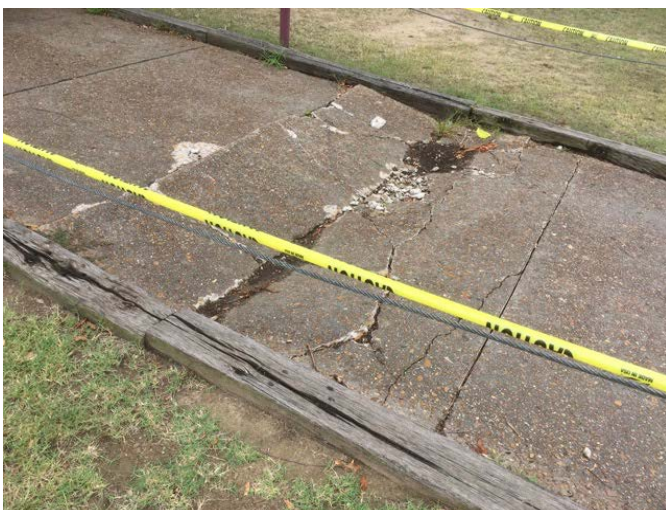
The site is comprised primarily of hard surfaces with little to no green space for students. The front entrance sidewalk is currently in a state of disrepair due to a hole developing underneath the primary school entrance pathway. Typical lifecycle replacements are anticipated for the remainder of the site assets.

5 - CONCRETE SIDEWALK DAMAGE
