# FACILITY CONDITION ASSESSMENT

**Shelby County Board of Education**  
160 South Hollywood Street  
Memphis, Tennessee 38112-4892  
Michelle Stuart

LaRose Elementary School  
864 South Wellington Street  
Memphis, Tennessee 38126

*March 14, 2024*

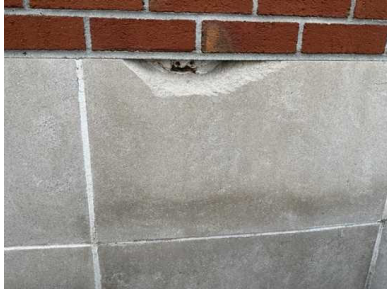
### Exterior Walls in Poor condition.

Concrete Block (CMU)  
LaRose Elementary Building Exterior

Damage to stone at the base of the building along the front facade. - AssetCALC ID: 7419670

Uniformat Code: B2010  
Recommendation: **Repair in 2024**

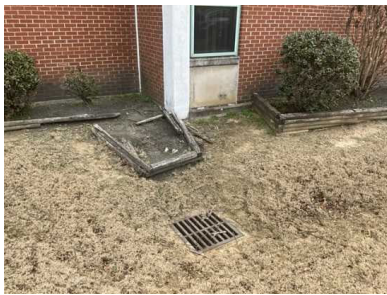
### Planter Boxes in Poor condition.

Basic or Wood Built-In Place  
LaRose Elementary Site

Broken and rotted in places - AssetCALC ID: 7419169

Uniformat Code: G2080  
Recommendation: **Replace in 2025**

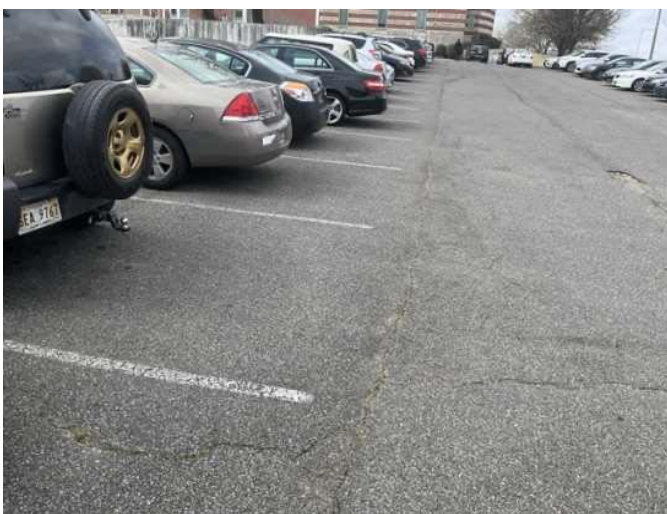
23 - ASPHALT PAVEMENT

The asphalt paving in the parking area and near the playground has potholes and extensive cracking and requires replacement. The sidewalks are in fair condition. The retaining wall has minor damage that will require repairs. The playground equipment is enclosed by a chain link fence and appears to be in good condition.
