# FACILITY CONDITION ASSESSMENT

Levi Elementary  
1270 North Graham Street  
Memphis, Tennessee 38122

**BV PROJECT #:**  
163745.23R000-132.354

**DATE OF REPORT:**  
October 2, 2024

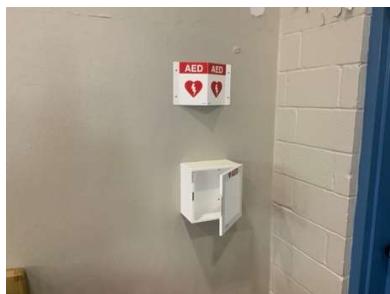
### Healthcare Equipment in Failed condition.

Defibrillator (AED), Cabinet-Mounted  
Gymnasium Levi Elementary Gymnasium

Cabinet empty - AssetCALC ID: 8304246

Recommendation: **Replace in 2024**

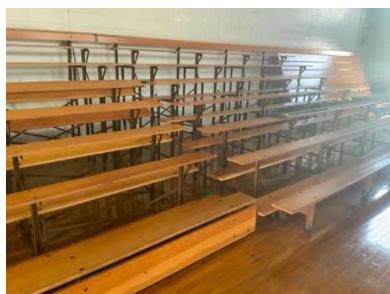
### Bleachers in Failed condition.

Telescoping Manual, up to 15 Tier (per Seat)  
Gymnasium Levi Elementary Gymnasium

These do not have vertical stops for legs - AssetCALC ID: 8304265

Recommendation: **Replace in 2025**

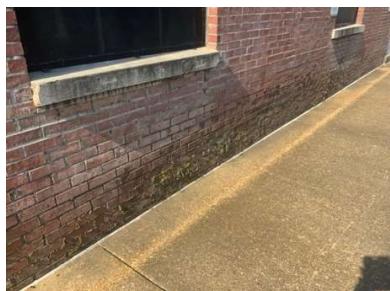
### Exterior Walls in Poor condition.

Growth on bricks - AssetCALC ID: 8304240

Recommendation: **Clean in 2026**

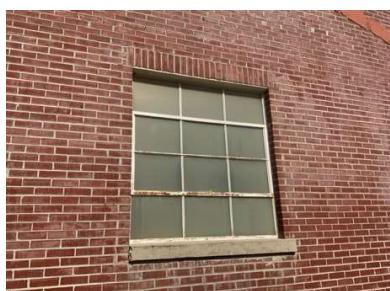
### Window in Poor condition.

Steel, 16-25 SF

Single pane - AssetCALC ID: 8304222

Recommendation: **Replace in 2026**

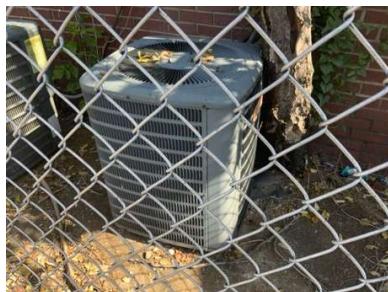
## Split System in Poor condition.

Condensing Unit/Heat Pump  
Gymnasium Levi Elementary Building Exterior

Disconnect off - AssetCALC ID: 8304248

Uniformat Code: D3030  
Recommendation: **Replace in 2024**

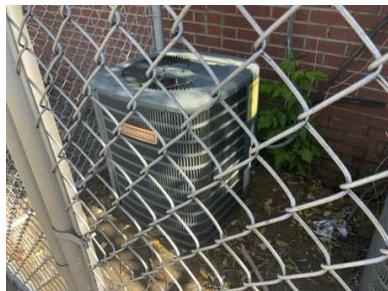
## Split System in Poor condition.

Condensing Unit/Heat Pump  
Gymnasium Levi Elementary Building Exterior

Disconnect off - AssetCALC ID: 8304254

Uniformat Code: D3030  
Recommendation: **Replace in 2024**

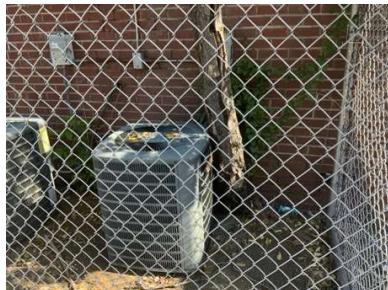
## Landscaping in Poor condition.

Mature Trees, Removal/Trimming  
Gymnasium Levi Elementary Site

Too close to bldg, and equipment - AssetCALC ID: 8304264

Uniformat Code: G2080  
Recommendation: **Repair in 2025**

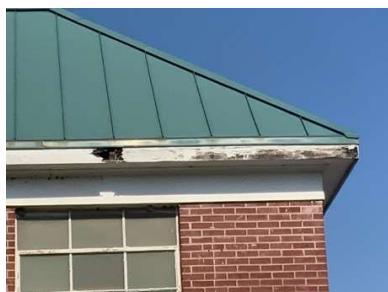
## Soffit/Fascia in Poor condition.

Metal  
Gymnasium Levi Elementary Roof

Holes and missing - AssetCALC ID: 8304247

Uniformat Code: B3080  
Recommendation: **Replace in 2025**

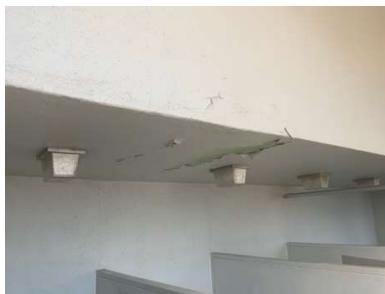
## Ceiling Finishes in Failed condition.

any flat surface  
Gymnasium Levi Elementary Throughout Building

Paint peeling, stained, cracking - AssetCALC ID: 8304245

Uniformat Code: C2050  
Recommendation: **Prep & Paint in 2025**

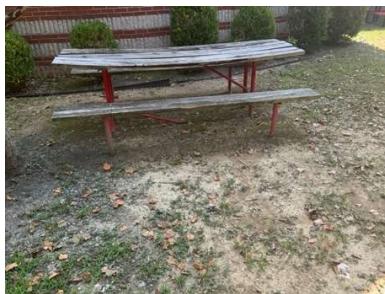
## Picnic Table in Poor condition.

Wood/Composite/Fiberglass  
Classroom Building Levi Elementary Site

Wood is cupped - AssetCALC ID: 8305196

Uniformat Code: G2060  
Recommendation: **Replace in 2026**

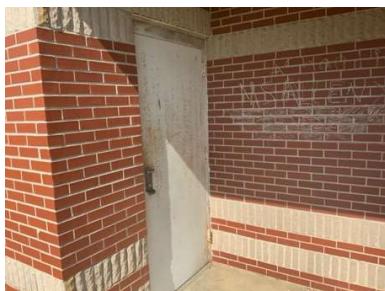
## Exterior Door in Poor condition.

Steel, Standard  
Classroom Building Levi Elementary Building Exterior

Showing rust damage - AssetCALC ID: 8305215

Uniformat Code: B2050  
Recommendation: **Replace in 2026**

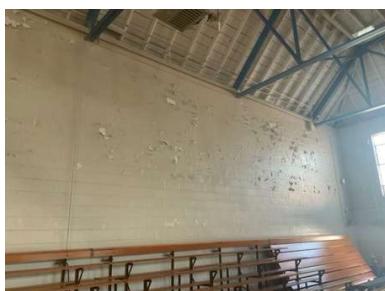
## Wall Finishes in Poor condition.

any surface  
Gymnasium Levi Elementary Gymnasium

Paint is peeling - AssetCALC ID: 8304215

Uniformat Code: C2010  
Recommendation: **Prep & Paint in 2026**

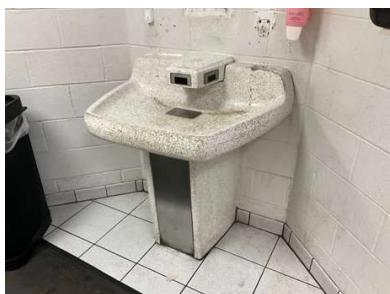
## Sink/Lavatory in Poor condition.

Trough Style, Solid Surface  
Classroom Building Levi Elementary Hallways  
& Common Areas

Uniformat Code: D2010  
Recommendation: **Replace in 2026**
