FACILITY CONDITION ASSESSMENT

Shelby County Board of Education
160 South Hollywood Street
Memphis, Tennessee 38112-4892
Michelle Stuart

Lucie E. Campbell Elementary School
3232 Birchfield Drive
Memphis, Tennessee 38127

April 19, 2024

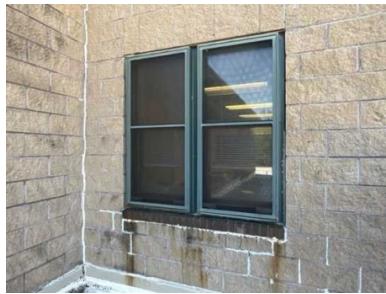
Exterior Walls in Poor condition.

Concrete Block (CMU)

Refresh and address previous repair areas - AssetCALC ID: 7177828

| ID | Location | Location Description | UF Code | Description | Condition | Plan Type | Cost |
|---|---|---|---|---|---|---|---|
| 7177828 | Lucie E. Campbell Elementary School | Building exterior | B2010 | Exterior Walls, Concrete Block (CMU), Repair/Repoint | Poor | Performance/Integrity | \$20,000 |

Recommendation: **Repair/Repoint in 2023**

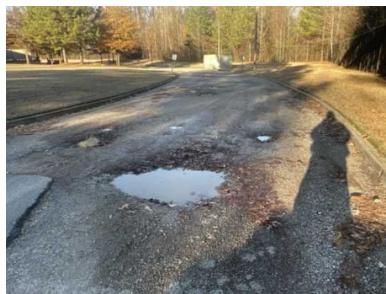
Site asphalt pavement is heavily weathered and cracked with potholes in several areas on the roadway which goes around the rear of the school. Pavement markings are also heavily weathered and worn. An allowance to mill and overlay the asphalt pavement has been included in the asset listing.

Parking Lots in Poor condition.

Pavement, Asphalt

Alligator cracking and potholes - AssetCALC ID: 7168627

Recommendation: **Mill and Overlay in 2025**

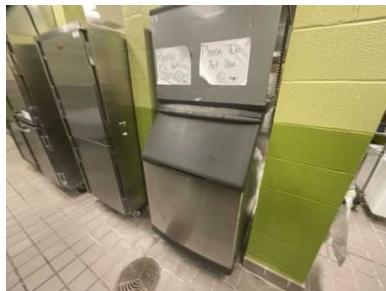
Foodservice Equipment in Failed condition.

Icemaker, Freestanding

Not operating - AssetCALC ID: 7168683

| ID | Location | Location Description | UF Code | Description | Condition | Plan Type | Cost |
|---|---|---|---|---|---|---|---|
| 7168683 | Lucie E. Campbell Elementary School | Kitchen | E1030 | Foodservice Equipment, Icemaker, Freestanding, Replace | Failed | Performance/Integrity | \$6,700 |

Recommendation: **Replace in 2023**

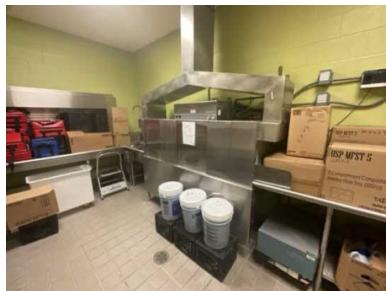
Foodservice Equipment in Failed condition.

Dishwasher Commercial

Out of service - AssetCALC ID: 7168650

| ID | Location | Location Description | UF Code | Description | Condition | Plan Type | Cost |
|---|---|---|---|---|---|---|---|
| 7168650 | Lucie E. Campbell Elementary School | Kitchen | E1030 | Foodservice Equipment, Dishwasher Commercial, Replace | Failed | Performance/Integrity | \$21,500 |

Recommendation: **Replace in 2023**

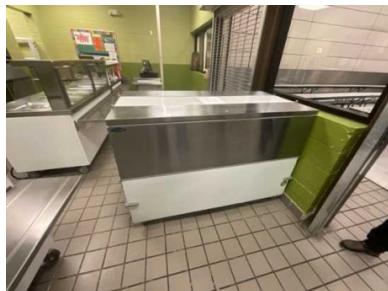
Foodservice Equipment in Failed condition.

Refrigerator, Undercounter 1-Door
 Lucie E. Campbell Elementary School Kitchen
 Uniformat Code: E1030
 Recommendation: **Replace in 2023**

Out of service - AssetCALC ID: 7168599

| ID | Location | Location Description | UF Code | Description | Condition | Plan Type | Cost |
|---|---|---|---|---|---|---|---|
| 7168599 | Lucie E. Campbell Elementary School | Kitchen | E1030 | Foodservice Equipment, Refrigerator, Undercounter 1-Door, Replace | Failed | Performance/Integrity | \$1,100 |

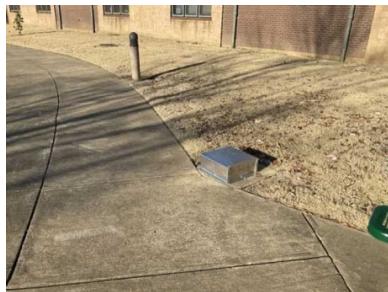
There are reports that the site lighting is inadequate along the rear roadway and in the main parking lots and there is a desire to upgrade the existing lighting as well as add additional lighting in these areas.

Site Walkway Fixture w/ Lamp in Poor condition.

Bollard Style
 Lucie E. Campbell Elementary School Site
 Uniformat Code: G4050
 Recommendation: **Replace/Install in 2024**

Some lights damaged and missing - AssetCALC ID: 7168625
