# FACILITY CONDITION ASSESSMENT

**Shelby County Board of Education**  
160 South Hollywood Street  
Memphis, Tennessee 38112-4892  
Michelle Stuart

Lucy Elementary School  
6269 Amherst Road  
Millington, Tennessee 38053

*October 28, 2024*

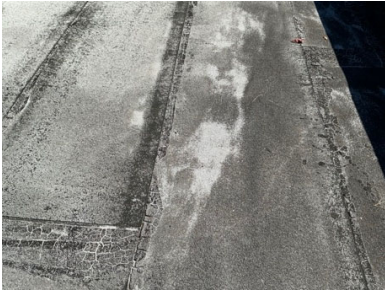
### Roofing in Poor condition.

Single-Ply Membrane, TPO/PVC  
Main Building Lucy Elementary School Roof

Roof is very stained and damaged. - AssetCALC ID: 8483571

Uniformat Code: B3010  
Recommendation: **Replace in 2025**

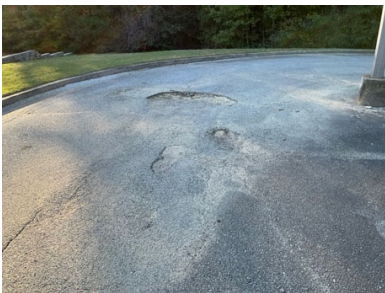
Site maintenance appears to be average, and site improvements and landscaping are generally in fair condition. Sidewalks are in fair condition. The asphalt pavement located near the back of the main building's parking area is heavily worn with cracking and holes throughout, and replacement is recommended.

### Parking Lots in Poor condition.

Pavement, Asphalt  
Site Lucy Elementary School Site

Parking lot behind school has potholes in the pavement - AssetCALC ID: 8483581

ID	Location	Location Description	UF Code	Description	Condition	Plan Type	Cost
8483581	Lucy Elementary School / Site	Site	G2020	Parking Lots, Pavement, Asphalt, Cut & Patch	Poor	Performance/Integrity	\$5,500
<b>Total (1 items)</b>							<b>\$5,500</b>

Uniformat Code: G2020  
Recommendation: **Cut and Patch in 2024**

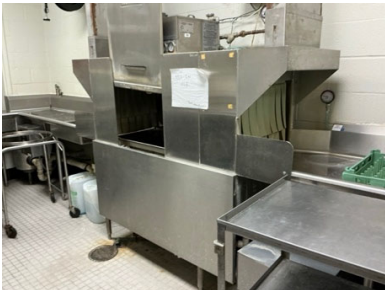
### Foodservice Equipment in Failed condition.

Dishwasher Commercial  
Main Building Lucy Elementary School Kitchen

This dishwasher is currently out of order. - AssetCALC ID: 8483396

Uniformat Code: E1030  
Recommendation: **Replace in 2024**

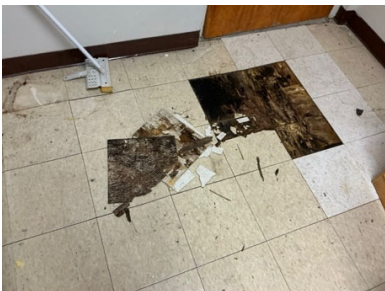
### Flooring in Poor condition.

Vinyl Tile (VCT)  
Annex Lucy Elementary School Annex Art Room

Bad leak has caused the floor to break and become uneven - AssetCALC ID: 8483466

ID	Location	Location Description	UF Code	Description	Condition	Plan Type	Cost
8483466	Lucy Elementary School / Annex	Annex Art Room	C2030	Flooring, Vinyl Tile (VCT), Repair	Poor	Performance/Integrity	\$800
<b>Total (1 items)</b>							<b>\$800</b>

Uniformat Code: C2030  
Recommendation: **Repair in 2024**

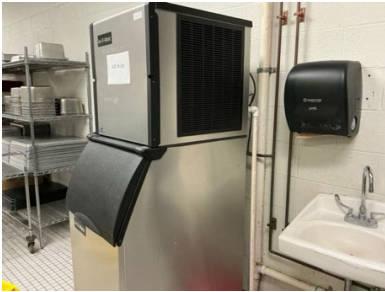
### Foodservice Equipment in Poor condition.

Icemaker, Freestanding  
Main Building Lucy Elementary School Kitchen

Ice maker is not operational - AssetCALC ID: 8483418

Uniformat Code: E1030  
Recommendation: **Replace in 2024**

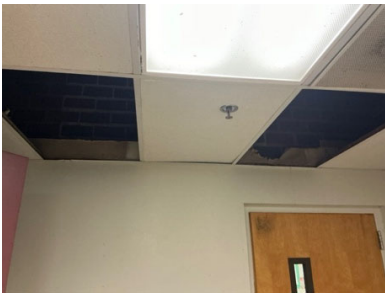
### Suspended Ceilings in Poor condition.

Acoustical Tile (ACT)  
Annex Lucy Elementary School Annex Art Room

Bad leak has caused ceiling tiles to break and fall. - AssetCALC ID: 8483417

Uniformat Code: C1070  
Recommendation: **Replace in 2026**

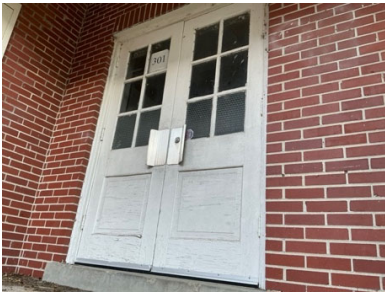
### Exterior Door in Poor condition.

Wood, any type  
Annex Lucy Elementary School Annex

Wood is starting to rot - AssetCALC ID: 8483462

Uniformat Code: B2050  
Recommendation: **Refinish in 2026**

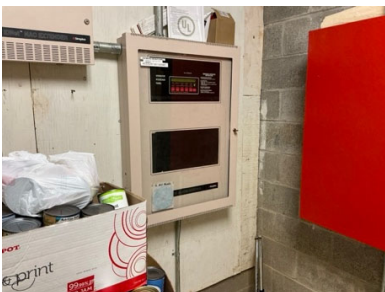
### Fire Alarm System

Full System Upgrade, Standard Addressable  
Main Building Lucy Elementary School

Uniformat Code: D7050  
Recommendation: **Install in 2026**
