# FACILITY CONDITION ASSESSMENT

**Shelby County Board of Education**  
160 South Hollywood Street  
Memphis, Tennessee 38112-4892  
Michelle Stuart

Macon Hall Elementary  
9800 Macon Road  
Memphis, Tennessee 38016

*July 31, 2024*

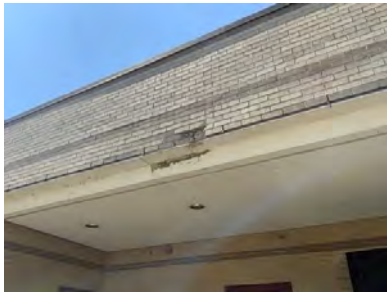
### Exterior Walls in Poor condition.

Brick  
Main Building Macon Hall Elementary Building  
Exterior

Damaged possibly hit by truck - AssetCALC ID: 7696308

Uniformat Code: B2010  
Recommendation: **Repair/Repoint in 2024**

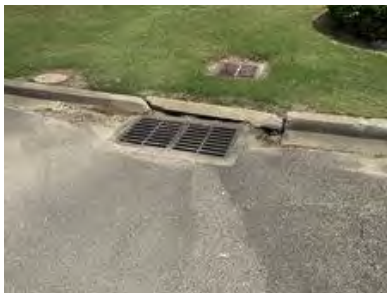
### Storm Drainage Components in Poor condition.

Catch Basin, 6' Deep  
Main Building Macon Hall Elementary Site

Breaking up - AssetCALC ID: 7696383

Uniformat Code: G3030  
Recommendation: **Replace/Install in 2026**

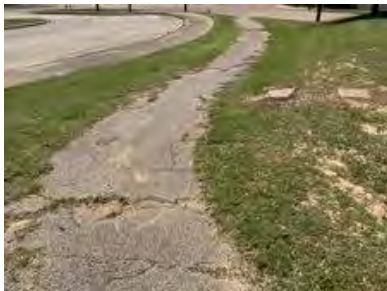
### Sidewalk in Poor condition.

Asphalt  
Main Building Macon Hall Elementary Site

Breaking up, cracked, weeds - AssetCALC ID: 7696382

Uniformat Code: G2030  
Recommendation: **Replace in 2026**

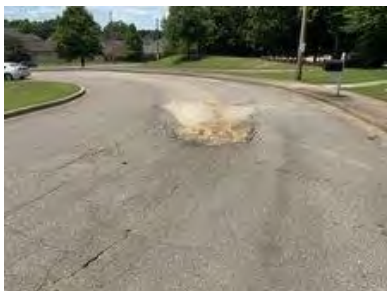
### Parking Lots in Poor condition.

Pavement, Asphalt  
Main Building Macon Hall Elementary Site

Broken out to gravel - AssetCALC ID: 7696281

Uniformat Code: G2020  
Recommendation: **Cut and Patch in 2024**

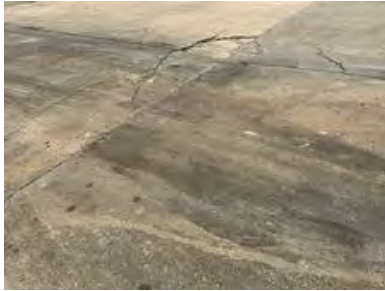
### Parking Lots in Poor condition.

Pavement, Concrete  
Main Building Macon Hall Elementary Site

Cracked, heaving - AssetCALC ID: 7696301

Uniformat Code: G2020  
Recommendation: **Replace in 2026**

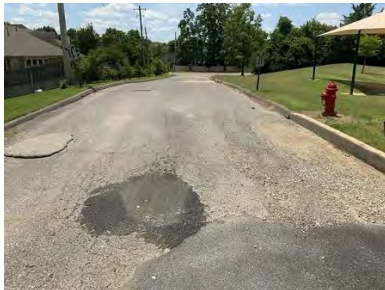
### Parking Lots in Poor condition.

Pavement, Asphalt  
Main Building Macon Hall Elementary Site

patches, breaking up - AssetCALC ID: 7696277

Uniformat Code: G2020  
Recommendation: **Mill and Overlay in 2026**

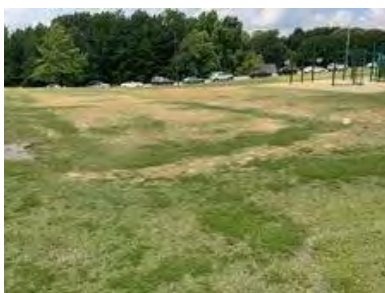
### Landscaping in Poor condition.

Eroded Areas, Sodding  
Main Building Macon Hall Elementary Site

Washed out areas - AssetCALC ID: 7696349

Uniformat Code: G2080  
Recommendation: **Repair in 2024**

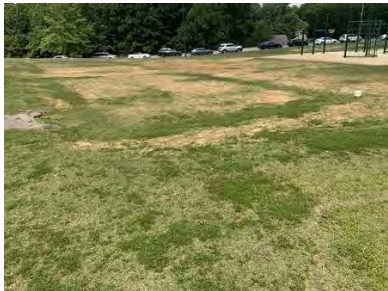
Landscaping in Poor condition.

Lawns and Grounds, Re-Establishment  
Main Building Macon Hall Elementary Site

Worn bare. Does not include around 5th grade building - AssetCALC ID: 7696386

Uniformat Code: G2080  
Recommendation: **Repair in 2024**

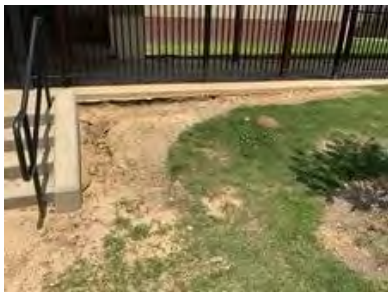
Landscaping in Poor condition.

Lawns and Grounds, Re-Establishment  
Main Building Macon Hall Elementary Site

Washing out, worn - AssetCALC ID: 7696271

Uniformat Code: G2080  
Recommendation: **Repair in 2024**

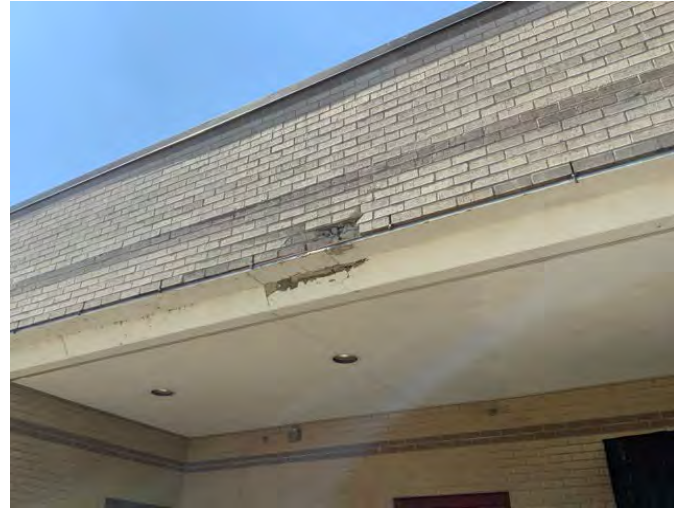
14 - EXTERIOR WALLS DAMAGED

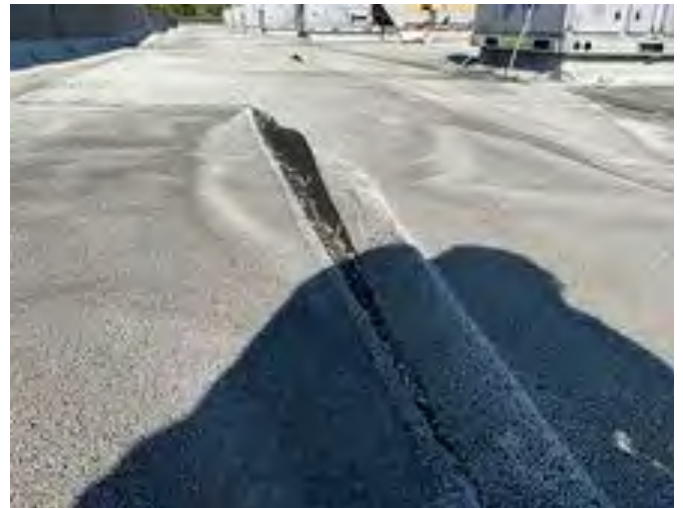
16 - BLISTERED ROOF

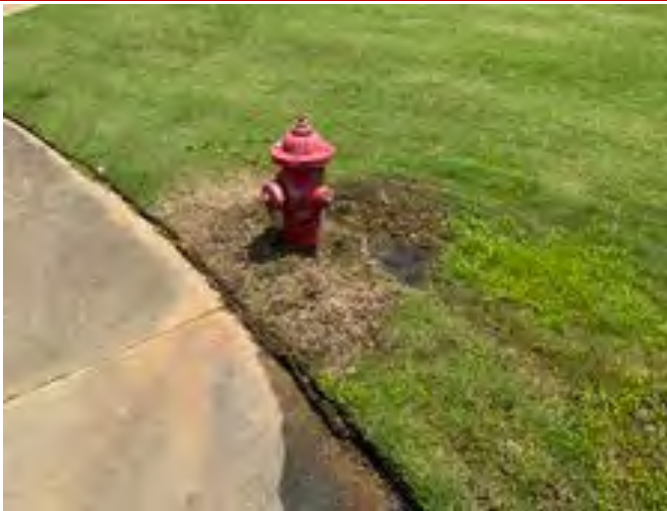
37 - HYDRANT (LEAKING)
