FACILITY CONDITION ASSESSMENT

Melrose High School
2870 Deadrick Avenue
Memphis, Tennessee 38114

April 19, 2024

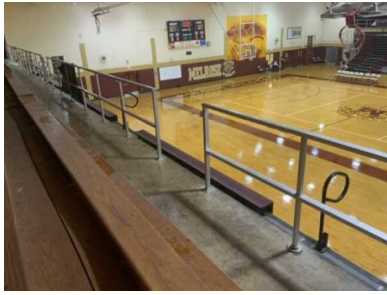
Stair/Ramp Rails in Failed condition.

Metal
Melrose High School Gymnasium

Missing gates to stop walking off, gaps too wide - AssetCALC ID: 7210012

Uniformat Code: B1080
Recommendation: **Repair/Install in 2024**

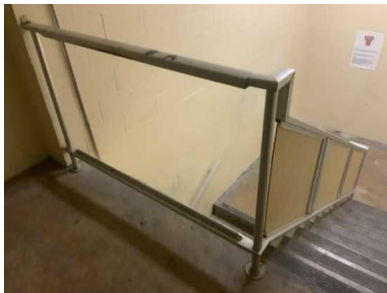
Stair/Ramp Rails in Failed condition.

Metal
Melrose High School Stairwells

Missing panel off mezzanine, some joints missing connectors - AssetCALC ID: 7209969

Uniformat Code: B1080
Recommendation: **Refinish in 2024**

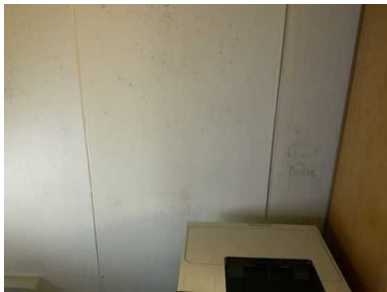
Wall Finishes in Poor condition.

Wallpaper
Melrose High School Classrooms

Peeling in some rooms - AssetCALC ID: 7209926

Uniformat Code: C2010
Recommendation: **Replace in 2025**

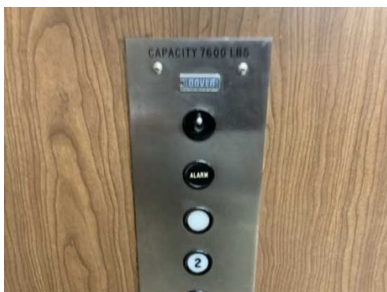
Passenger Elevator in Poor condition.

Hydraulic, 2 Floors
Melrose High School Elevator

Doors don't fully open Regular service calls almost weekly - AssetCALC ID: 7209932

Uniformat Code: D1010
Recommendation: **Renovate in 2025**

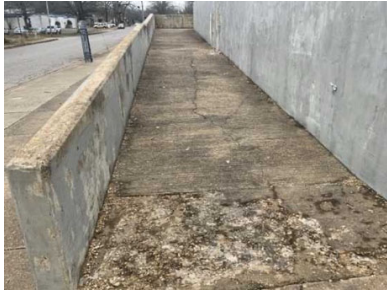
Sidewalk in Poor condition.

Concrete, Large Areas
Melrose High School Site

Cracked, severe spalling in areas - AssetCALC ID: 7209977

Uniformat Code: G2030
Recommendation: **Replace in 2025**

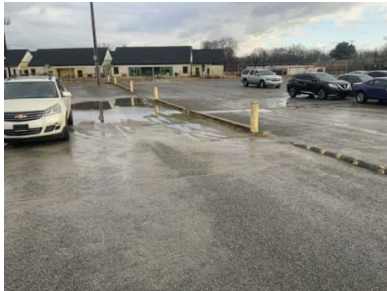
Parking Lots in Poor condition.

Pavement, Asphalt
Melrose High School Site

Potholes, not sealed, broken curbs, needs stripes - AssetCALC ID: 7209914

Uniformat Code: G2020
Recommendation: **Mill and Overlay in 2025**

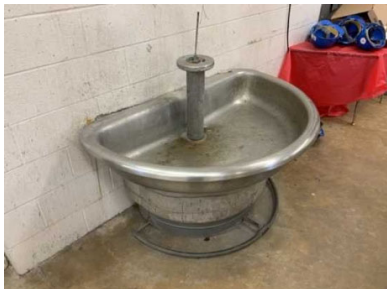
Sink/Lavatory

Trough Style, Solid Surface
Melrose High School Classrooms

Top removed Out of service - AssetCALC ID: 7209935

Uniformat Code: D2010
Recommendation: **Replace in 2024**

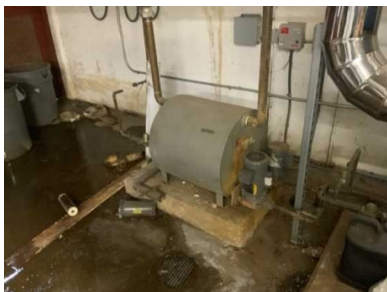
HVAC Steam Components in Failed condition.

Pump, Condensate Water Return
Melrose High School Boiler room

Out of service - AssetCALC ID: 7209989

Uniformat Code: D3050
Recommendation: **Replace in 2024**

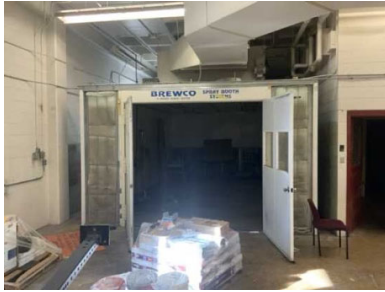
Paint Booth in Failed condition.

Pre-Engineered Structure, Fully Wired and Conditioned, ~ 600 GSF
Melrose High School Classrooms

Out of service - AssetCALC ID: 7209799

Uniformat Code: F1020
Recommendation: **Replace in 2023**

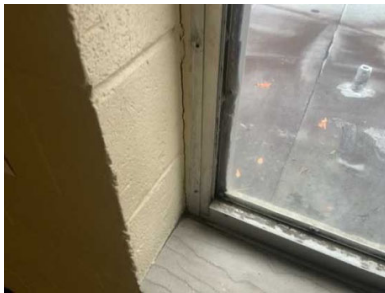
Caulking in Poor condition.

Window Edge/Trim, per 12 SF Window (or 14 LF)
Melrose High School Building Exterior

Cracked all around on inside - AssetCALC ID: 7209793

Uniformat Code: B2010
Recommendation: **Replace in 2024**

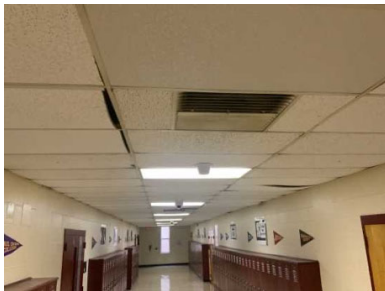
Suspended Ceilings in Poor condition.

Acoustical Tile (ACT)
Melrose High School Throughout building

Missing in areas, very dirty, poor fitting, bowing down in areas - AssetCALC ID: 7210016

Uniformat Code: C1070
Recommendation: **Replace in 2025**

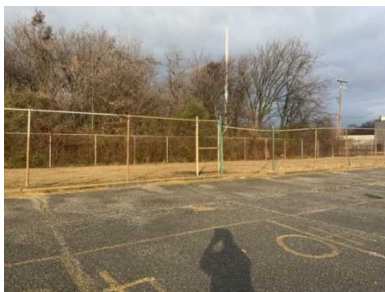
Fences and Gates in Poor condition.

Fence, Chain Link 8'
Melrose High School Site

Poles bent, rails not connected, rusted out - AssetCALC ID: 7210023

Uniformat Code: G2060
Recommendation: **Replace in 2025**

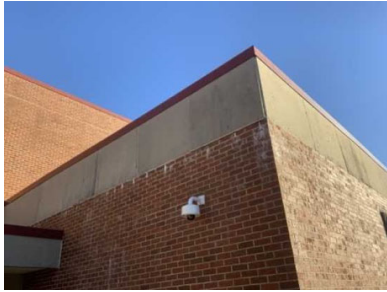
Caulking in Poor condition.

Cold Joints, 1/2" to 1"
Melrose High School Building Exterior

Areas are falling out - AssetCALC ID: 7209838

Uniformat Code: B2010
Recommendation: **Replace in 2025**

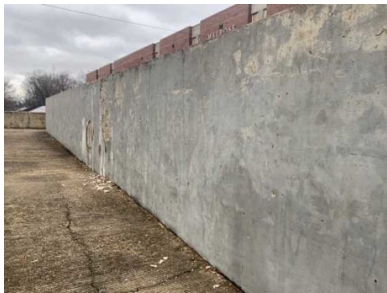
Retaining Wall in Poor condition.

Concrete Cast-in-Place
Melrose High School Site

Spalling falling off in areas - AssetCALC ID: 7209913

Uniformat Code: G2060
Recommendation: **Replace in 2025**

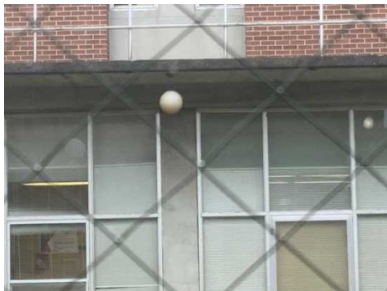
Exterior Fixture with Lamp in Poor condition.

any type, with LED Replacement
Melrose High School Courtyard

Many appear non-functional, lenses missing - AssetCALC ID: 7209975

Uniformat Code: G4050
Recommendation: **Replace in 2025**

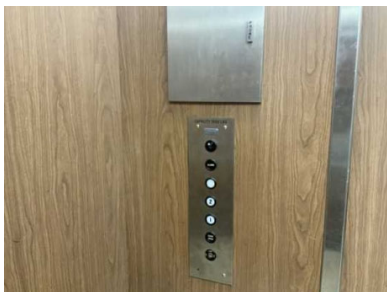
Elevator Controls in Poor condition.

Automatic, 1 Car
Melrose High School Elevator

Not current to ADA - AssetCALC ID: 7209954

Uniformat Code: D1010
Recommendation: **Replace in 2025**

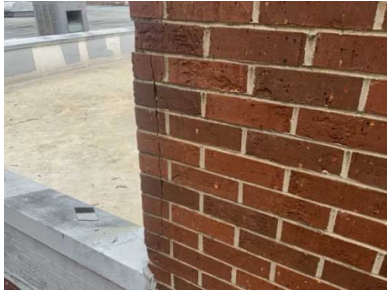
Exterior Walls in Poor condition.

Brick
Melrose High School Building Exterior

Damaged in multiple areas, including roof - AssetCALC ID: 7209883

Uniformat Code: B2010
Recommendation: **Repair/Repoint in 2024**

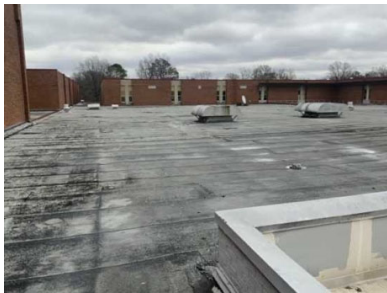
Roofing in Poor condition.

Modified Bitumen
Melrose High School Roof

Blistered, cracked, dams water flow - AssetCALC ID: 7209834

Uniformat Code: B3010
Recommendation: **Replace in 2025**

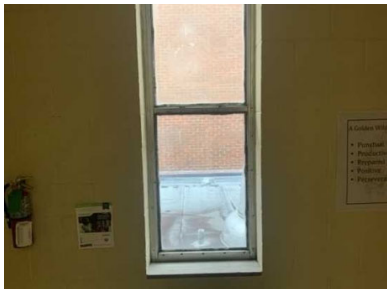
Window in Poor condition.

Aluminum Double-Glazed, up to 15 SF
Melrose High School Building Exterior

Single plexiglass, no call, bad window caulk - AssetCALC ID: 7210011

Uniformat Code: B2020
Recommendation: **Replace in 2025**

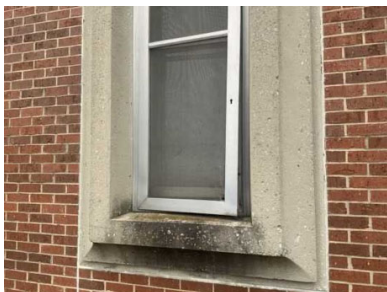
Window in Poor condition.

Aluminum Double-Glazed, up to 15 SF
Melrose High School Building Exterior

Some screens loose, need caulking, - AssetCALC ID: 7209887

Uniformat Code: B2020
Recommendation: **Replace in 2025**

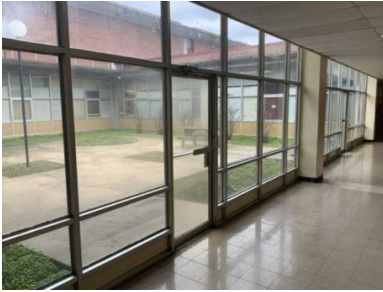
Storefront in Poor condition.

Glazing and Framing
Melrose High School Building Exterior

Single pane, glass cloudy, some leaks - AssetCALC ID: 7209915

Uniformat Code: B2020
Recommendation: **Replace in 2025**

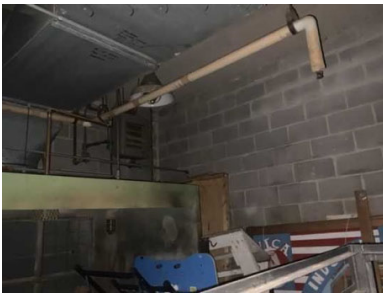
Fire Suppression System in Poor condition.

Full System Install/Retrofit, Low
Density/Complexity
Melrose High School Classrooms

In old finishing room and incinerator room. Reported out of service - AssetCALC ID: 7209833

Uniformat Code: D4010
Recommendation: **Renovate in 2025**

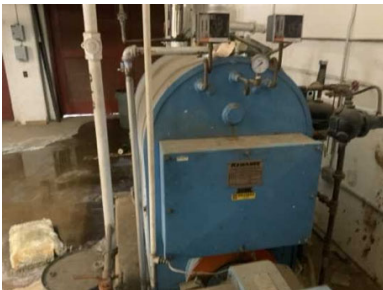
Boiler in Failed condition.

Gas, HVAC, 501 to 750 MBH
Melrose High School Boiler room

Out of service - AssetCALC ID: 7209941

Uniformat Code: D3020
Recommendation: **Replace in 2024**

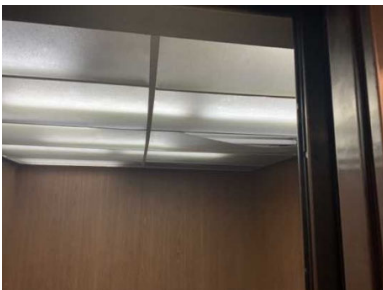
Elevator Cab Finishes in Poor condition.

Economy
Melrose High School Elevator

Worn, lights not fitting, control panel needs replacement - AssetCALC ID: 7210005

Uniformat Code: D1010
Recommendation: **Replace in 2025**

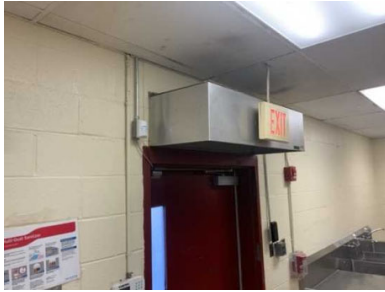
Supplemental Components in Poor condition.

Air Curtain, 5' Wide Non-Heated
Melrose High School Kitchen

Diffuser missing, no filter - AssetCALC ID: 7209939

Uniformat Code: D3060
Recommendation: **Replace in 2025**

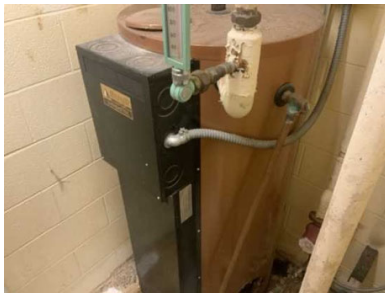
Water Heater in Failed condition.

Electric, Residential
Melrose High School Classrooms

Uniformat Code: D2010
Recommendation: **Replace in 2024**

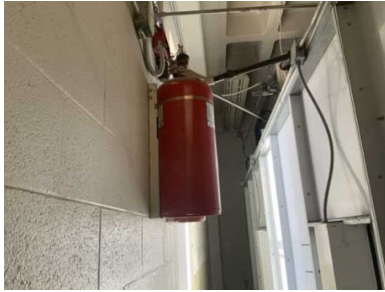
Fire Suppression System in Failed condition.

Commercial Kitchen, per LF of Hood
Melrose High School Classrooms

Out of service - AssetCALC ID: 7209888

Uniformat Code: D4010
Recommendation: **Replace in 2024**

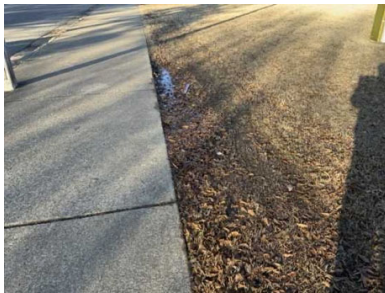
Landscaping in Poor condition.

Sod at Eroded Areas
Melrose High School Site

Multiple areas - AssetCALC ID: 7210026

Uniformat Code: G2080
Recommendation: **Repair in 2024**

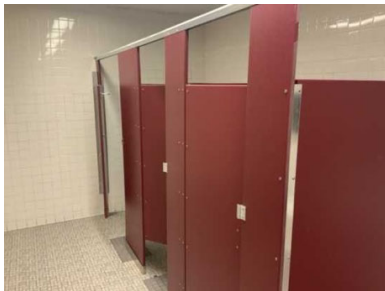
Toilet Partitions in Poor condition.

Plastic/Laminate
Melrose High School Restrooms

Some wood - AssetCALC ID: 7209817

Uniformat Code: C1090
Recommendation: **Replace in 2025**

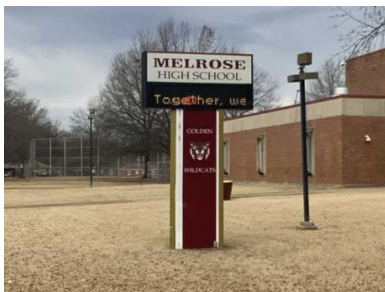
Signage in Poor condition.

Property, Pylon Robust/Electronic
Programmable
Melrose High School Site

Side and face damaged display color issues - AssetCALC ID: 7209866

Uniformat Code: G2060
Recommendation: **Replace/Install in 2025**

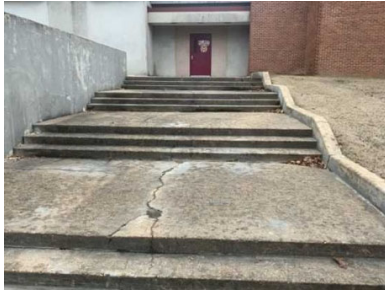
Stairs in Poor condition.

Concrete, Exterior
Melrose High School Site

Cracking - AssetCALC ID: 7209850

Uniformat Code: B1080
Recommendation: **Replace in 2025**

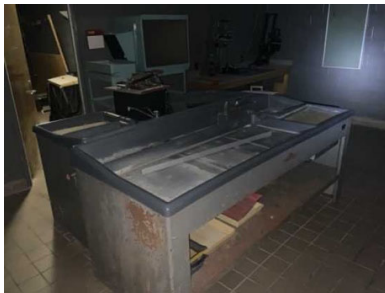
Sink/Lavatory

Trough Style, Solid Surface
Melrose High School Classrooms

Uniformat Code: D2010
Recommendation: **Replace in 2024**
